A Geophysical Investigation of Glacial Lake Outburst Potential of Nourse Moraine, Taiya River Watershed, Skagway, Alaska

**A Geophysical Investigation of Glacial
Lake Outburst Potential
of Nourse Moraine, Taiya River
Watershed, Skagway, Alaska**

BLM Open File Report 123
September 2009

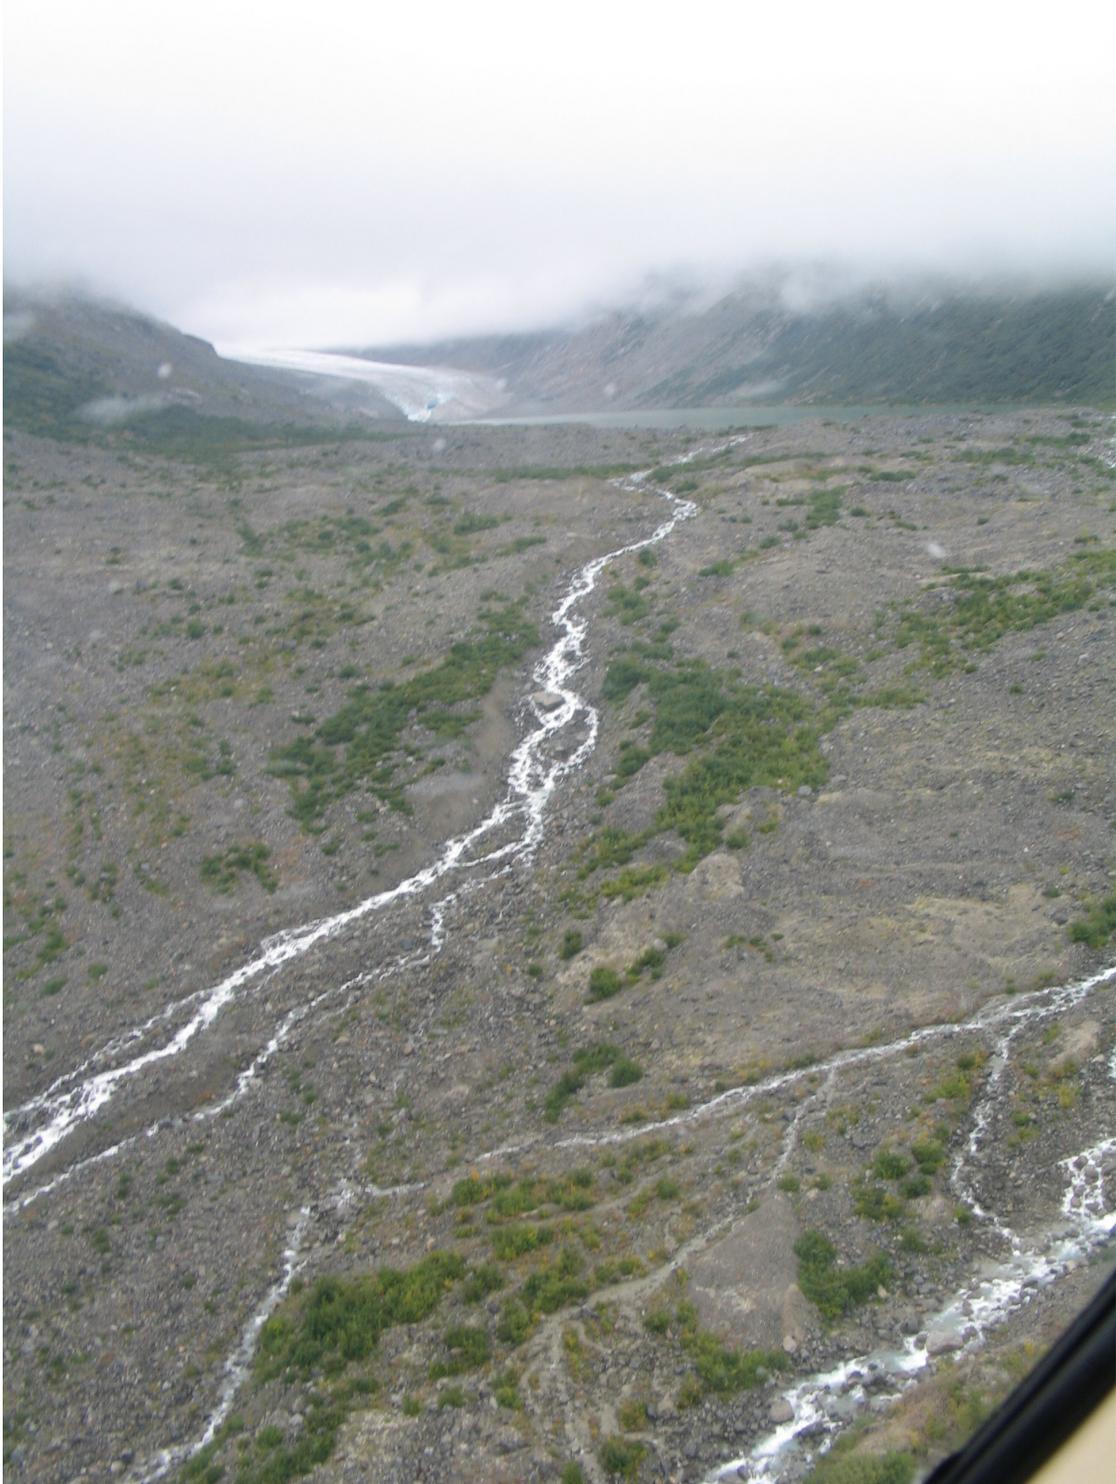
The Nourse Moraine (lat -135.4250, long 159.5693) impounds a large icy-blue proglacial lake known as Nourse Lake. The lake is estimated to occupy a surface area of 200 acres (80.94 ha) with a depth of 95 feet (28.956m) and spills over the moraine at two primary locations (Figure 1). With an estimated gradient of 14.5% (Capps, 2004), the outlets form high-gradient glacial streams that flow to a smaller unnamed proglacial lake. Eventually this watershed enters the Taiya River at a confluence approximately 8 miles (12.88 km) downstream. Located approximately 22 river miles (35.4 km) farther downstream is Dyea, Alaska. The broad, U-shaped Nourse and Taiya River valleys were carved out by past glacial events. Though the glaciers remain, they have significantly receded and mainly reside high in the mountains. The surface of Nourse Moraine is composed of multiple-size class sediments, including large boulders, cobbles, gravel and sand with clusters of dense vegetative growth, primarily common alder (*Alnus glutinosa*) (Figure 2). The Nourse Moraine has a measured length of 2640 ft (804 m), an average slope of 15%, and a calculated height of 396 ft (120 m) (Denton, 2005). The estimated width of the moraine is 2296 ft (700 m).

Figure 1. Two high-energy streams flow across the surface of Nourse Moraine to a downstream glacial lake. These streams initiate from a proglacial lake created by the retreat of the Nourse Glacier (*background*).

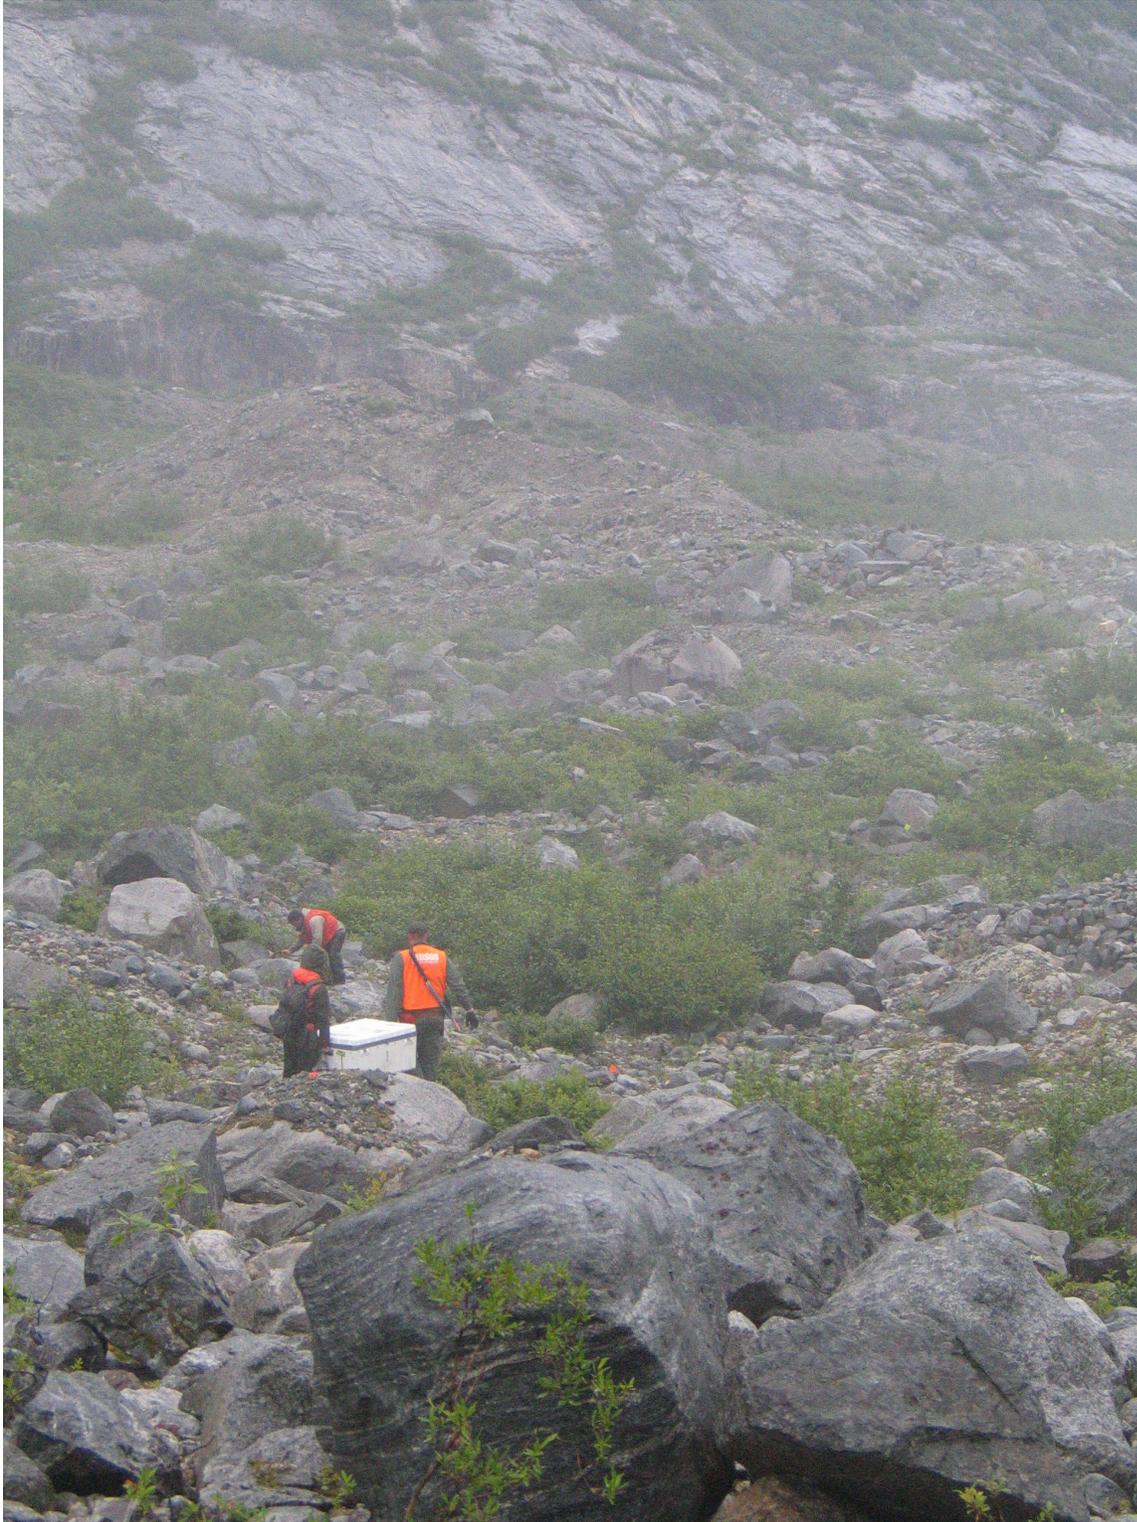
Figure 2. Nourse assessment team carries equipment across moraine composed of multiple-size class sediments, including large boulders, cobbles, gravel and sand.

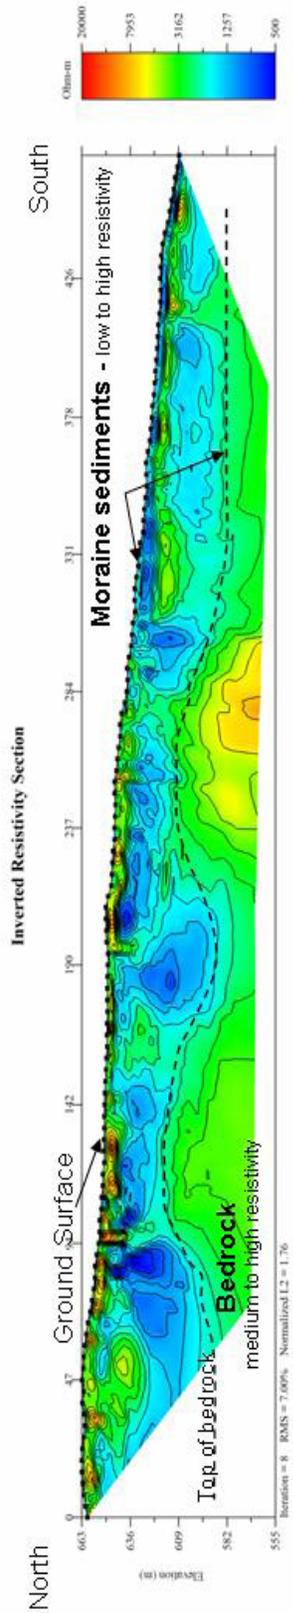
Figure 3. Resistivity profile of Nourse Moraine

Preliminary findings of each of the geophysical methods suggest there is no ice-core within the Nourse Moraine; however, the data were only collected on the western half of the moraine as access to the eastern half was too hazardous for helicopter landings or for crossing the moraine's outlets. To date, the dc resistivity results provide the best insight to the internal structure of the moraine (Figure 3). The 500m long (546.8 yd) resistivity profile indicates a thick layer (30m to 80m) (32.8yd to 87.48yd) of unconsolidated gravels and boulders atop a competent bedrock surface. The GEM survey (EM) acquired 20km (12.4274 miles) of data that shows spatial changes related to the various sediment deposits of the moraine (Figure 4). Simultaneous to the acquisition of the EM data, detailed topographic information (X, Y, Z) was collected with decimeter or better accuracies to produce a topographic map of the study area (available on request).

Preliminary Resistivity Profile of Nourse Moraine
 An unconsolidated layer of moraine sediments consisting primarily of gravel and boulders extends from ground surface to a the top of bedrock, varying in thickness from 30 to 80 meters (96ft to 256ft).

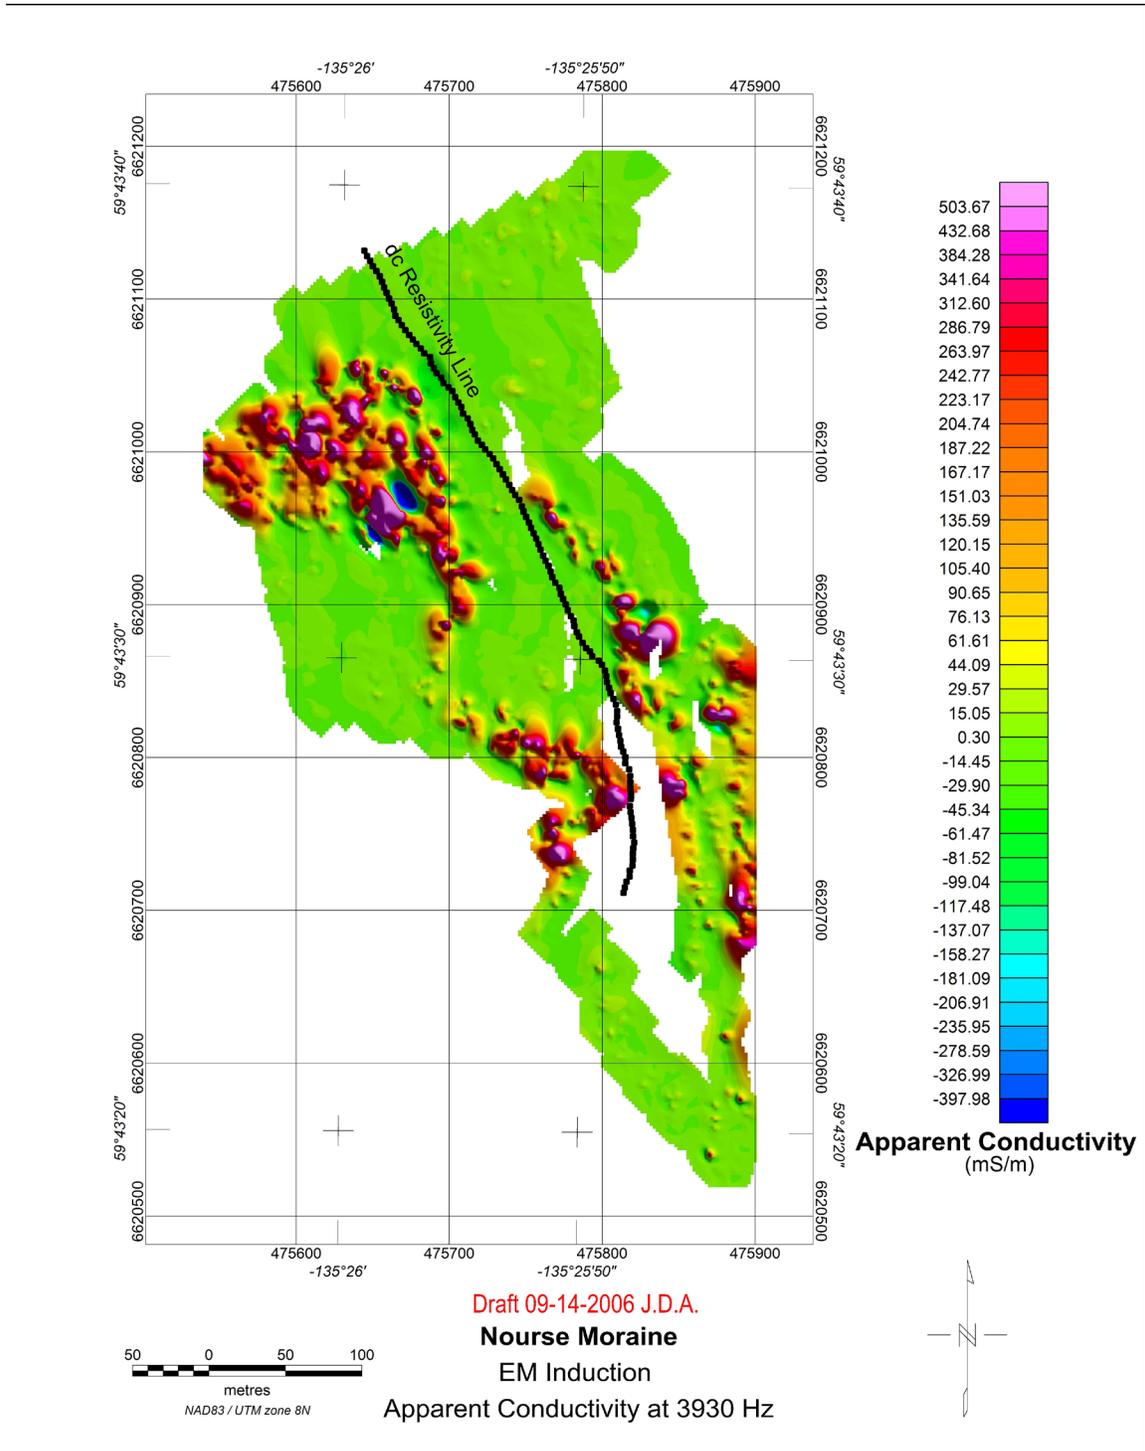
Figure 4. Map of EM Induction analysis and apparent conductivity at Nourse Moraine.

Although more time is needed to invert the EM information and obtain depth information, the preliminary data suggest the lack of an ice-core. The gravity meter rented from Scintrex is the best available gravity technology, but its battery problems significantly reduced the amount of gravity data collected. Though only 13 stations were acquired out of the 50 planned, the preliminary gravity data collected also suggest the lack of an ice-core.
