THE ALASKA EARTHQUAKE, MARCH 27, 1964:
EFFECTS ON TRANSPORTATION, COMMUNICATIONS, AND UTILITIES

Effect of the Earthquake
Of March 27, 1964, on
The Eklutna Hydroelectric
Project, Anchorage, Alaska

By MALCOLM H. LOGAN

GEOLOGICAL SURVEY PROFESSIONAL PAPER 545-A

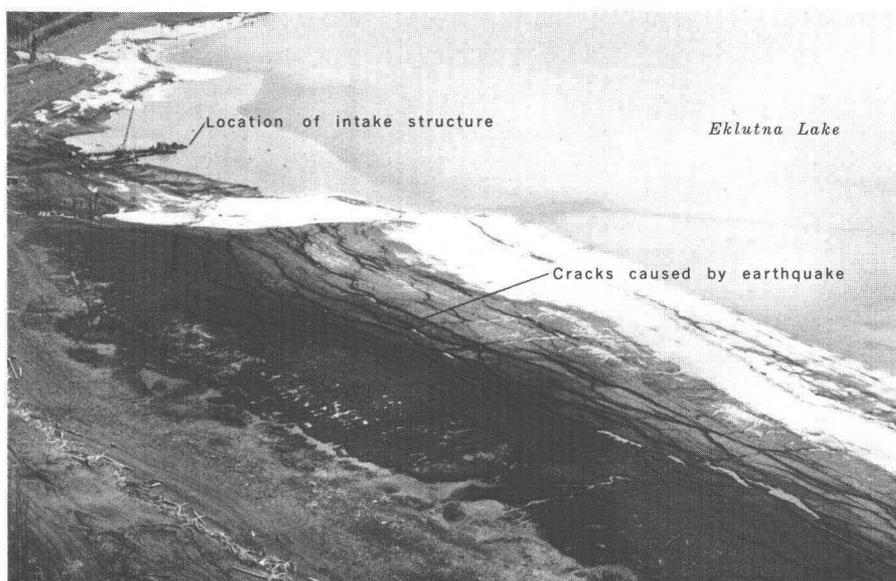
6.—View of Eklutna intake area, showing intricate network of cracks caused by the earthquake along the shore of the lake.

Earthquake-induced densification of materials in Eklutna Lake (fig. 6) caused the intake structure to move approximately 44 inches toward the lake. Principal movement was in a horizontal direction, but was accompanied by a lesser amount of vertical displacement.

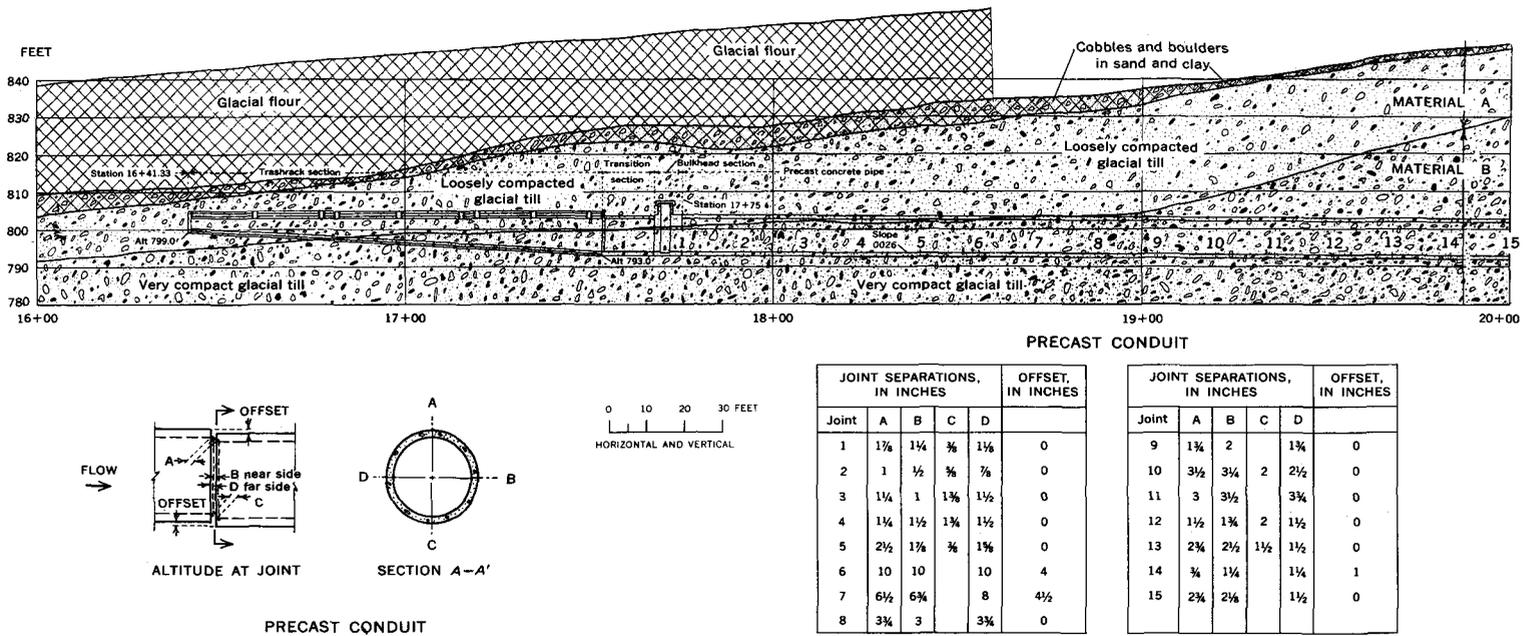
Tensional forces produced by the horizontal shift caused separation along joints in the precast conduit, as shown in figure 7. Unconsolidated sediments, ranging in size from fine sand to cobbles the size of a football, funneled through these ruptures. An elliptical cone-shaped depression, approximately 40 feet in maximum dimension, formed at the edge of Eklutna Lake over the conduit alignment near station 18+55, and numerous cracks were present along the lakeshore on either side of the conduit.

7.—Geologic section showing location of earthquake damage to intake structure. Rupturing of joints in the precast conduit occurred at the numbered locations. Amount and direction of movement is shown in the table. Failure on or within the bedding material, induced by the earthquake, is believed to have caused the damage to the intake structure. No earthquake damage in the glacial till foundation was detected.

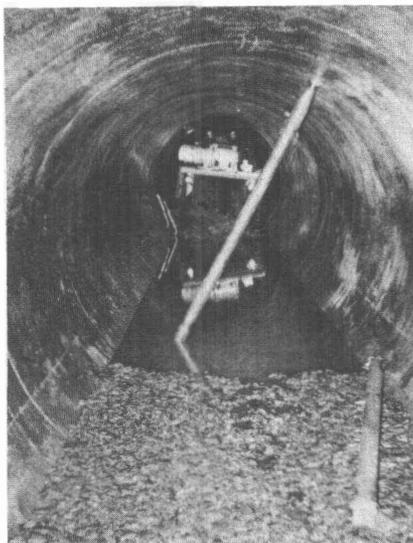
9.—Debris in Eklutna tunnel, typical of that deposited throughout the initial 3½ miles of tunnel as a result of the earthquake.

tunnel invert. The debris consisted predominantly of rock fragments 1 inch in diameter, but ranged in size from sand to an occasional fragment 14 inches across. The debris (fig. 9) was 12–18 inches deep and was uniformly distributed from the gate shaft at station 27+25 to near Station 103+00. From station 103+00 to station 235+00, debris was deposited in gravel bars of varying depths. The last mile of tunnel was relatively free of material. No structural damage to the tunnel was found.

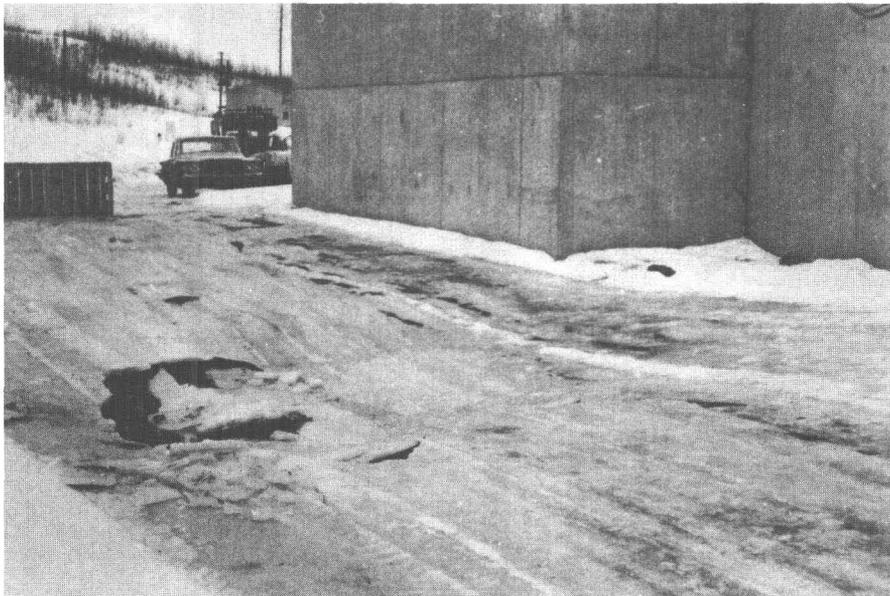
The penstock, surge tank, pile-supported anchor block, and powerhouse evidently oscillated as an integral unit during the earthquake. Very little relative movement occurred between these features although backfill in the anchor-block area subsided (fig. 13).

13 (left).—Earth settlement over the penstock anchor block directly behind the powerhouse. This settlement did not appear until 2 weeks after the earthquake. Presumably, the bridging effect of the blacktop and ground frost concealed the settlement during this period.

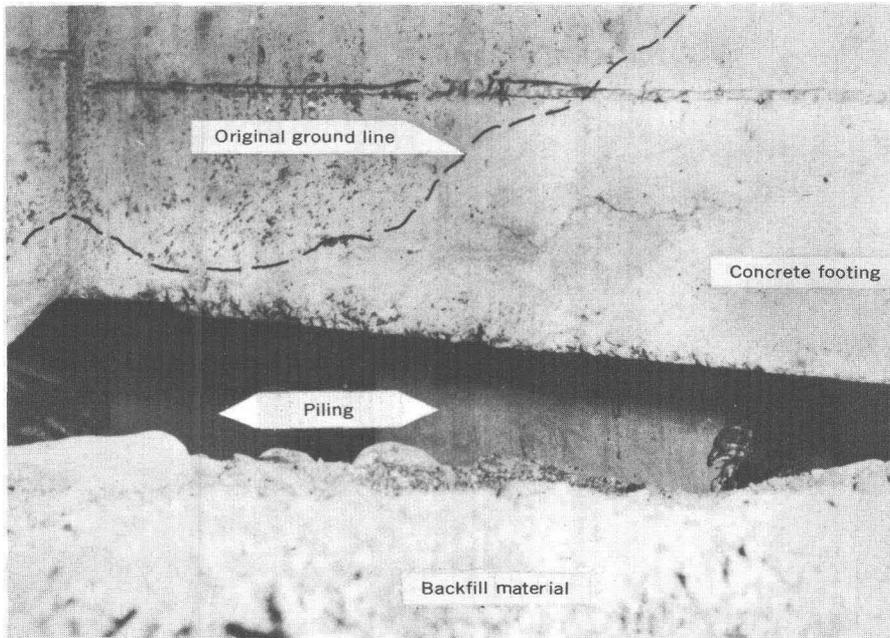
19.—Machine-shop foundation showing the separation of backfill material from the concrete footing. Approximately 1.5 feet of H-section pile is now exposed as a result of settlement caused by the earthquake.

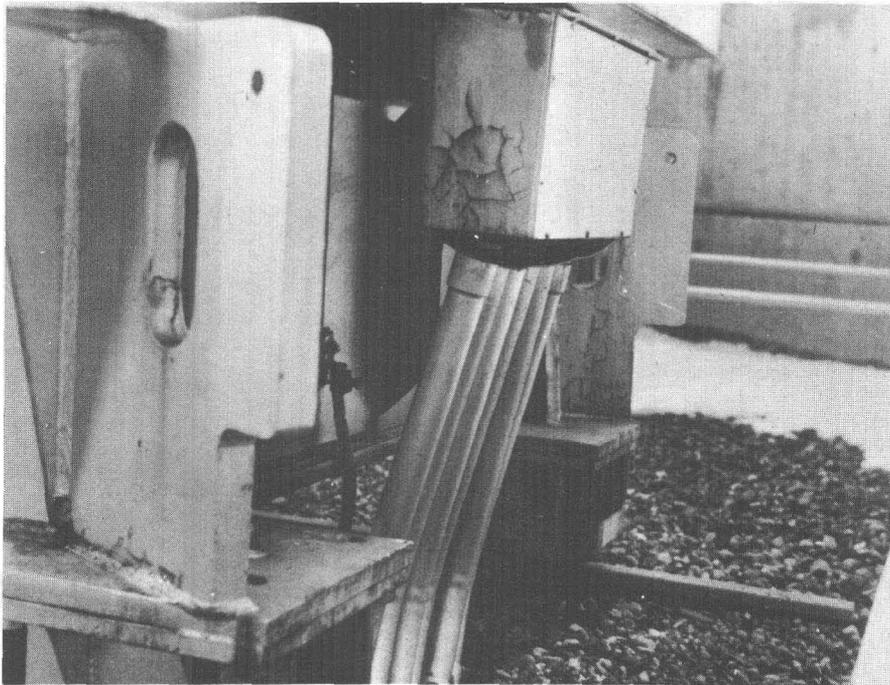
20.—The 20,000-kva transformer conduit and terminal box damaged by movement of the transformer during the earthquake. Rail stops consisted of a $\frac{1}{4}$ - by 1-inch-wide bar tack-welded to the rail. The tack-welds broke and allowed the transformer to move on the rails.

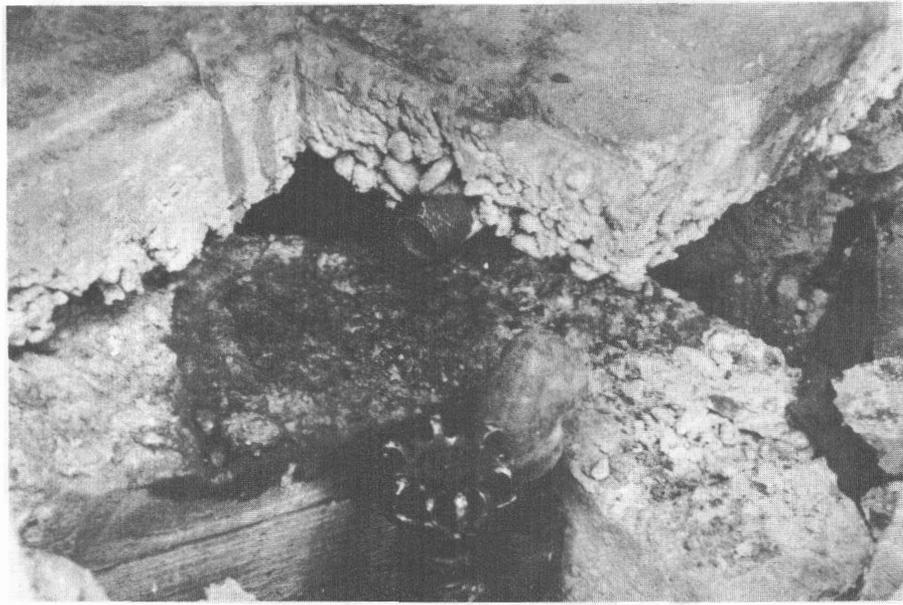
The ground beneath the north end of the wood-frame structure housing the automotive repair shop settled about 1 foot and moved approximately 10 inches horizontally along a tensional crack that destroyed the floor and the radiant heating system in the floor slab (fig. 21). Lighting fixtures were torn loose from the wall.

21.—Damage to the heating-system piping in the floor of the automotive repair shop caused by the earthquake.

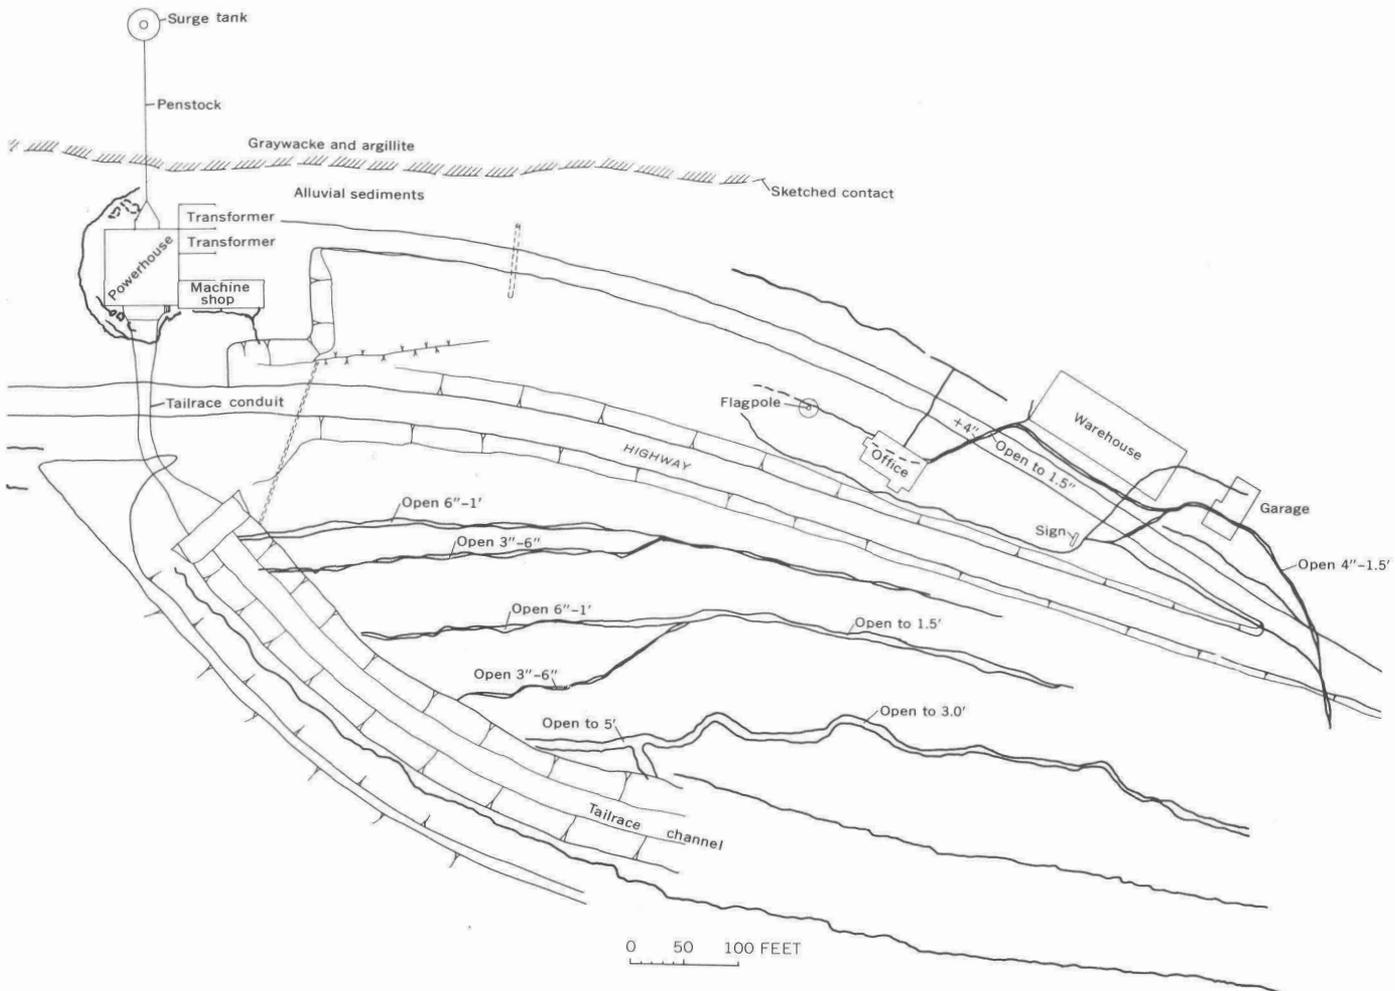
From a point west of the garage, cracks as much as a foot wide and several feet deep (figs. 22, 23) extended eastward adjacent to the north wall of the warehouse and crossed the roadway to the project office building. Cracks also extended from the garage to the southwest corner of the warehouse.

22.—Location of major earthquake cracks in the powerplant area.

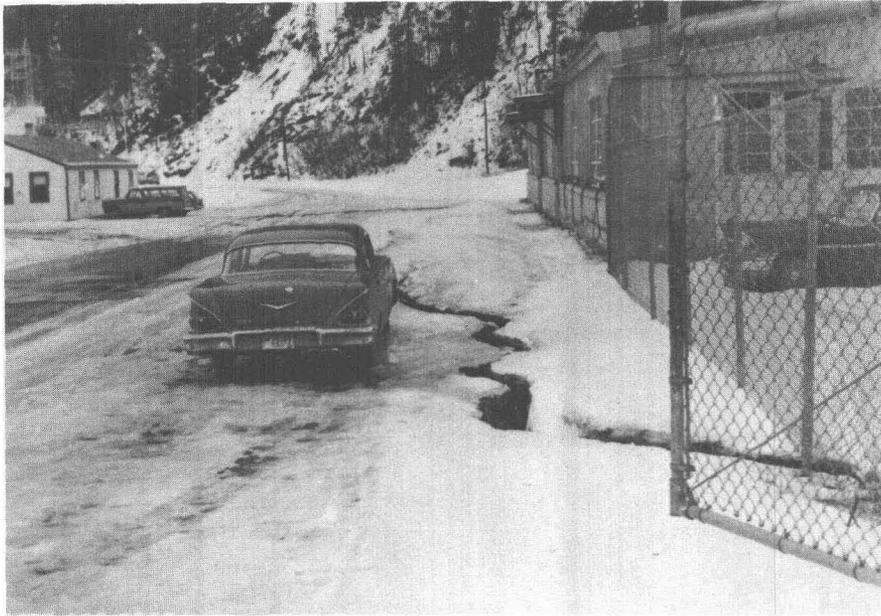
23.—Pavement damage caused by the earthquake. Cracks extend from the garage east along the north wall of the warehouse (right of photograph) and thence across the road to the project office (left of photograph).

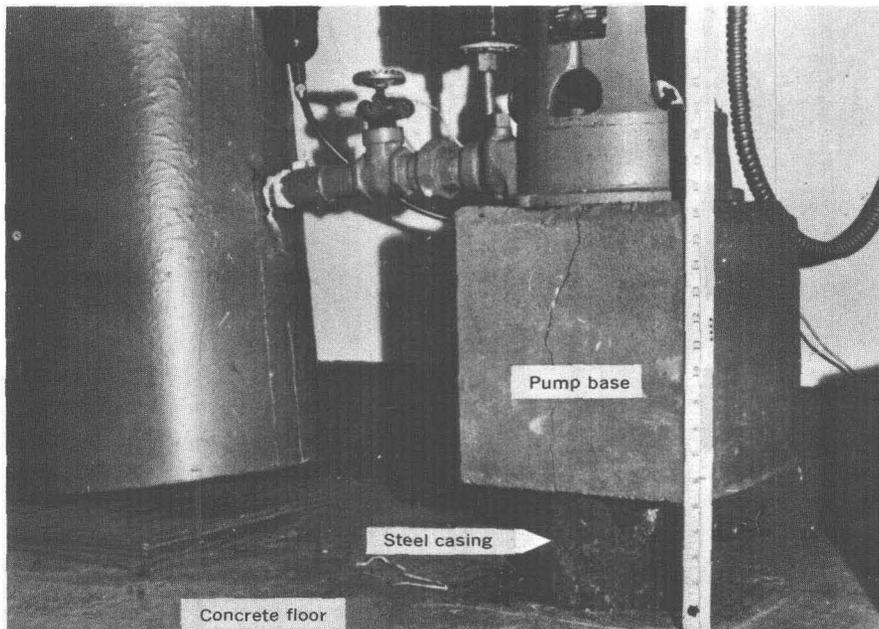
24.—Pump in Eklutna project office showing the effect of the earthquake. Base of pump is now approximately 5 inches above the floor.

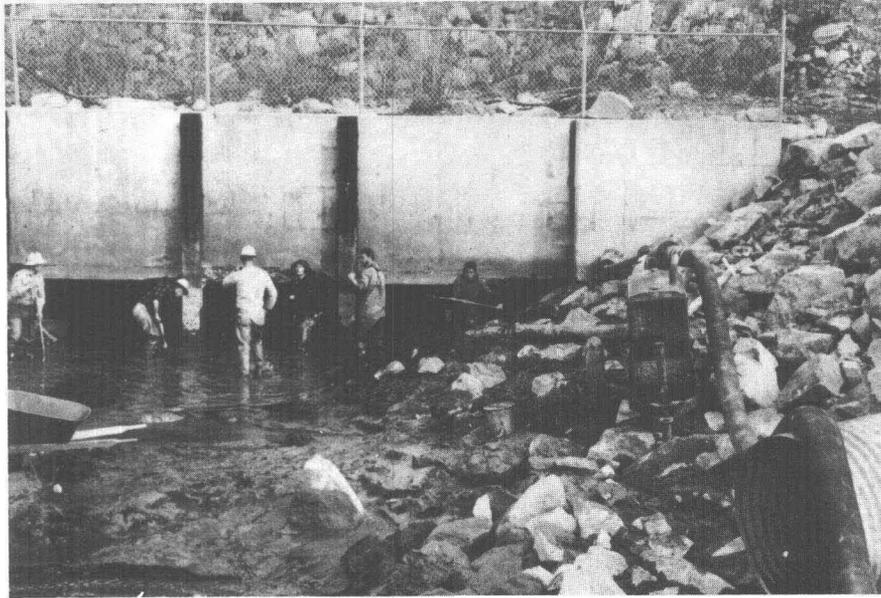
When the powerplant was shut down for repair of the intake (fig. 26), the 209-foot-long pressure tailrace conduit was inspected and cleaned. About 110 cubic yards of rock and mud had been deposited in the conduit, presumably after the break in the precast pipe section of the tunnel intake. The inspection also revealed considerable shifting of the sections nearest the powerplant (fig. 27). Regional subsidence raised the high-tide water level approximately 3 feet.

26.—Cleaning-up operation at the outlet of the tailrace conduit. Debris was deposited following the rupture of the tunnel intake at Eklutna Lake during the earthquake.

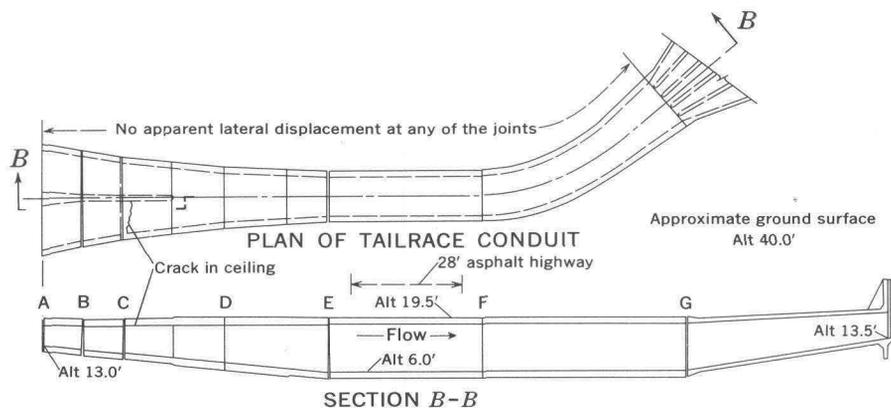
TAILRACE CONDUIT	
Joint	Remarks
A	Joint open $2\frac{1}{4}$ in. on top, open $\frac{3}{4}$ in. on bottom Waterstop torn for about 1 ft, gravel visible above tear
B	Joint open $\frac{3}{4}$ in. on top, open $1\frac{1}{2}$ in. on bottom with 3 in. vertical offset, downstream side lower. Larger leak on left side of left unit near floor
C	Joint closed on top, open $1\frac{1}{2}$ in. on bottom with $1\frac{1}{4}$ in. vertical offset, upstream side lower
Between C and D	Crack in ceiling, right unit
D	Joint closed
E	Joint open evenly $1\frac{1}{4}$ in. all around with $2\frac{1}{2}$ in. vertical offset, upstream side lower
F	Joint closed
G	Joint open 1 in. all around with $\frac{3}{4}$ in. vertical offset, upstream side lower. Leaking at top

27.—Summary of damage to tailrace conduit.

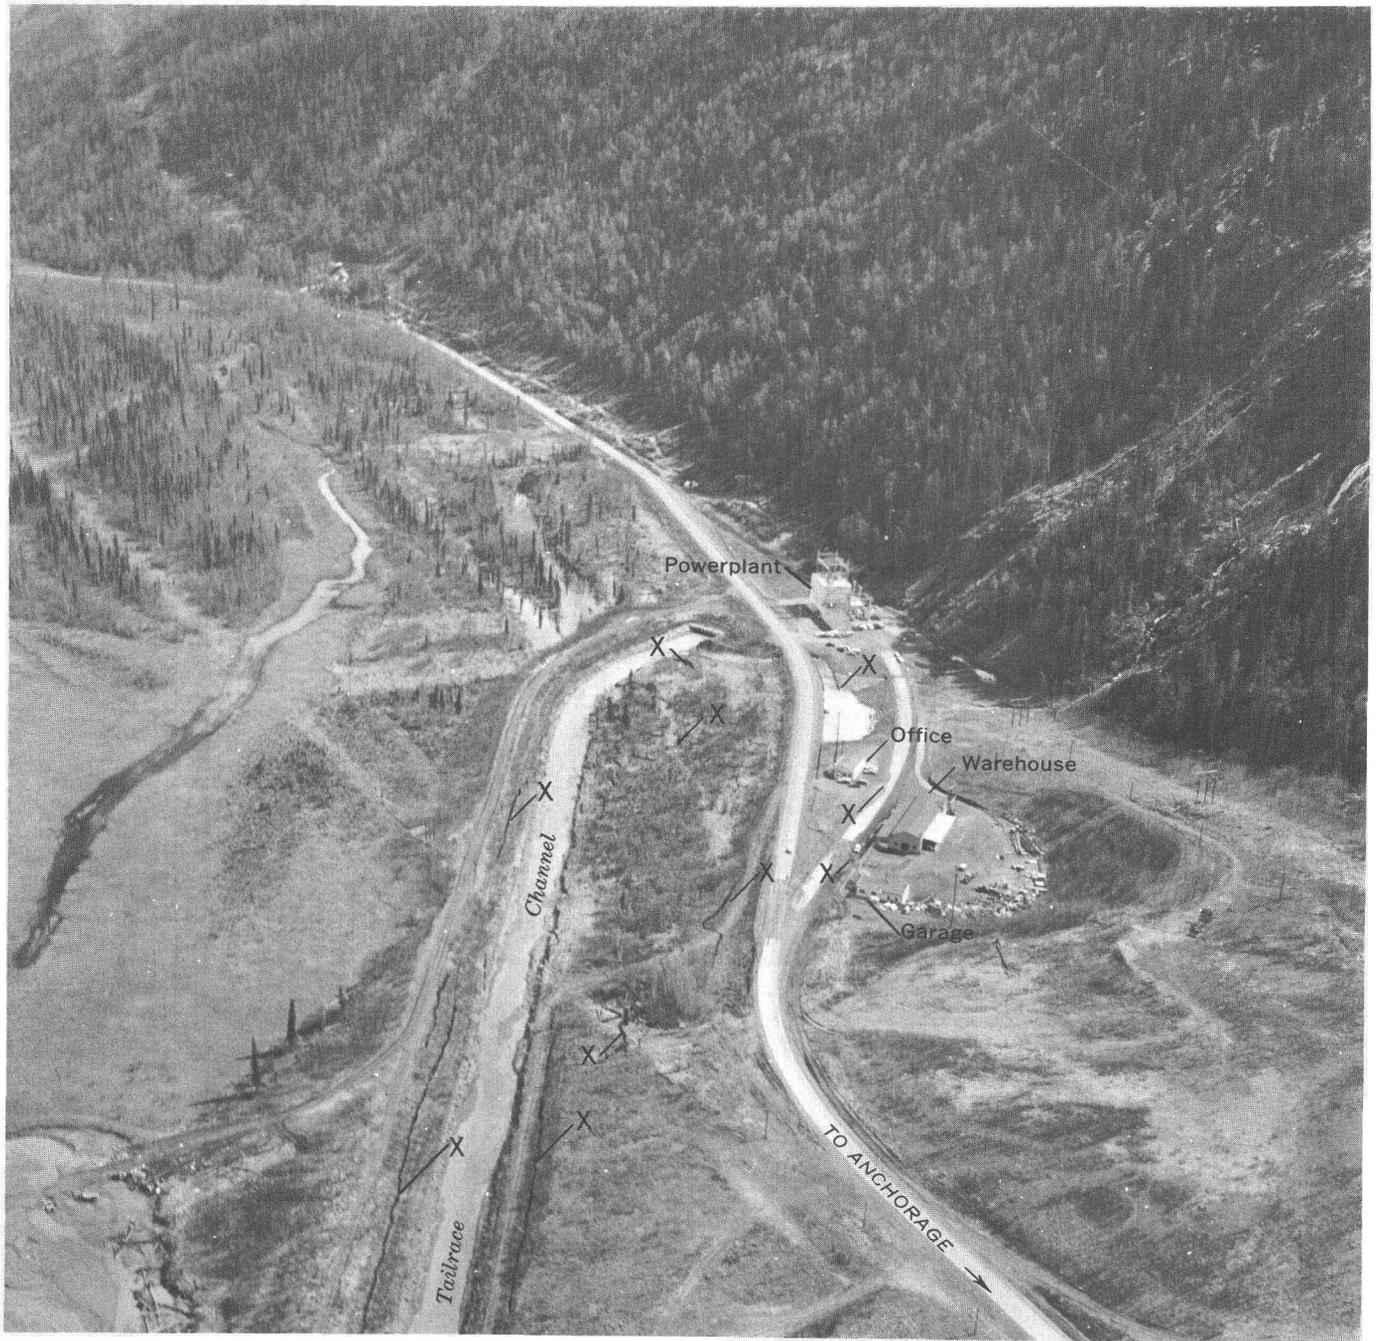
28.—Location of ground cracks in the vicinity of the powerplant.

The ground surface was severely cracked (fig. 28) in the area adjacent to, and parallel with, the 2,000-foot-long open canal section of the tailrace. The cracks ranged in width from a few inches to 5 feet and had the effect of squeezing in the sides of the channel. The invert was irregularly mantled by gravelly debris ranging in depth from a few inches to several feet.

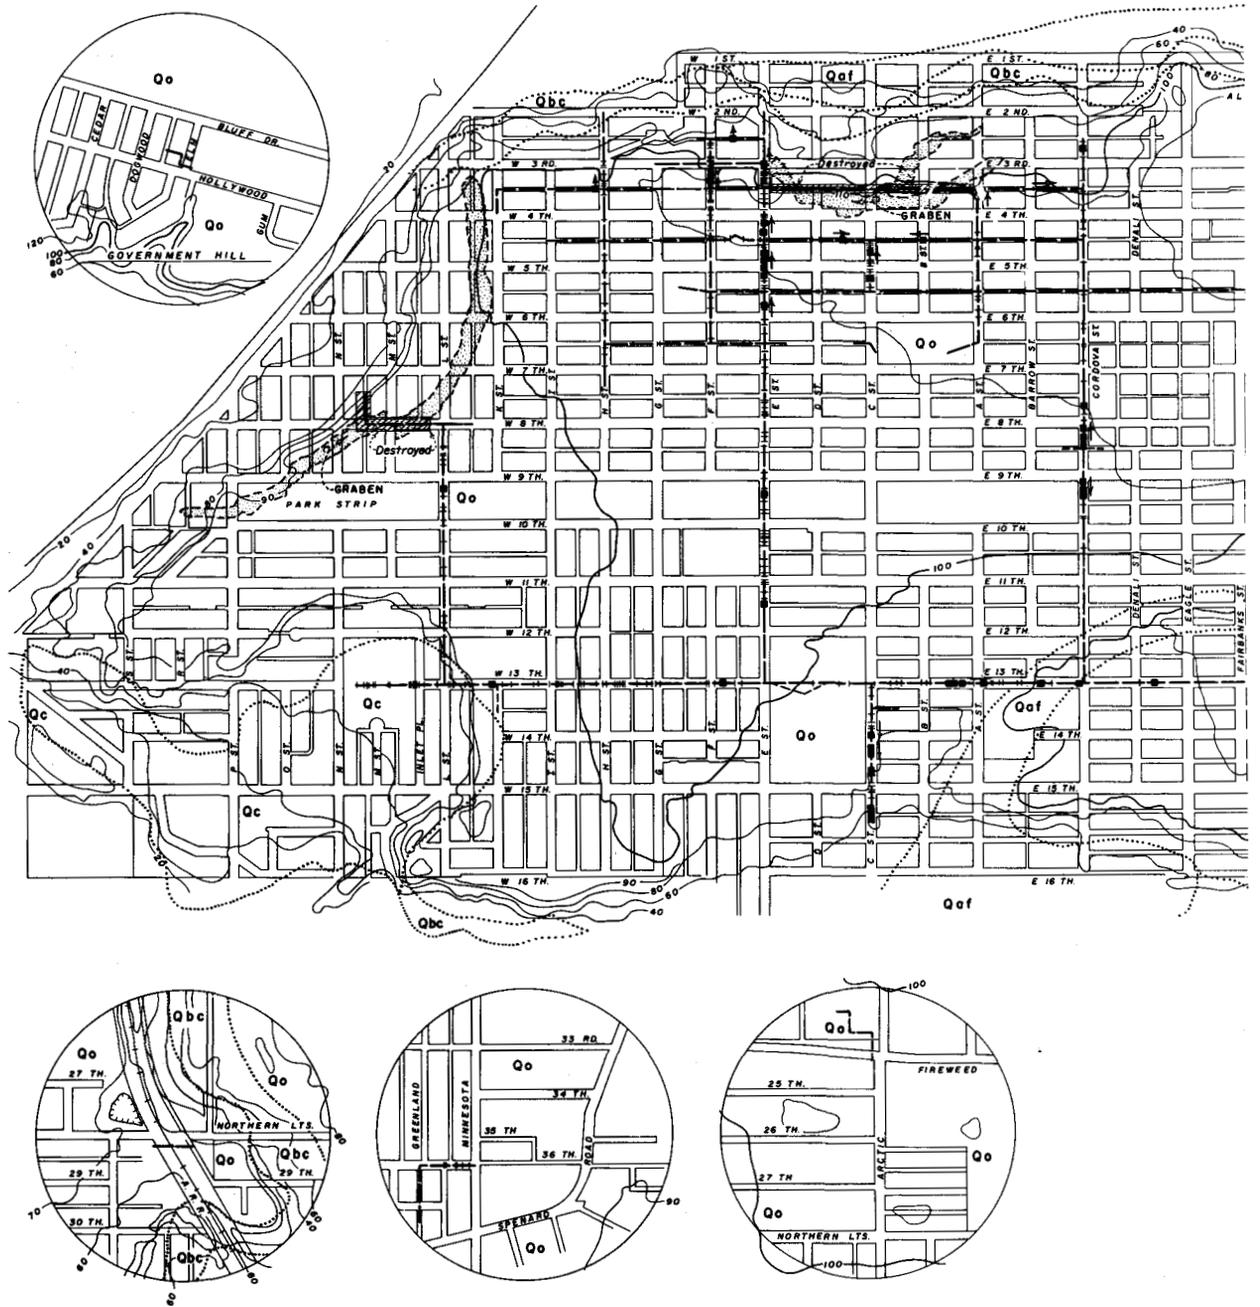
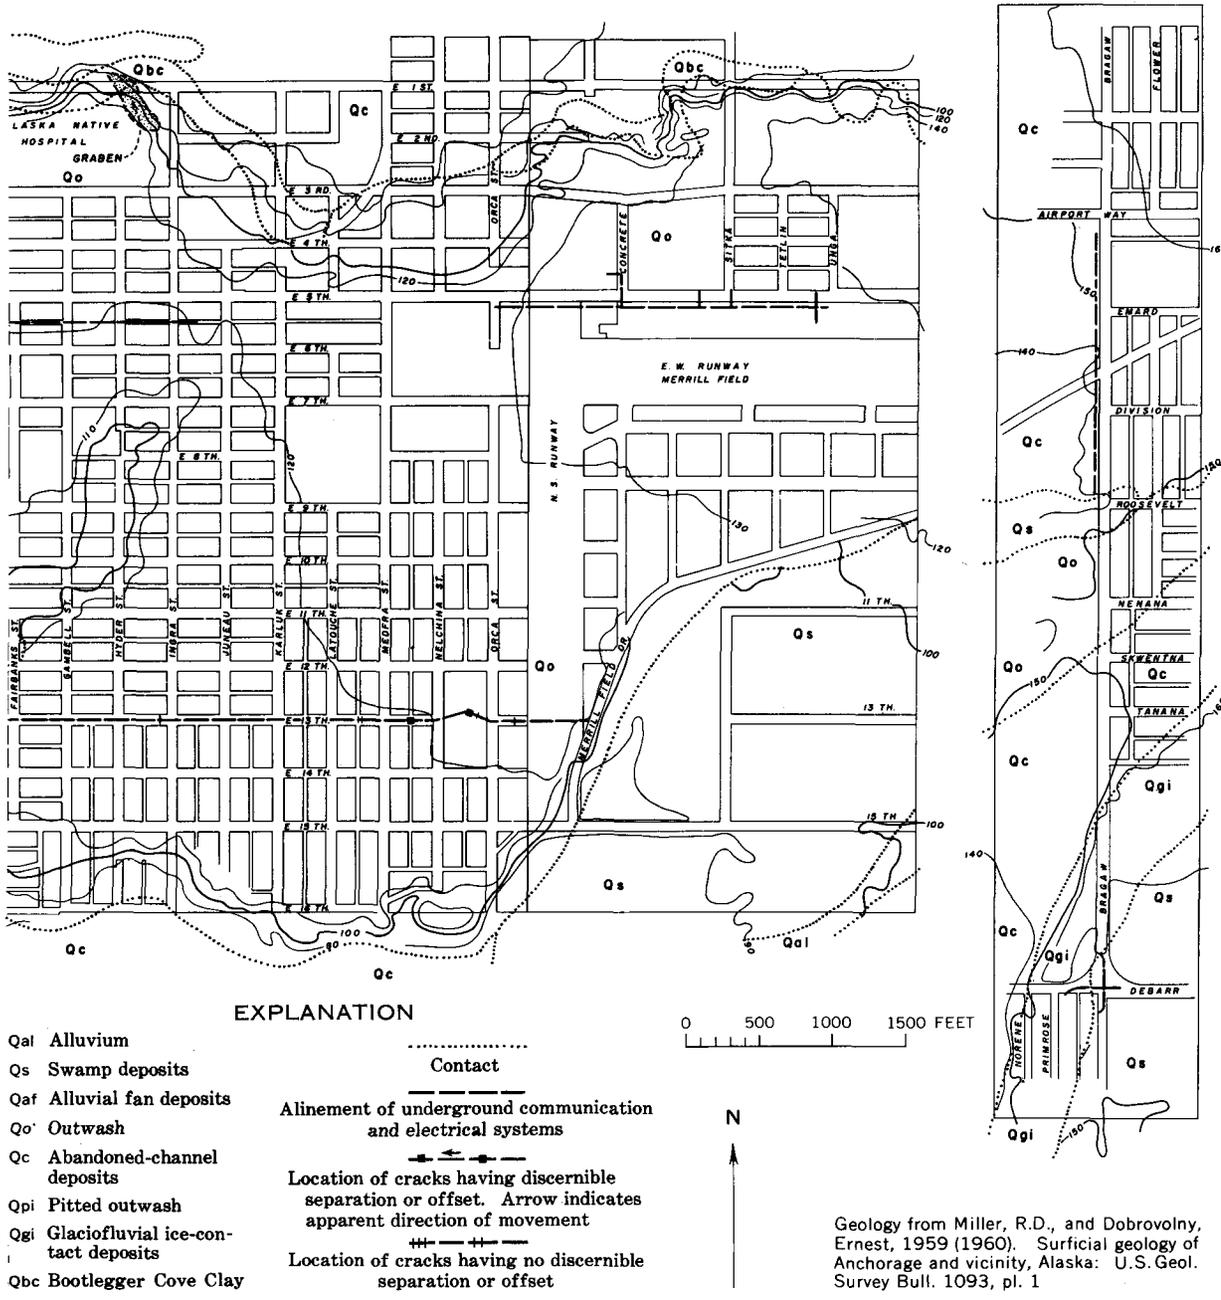
33.—Topography, surface geology, and location of fractures

in underground communication and electrical systems.

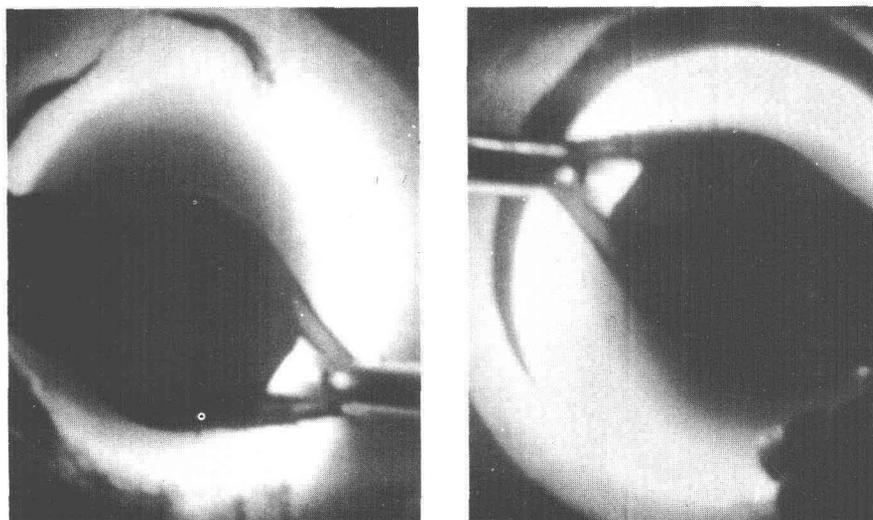
34.—Axial views of breaks in the ducts, as seen on the television monitor screen.

observed at 52 locations. Photographs of two such fractures, as viewed on the monitor screen, are shown in figure 34. The maximum displacement noted was 1 inch, although most were in the $\frac{1}{16}$ - to $\frac{1}{4}$ -inch range. Soil and water had entered the ducts through many such openings, and water was found in some areas where only hairline cracks were present.
