Public Data File 88-39

ENGINEERING-GEOLOGIC ASSESSMENT OF THE PROPOSED HATCHER PASS SKI RESORT AT
GOVERNMENT PEAK, SOUTHCENTRAL ALASKA

R.A. Combellick and R.D. Reger

October, 1988

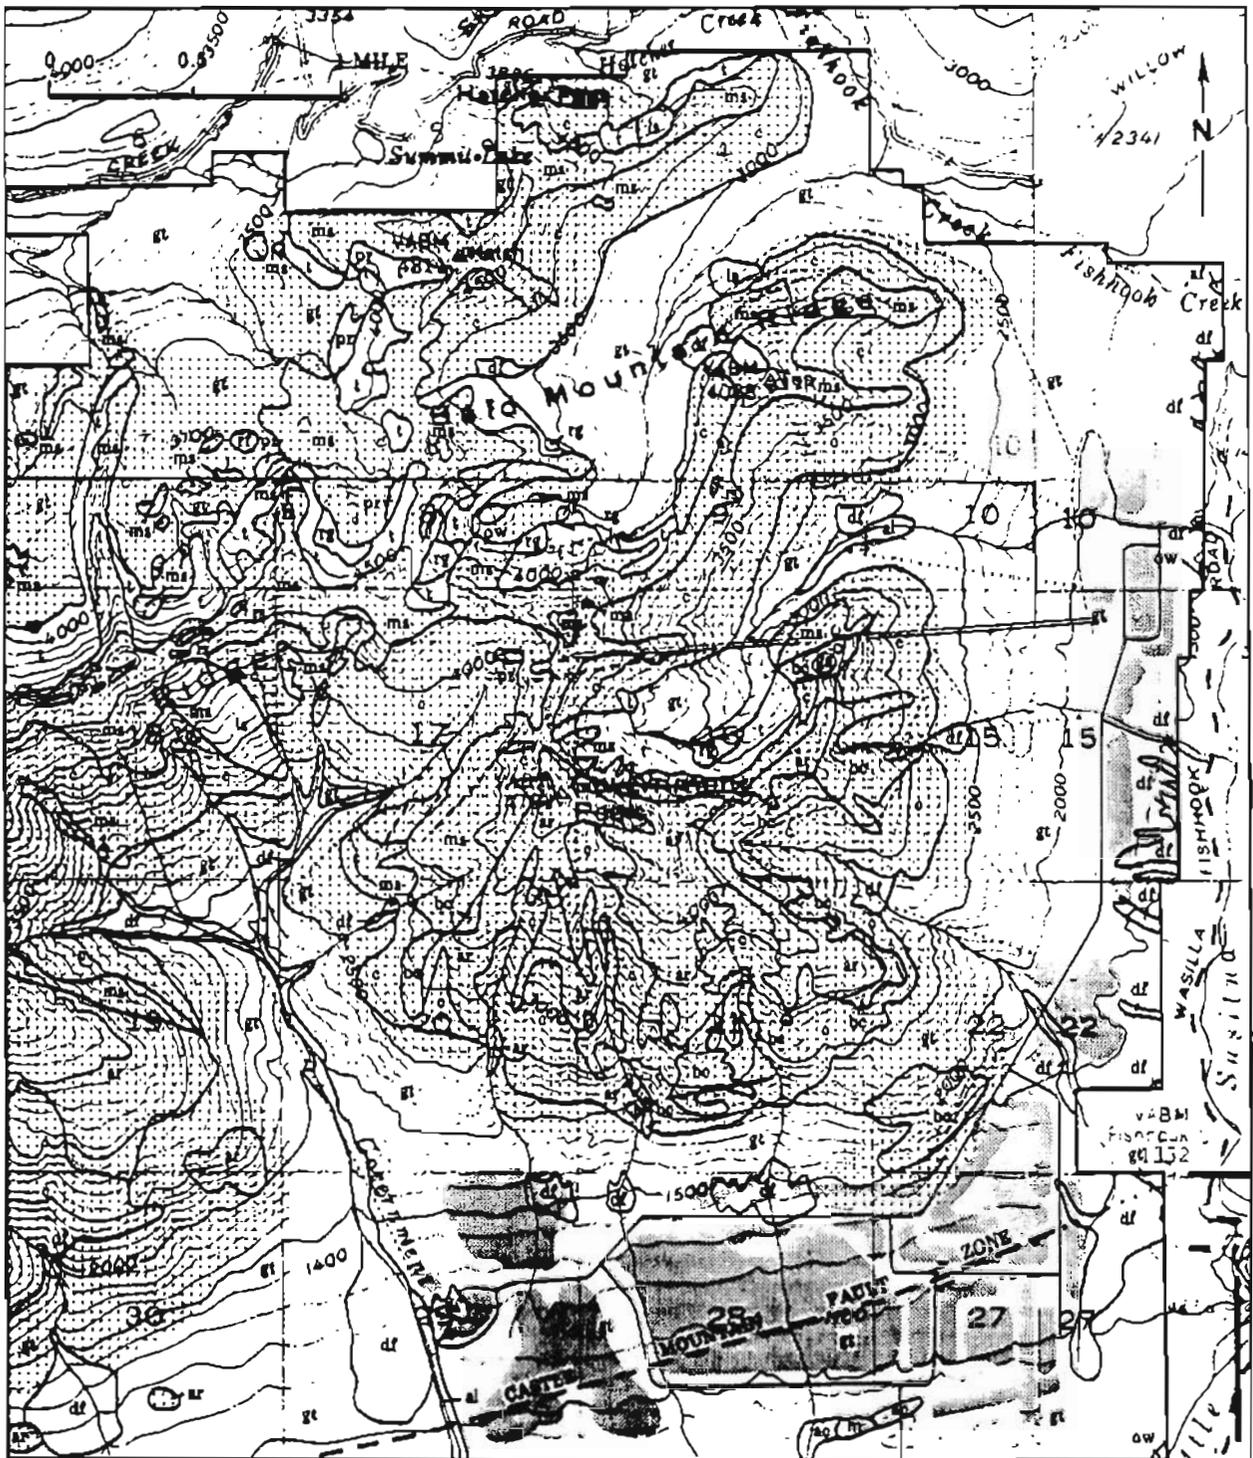
Figure 2.— Geologic map of the proposed Hatcher Pass ski resort. Geologic units are described in Table 1. Coarse stippled pattern indicates where bedrock is shallow (less than about 10 ft). Areas proposed for development are also indicated (see fig. 1).

The proposed locations for most facilities in the base areas of the ski resort are on glacial till (fig. 2). This deposit contains varying proportions of gravel, sand, and silt, including local concentrations of large boulders. In its natural state, the till is generally very dense and firm below a looser surface layer of peat, silt, and sandy till that ranges from about 1 to 6 ft thick. Its bearing capacity is therefore high and well suited as foundation material for large structures. If the till on or near steep slopes becomes saturated, however, it can be subject to flow failure (see Erosion and Debris Flows).

In addition to debris flows, there are two other types of landslides in the area. Debris slides (ls) were identified in three places (figs. 2 and 3). The two small slides in the northern part of the area are probably inactive, although they would not be good sites for permanent structures because of possible renewed activity. A large debris slide in the headwater area of Government Creek is probably still active. Present movement is probably by creep, although a major rapid failure is possible. No permanent structures should be built on or below this slide.

The Castle Mountain fault zone, which passes through the southern part of the area (figs. 2 and 3) is probably more likely to cause damage to structures in the proposed ski area than earthquakes along the subduction zone. The term 'fault zone' is used because the Castle Mountain fault has no single well-defined plane of displacement in this area. Rather, it is a zone of fault planes that may be several hundred feet wide. Geologic and seismologic evidence shows that this fault is active. A scarp more than 6 ft high along the fault between Houston and the Susitna River marks an area where the fault has displaced recent alluvium, and a magnitude 5.2 earthquake near Sutton in 1984 was directly attributed to slip on the fault.

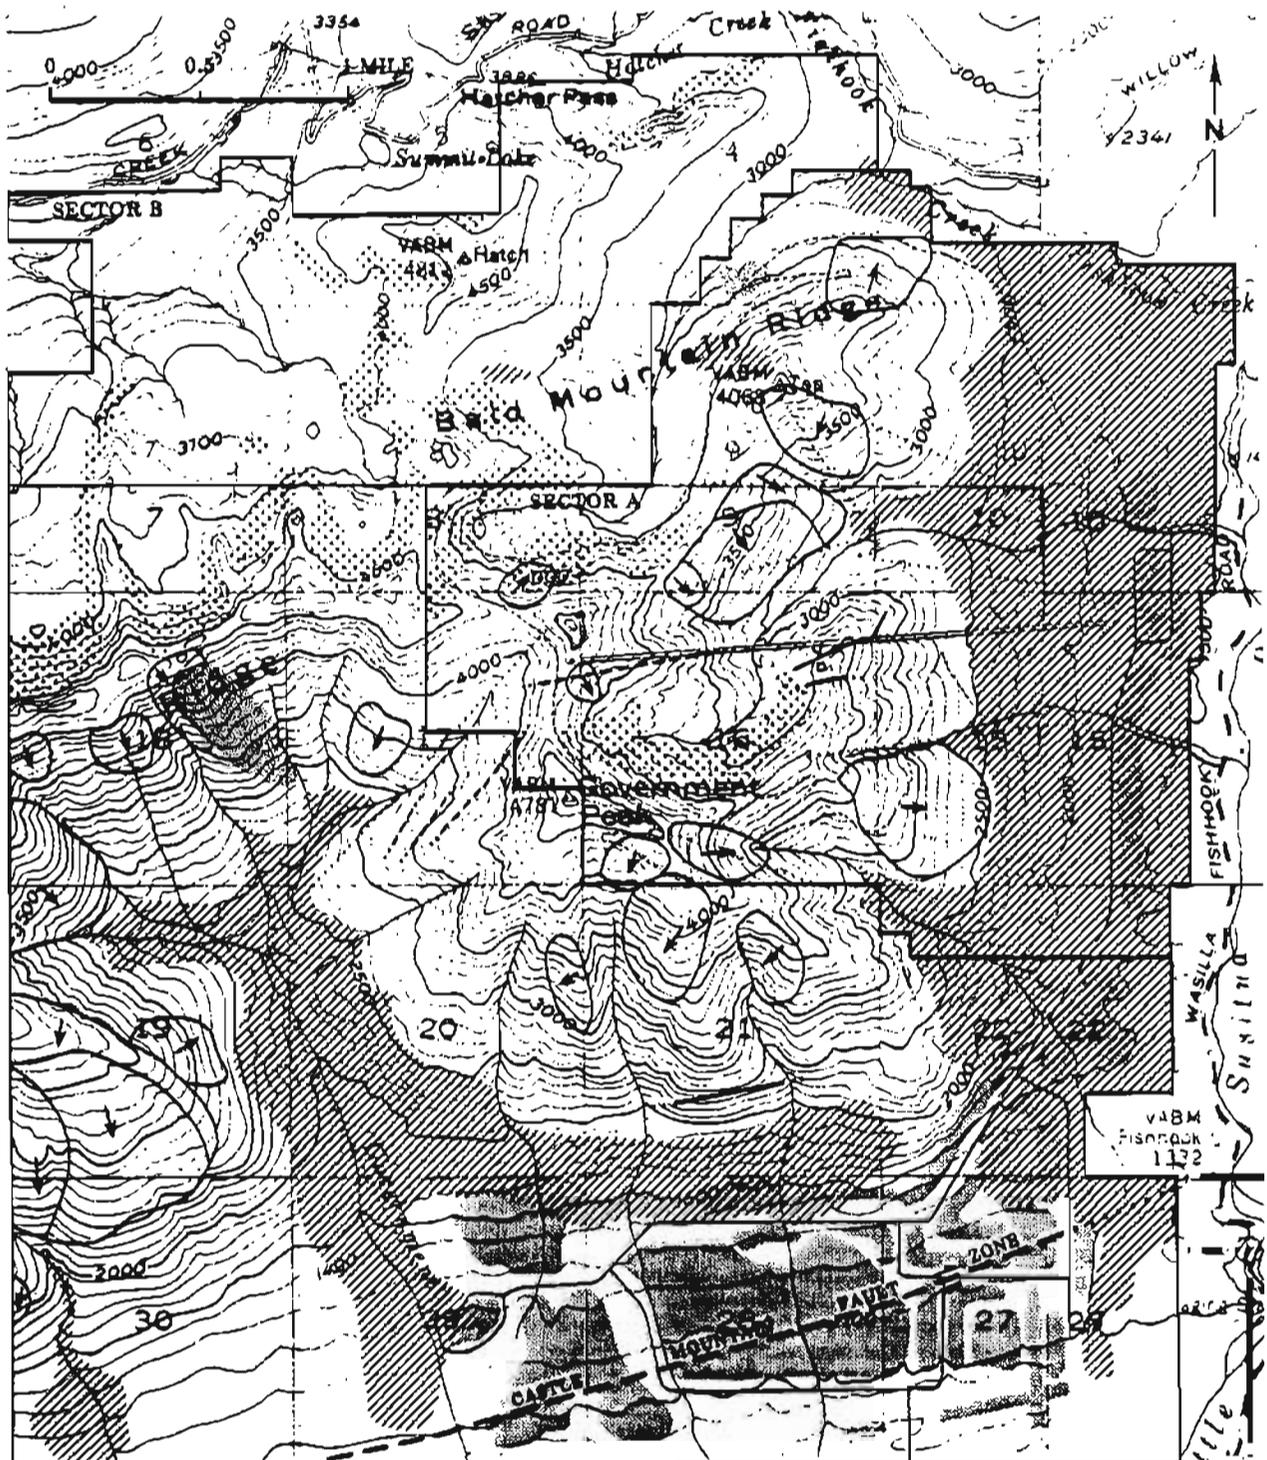
Geologic constraints to construction and use of the Government Peak area as a ski area vary with the types of geologic deposits present at the surface and the topography. Figure 2 is a geologic map that shows the distribution of geologic units in relation to the topography and proposed ski-area facilities. Descriptions of the geologic units and their engineering characteristics are summarized in Table 1. The areal distribution of major geologic constraints is shown in Figure 3.

Figure 3.— Geologic constraints to development in the proposed Hatcher Pass ski area (legend on following page).

Areas that are susceptible to gullying and debris-flows, based on evidence of where these processes have occurred in the past, are shown in Figure 3. Development activities in these areas that could increase the likelihood that gullying and debris flows become a hazard to facilities and public safety include:

2. Remove as little vegetation as possible within areas prone to erosion and debris flows (fig. 3) and revegetate excavated slopes where possible. On ski slopes, maintain as much ground vegetation as is consistent with the primary use of the slopes. Small debris flows may be a persistent minor maintenance problem on the ski slopes.

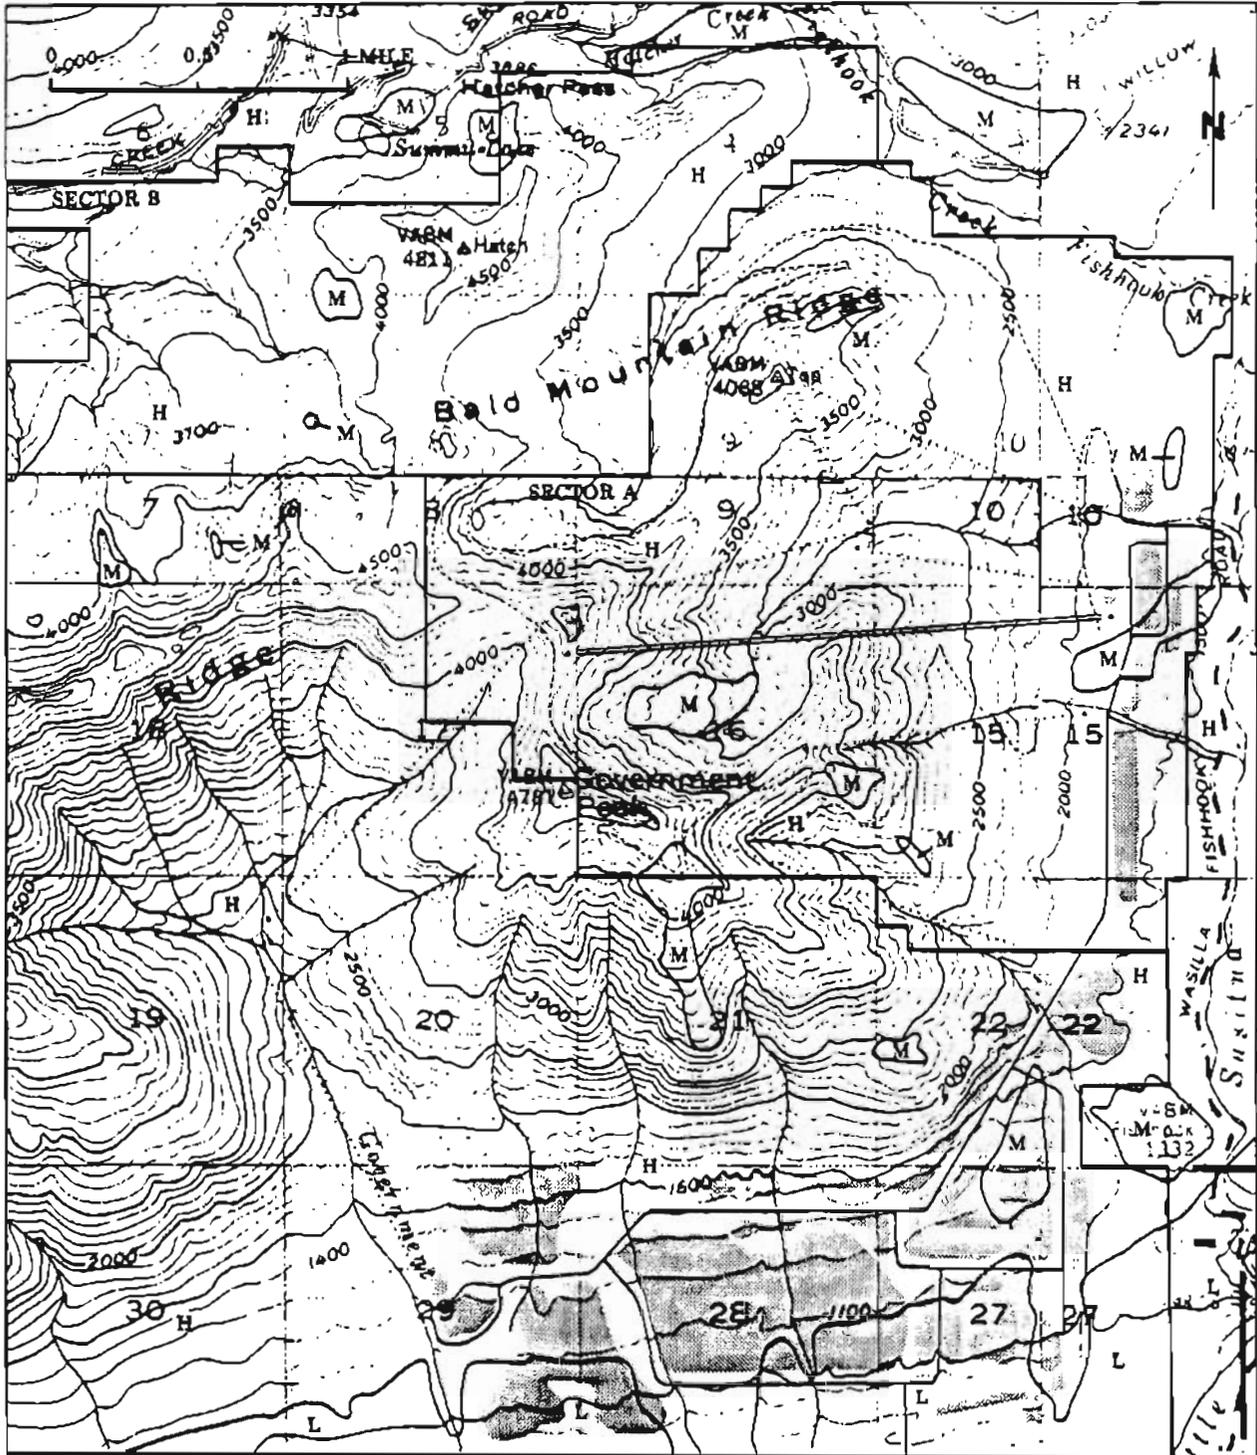
Figure 4.— Snow-avalanche potential in the proposed Hatcher Pass ski area. H—high potential, M—moderate potential, L—low potential. Areas proposed for development are also shown (see fig. 1). (Figure by G.D. March)
