Geology of Waterpower Sites on Crater Lake, Long Lake and Speel River near Juneau Alaska

G E O L O G I C A L S U R V E Y B U L L E T I N 1 0 3 1 - D

*A preliminary examination of the
geologic feasibility of proposed
damsites*

GEOLOGY OF WATERPOWER SITES ON CRATER LAKE, LONG LAKE, AND SPEEL RIVER NEAR JUNEAU, ALASKA

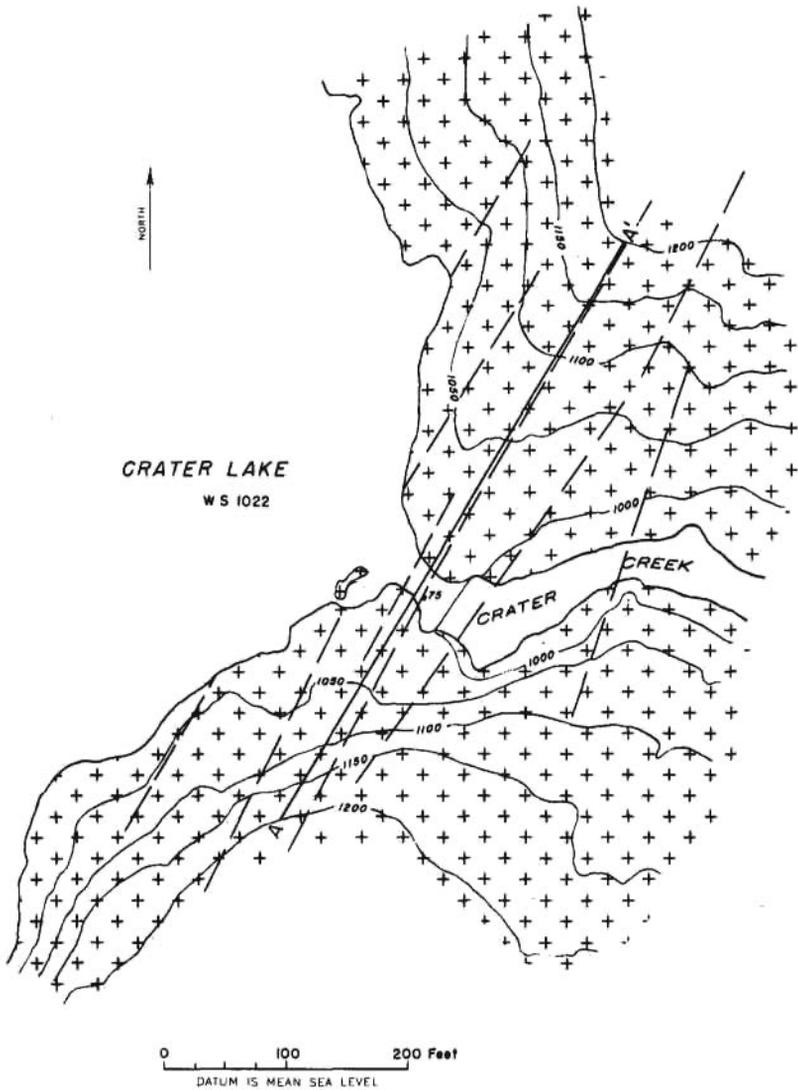
FIGURE 15.—Geologic map of Crater Lake powersite.

The damsite at the outlet of the lake is in hornblende-quartz diorite broken by northwestward-trending vertical joints or fractures. Only minor fractures were observed which intersected the principal joints or fractures. The principal fractures are transverse to the streamflow and could be grouted to prevent possible leakage. These joints and the geology of the site are shown on figure 15. The foundation and abutments would be in hornblende-quartz diorite which should be capable of supporting a dam 150 to 200 feet high. Leakage around the damsite seems unlikely, and, based on conditions observed in the field, no damage from rockslides or snowslides is anticipated.

The valley walls around most of the lake are steep and in places almost vertical. Near the head of the lake on the south bank there are large snowslides and rockslides. A few streams, which carry boulders and debris enter the lake on the north side. There is no evidence of snowslides of any consequence from the ridge across the outlet end of the lake. Landslides are not believed to pose a damage threat to the proposed reservoir or power facilities. Erosion by frost and ice action may result in some movement of large blocks of rock into the lake.

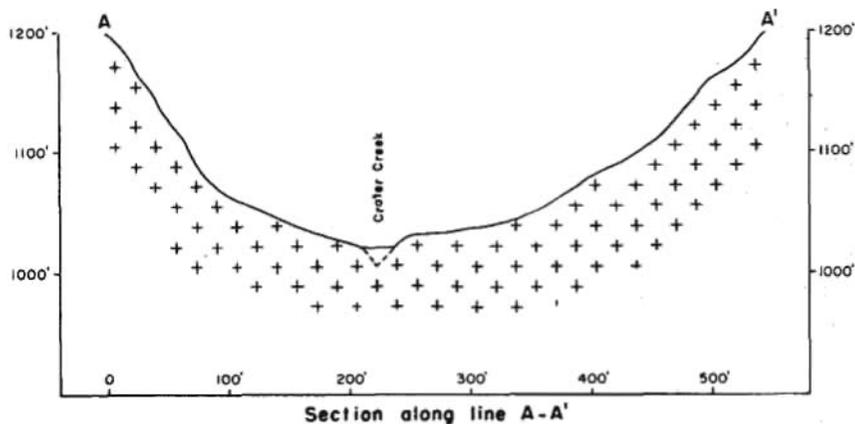
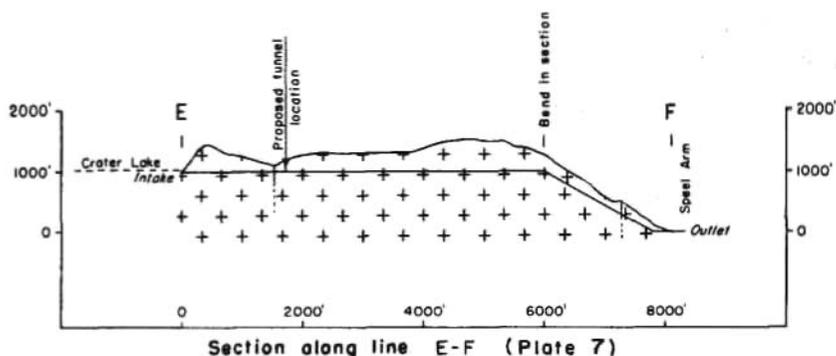
FIGURE 16.—Geologic sections of Crater Lake powersite.

Projection of surface trace of lineament
Depth of fracture not known

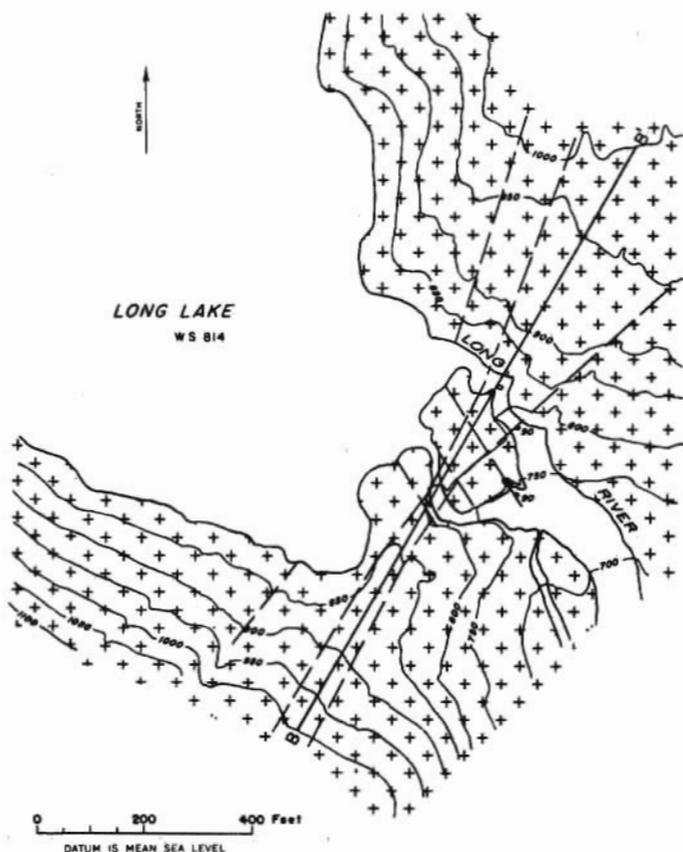
FIGURE 17.—Geologic map of Long Lake powersite.

The proximity of the Long Lake damsite to the fractured quartz diorite at the outlet of the lake requires that it be thoroughly explored by drilling as the first step in any plans for development.

and at the damsite, excessive leakage may be induced by the north-westward-trending fractures at the outlet unless extensive scaling or removal of perhaps 20 to 50 feet of bedrock is done in addition to grouting. An extensive drilling program will be necessary to determine how deep these fractures extend and whether excessive leakage may be expected. If exploratory drilling verifies the lack of an impervious foundation it may be possible to select another site about 150

feet downstream to avoid this fractured area. Such a location would add about 50 feet to the height of the required dam.

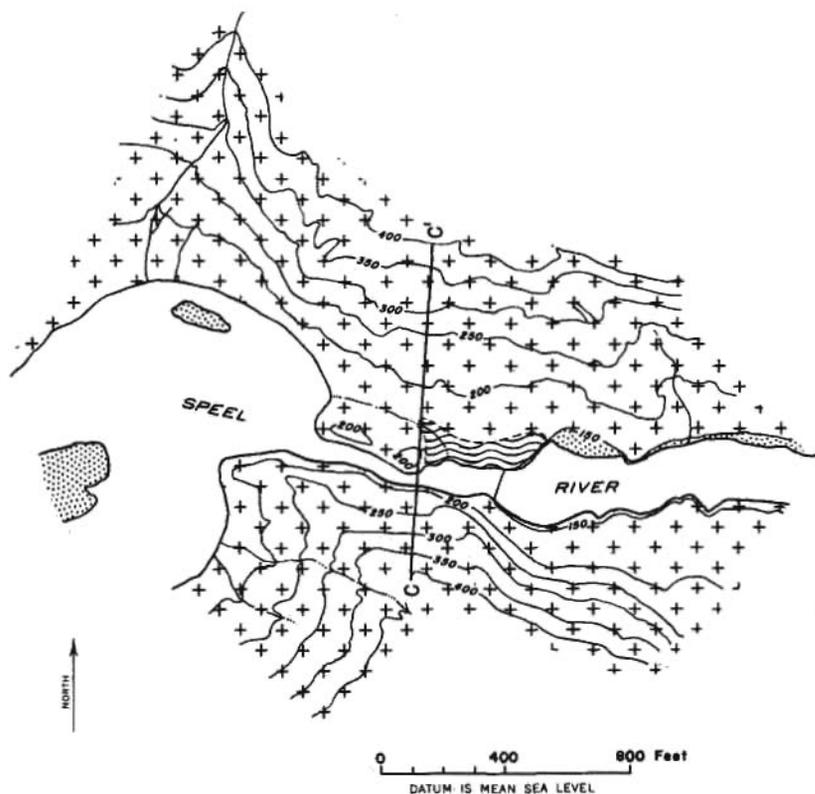
FIGURE 19.—Geologic map of Speel River powersite.

The foundation rock and the abutments appear capable of supporting a masonry dam 160 feet high, which is the maximum height that would likely be considered for this site.

The right abutment wall is fractured to some extent and may require grouting, while the left abutment area appears less fractured. The bedrock above an altitude of 200 feet is not well exposed, but aerial photographs and the observations in the escarpments above river level indicate that some fracturing may be present. Section C-C', figures 19, 20, show the general character of bedrock.

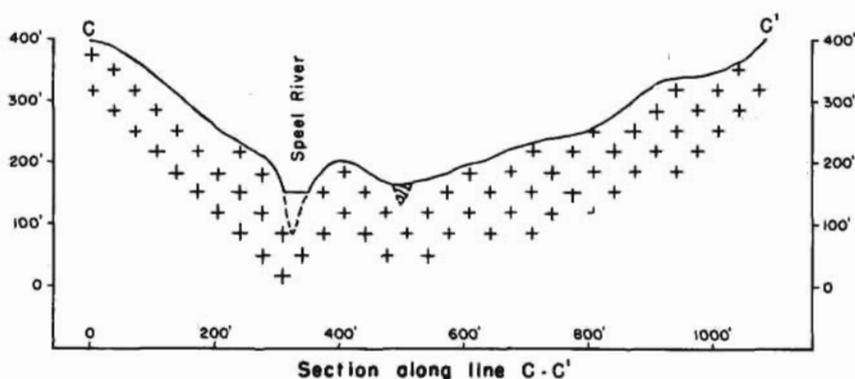
FIGURE 20.—Geologic section of Speel River powersite.

route from the Saddle dam to a powerhouse site on the shore of Speel Arm about 3,000 feet west of the mouth of Glacier Creek. This route is indicated at F-H on plate 7 and is shown in section on figure 20.

The entire tunnel course would be in quartz diorite. The rock, however, is disturbed in varying degrees by the fracture zones noted. No serious hindrance to tunneling is anticipated in these zones, and the rock is considered stable enough to maintain tunnel openings. The required tunnel would be about 3,800 feet long, and the penstock about

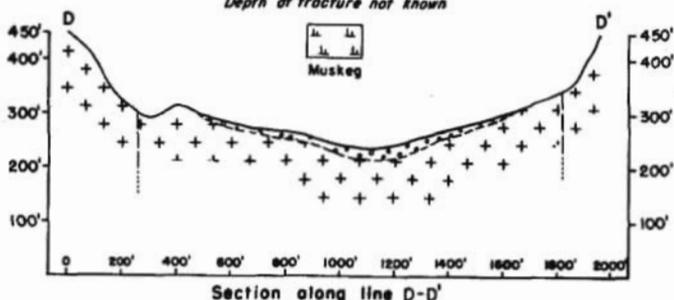
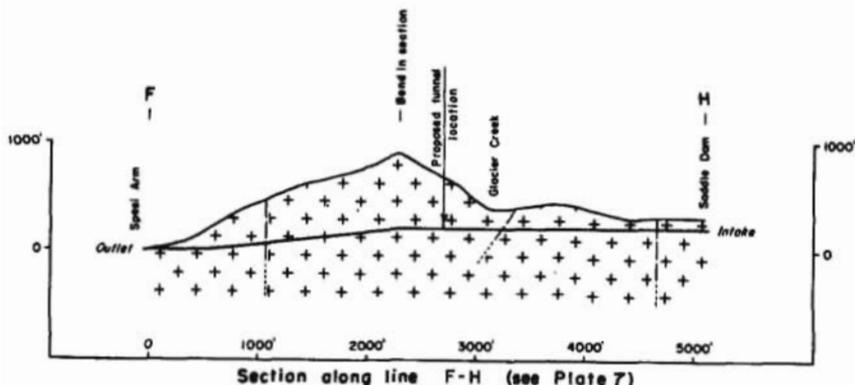
FIGURE 22.—Geologic sections of Saddle dams site and Speel River power site.

Projection of surface trace of lineament
Depth of fracture not known
