ICINGS ALONG THE TRANS-ALASKA PIPELINE ROUTE

OPEN-FILE REPORT 75-87

By Charles E. Sloan, Chester Zenone,
and Lawrence R. Mayo

Anchorage, Alaska
1975

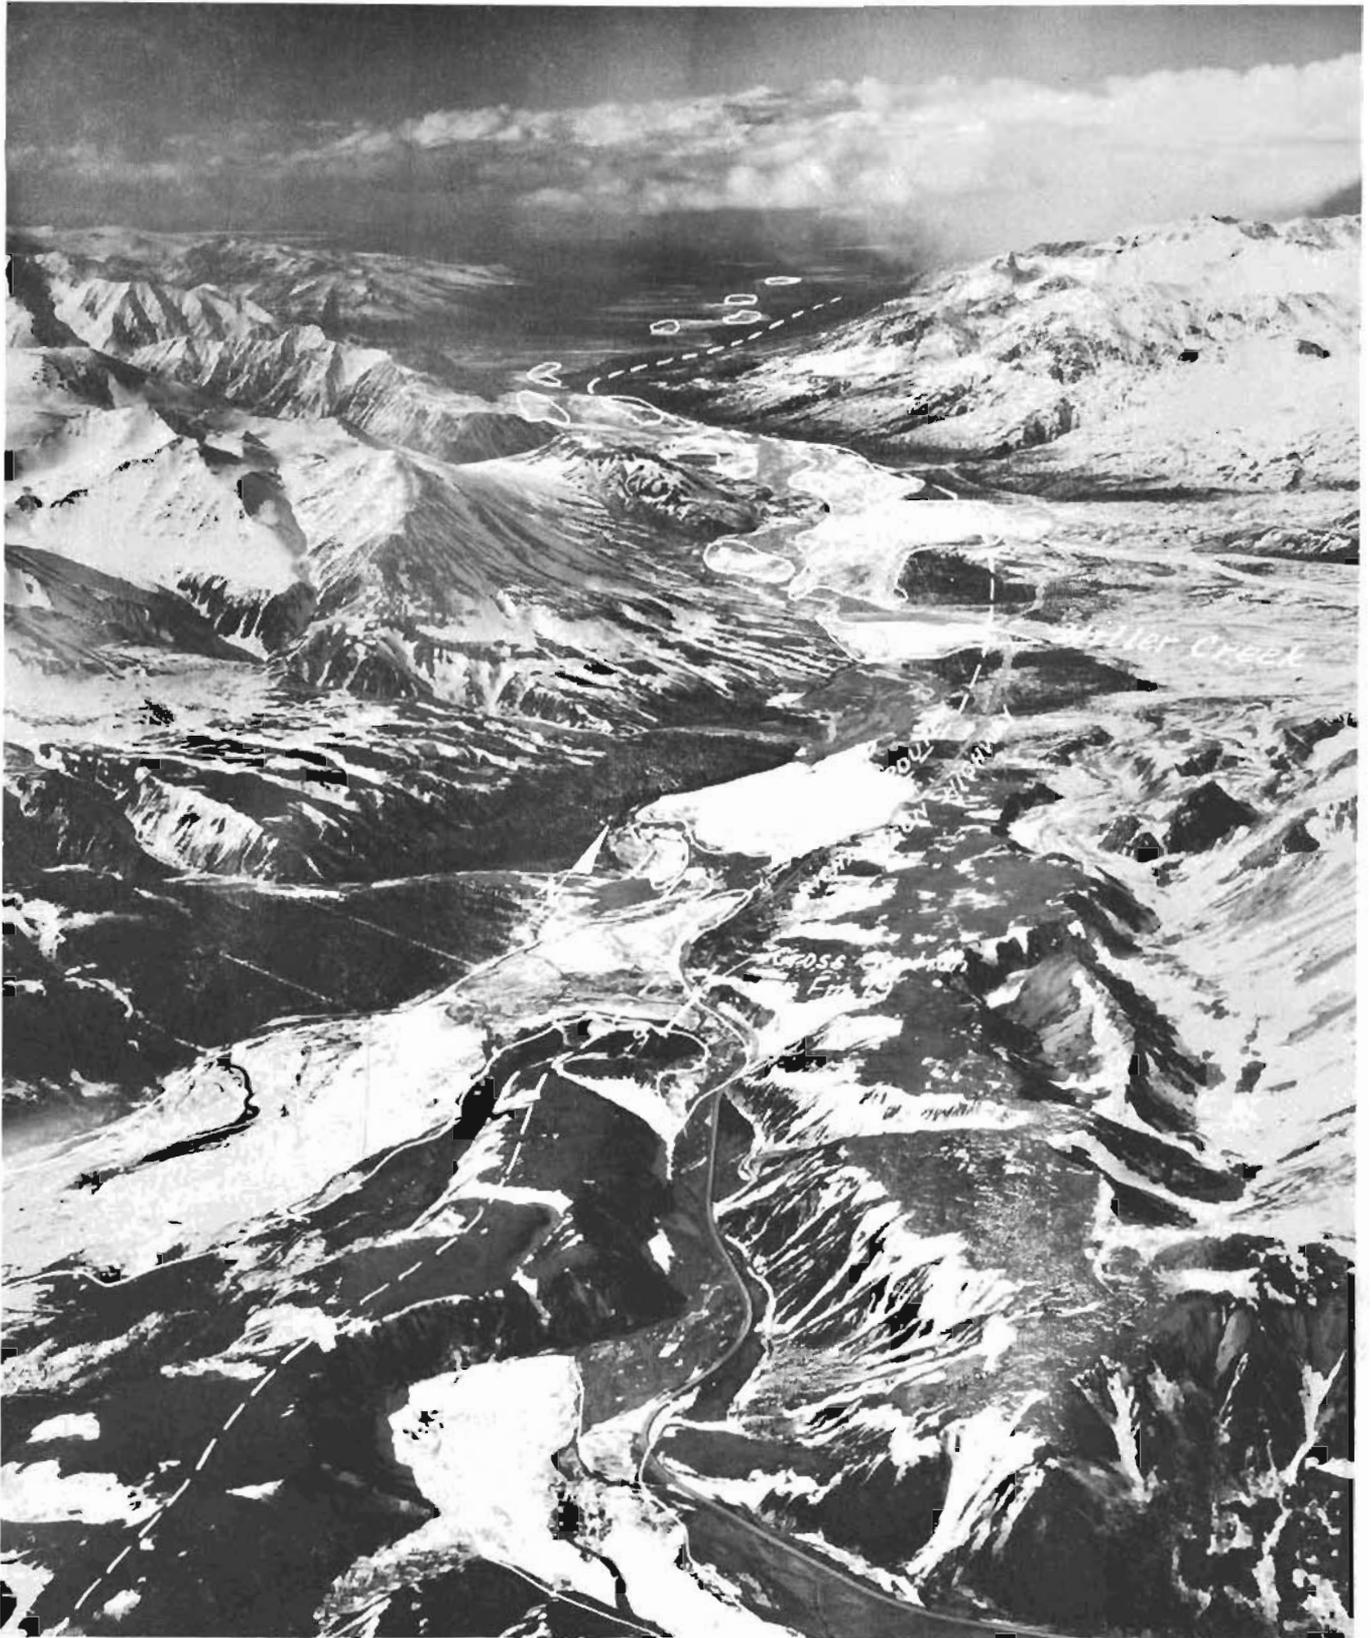
Figure 2.--Flood-plain icings on the Delta River and tributaries.
View north along the pipeline route, May 22, 1972.

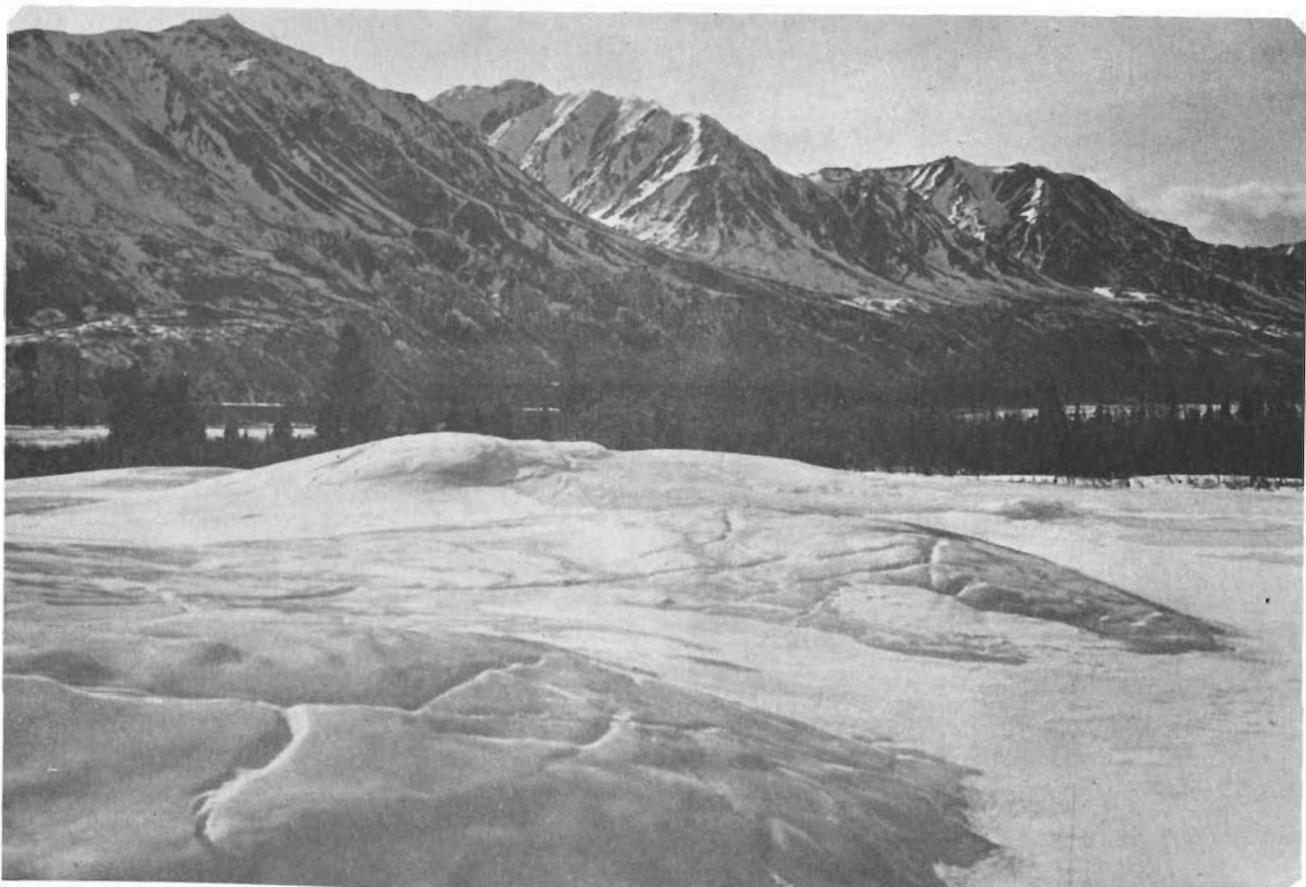
Icing mounds or hummocks are uplifted ice ridges, broad humps, or smaller conical domes (fig. 3) that are common features on large icings. As ice freezes downward, pockets of water may become isolated. The volume expansion that results from the freezing process in these pockets sharply increases the hydrostatic pressure. High hydrostatic pressure produces the uplifted area, which then cracks; the pressure is relieved as water bleeds out through radial or circular cracks. Occasionally, relief of pressure can occur suddenly and explosively, resulting in displaced and shattered blocks of ice (figs. 4 and 5). Such explosive events may be related to the release of entrapped gases.

Figure 3.--Icing mounds on Trims Creek near pipeline crossing,
Delta River valley, April 18, 1974.

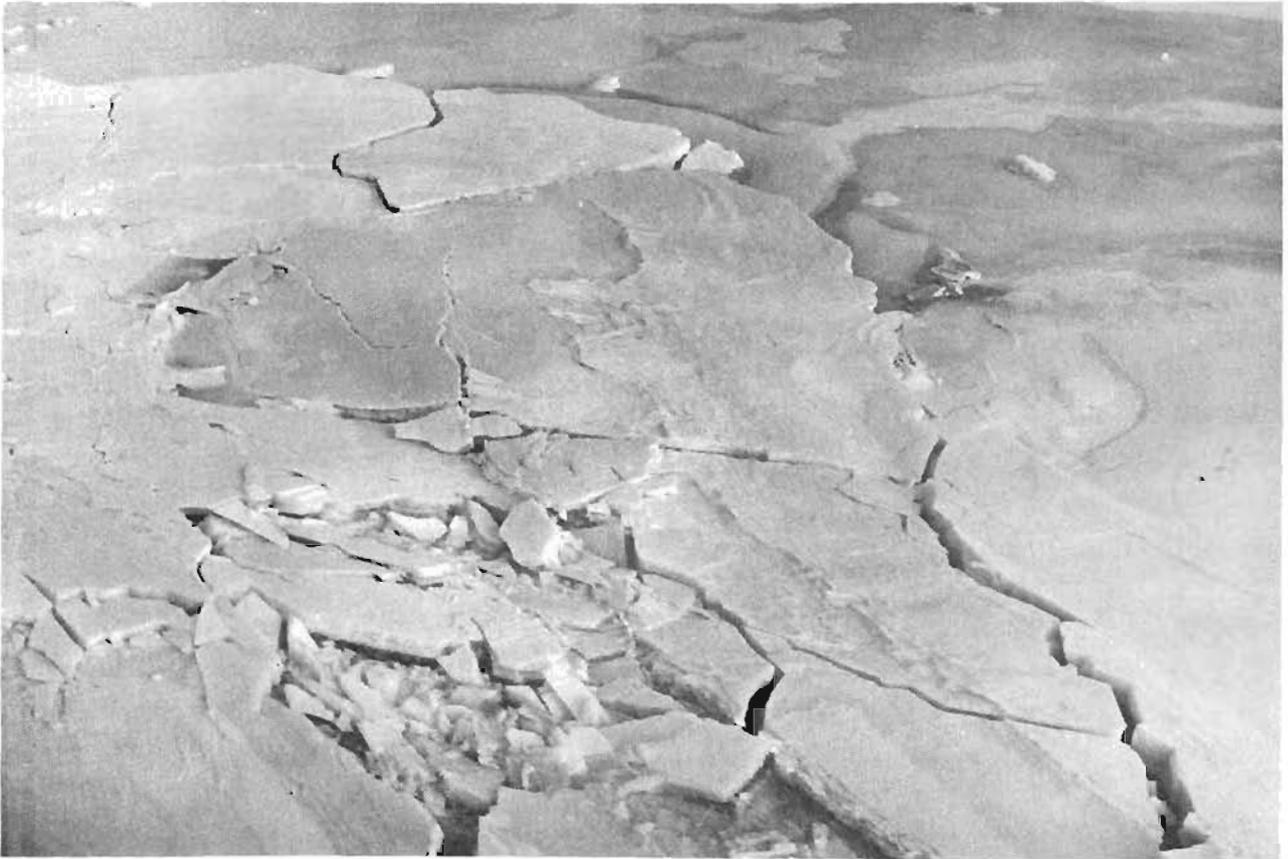
Figure 4.--Fractured icing mound on Dietrich River approximately 2 miles (3.2 km) downstream from confluence with Big Jim River, March 15, 1972. Explosive force scattered ice blocks for tens of feet.

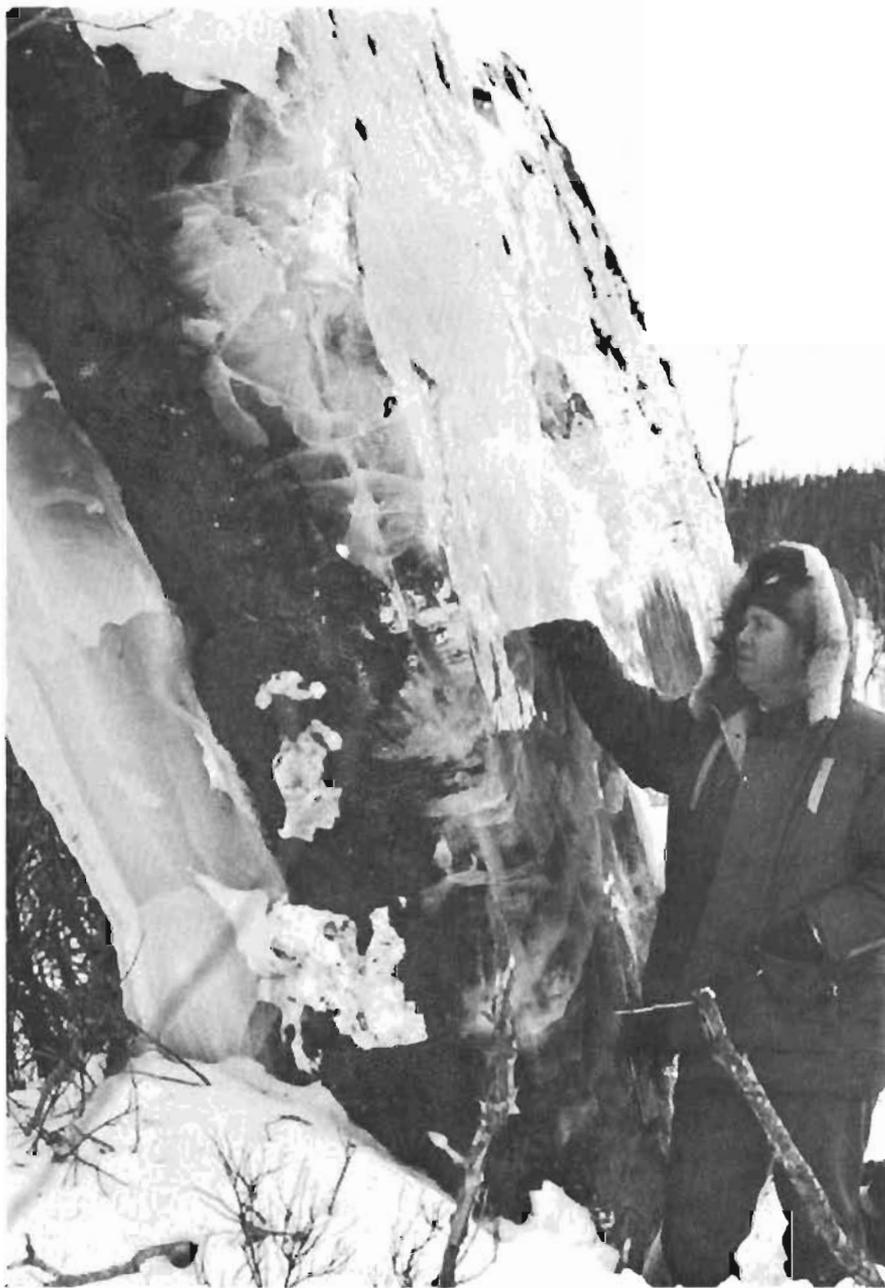
Figure 5.--Upheaved ice and soil block from exploded hillside icing mound north of Old Man camp in Fish Creek valley, March 21, 1974.

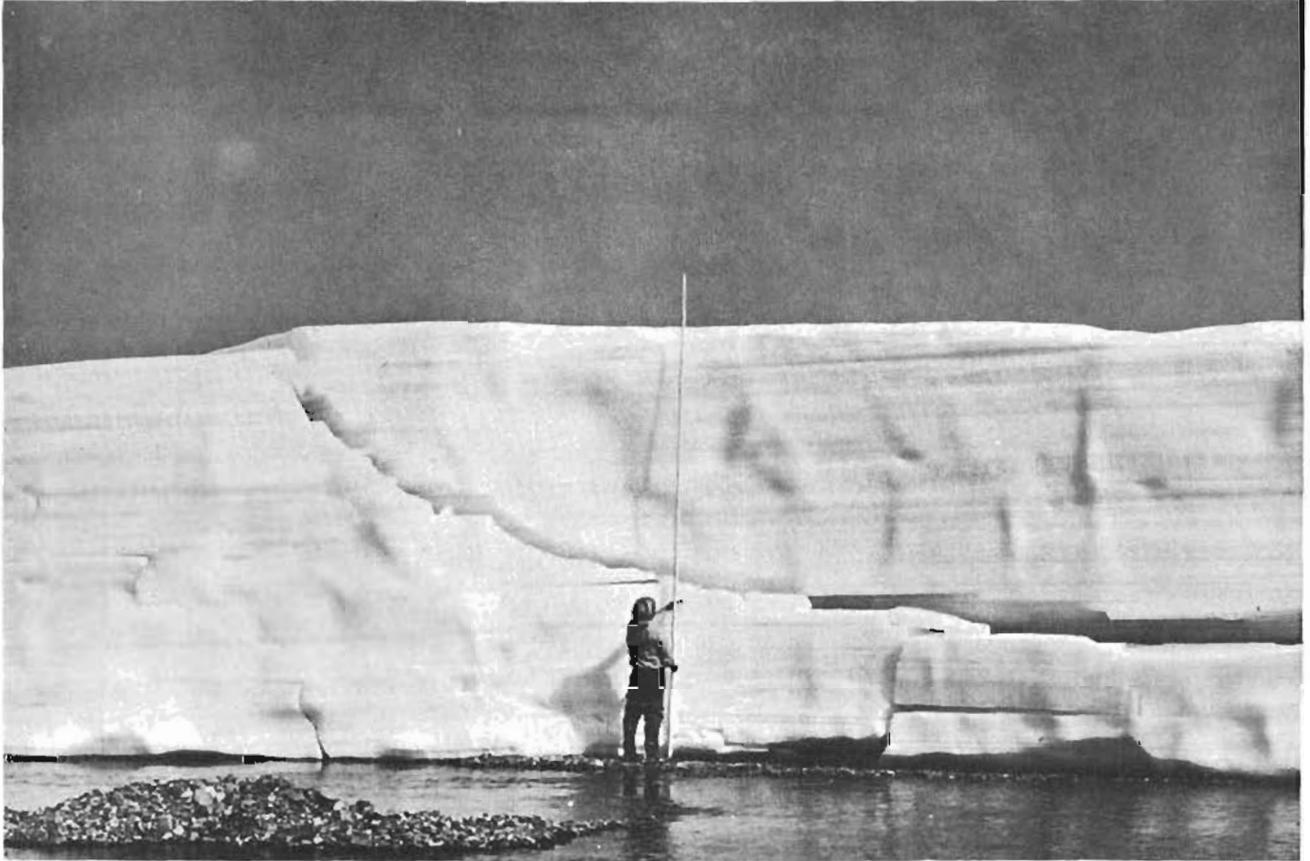
Figure 10.--Echooka River icing about 16 feet (5 m) thick, July 11, 1972.
Layering in ice shows that numerous overflows make up the icing.

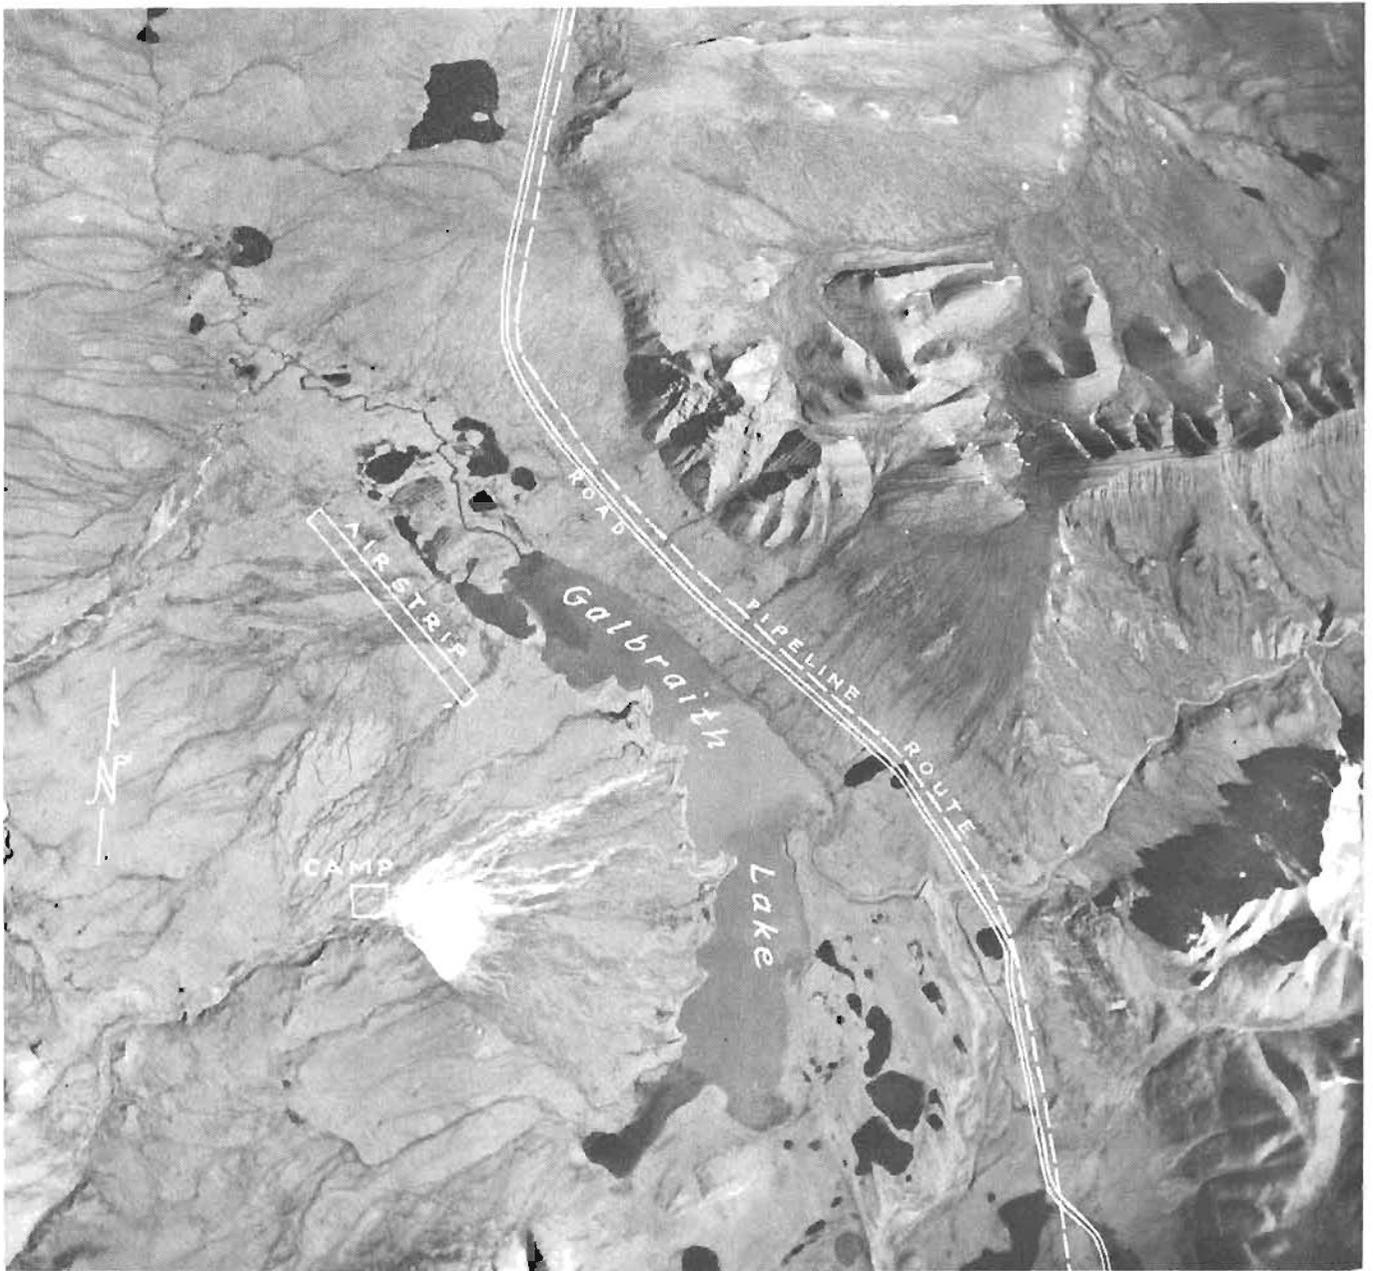
A large icing forms annually on the alluvial fan west of Galbraith Lake (figs. 11 and 12). Large icings also occur at wide, braided channel reaches of the upper Atigun River valley (figs. 11 and 13).

Figure 12.--Icing on alluvial fan at Galbraith Lake, July 21, 1956.
(Approximate scale: 1 inch = 4,000 feet or 1 centimetre
= 480 metres.)

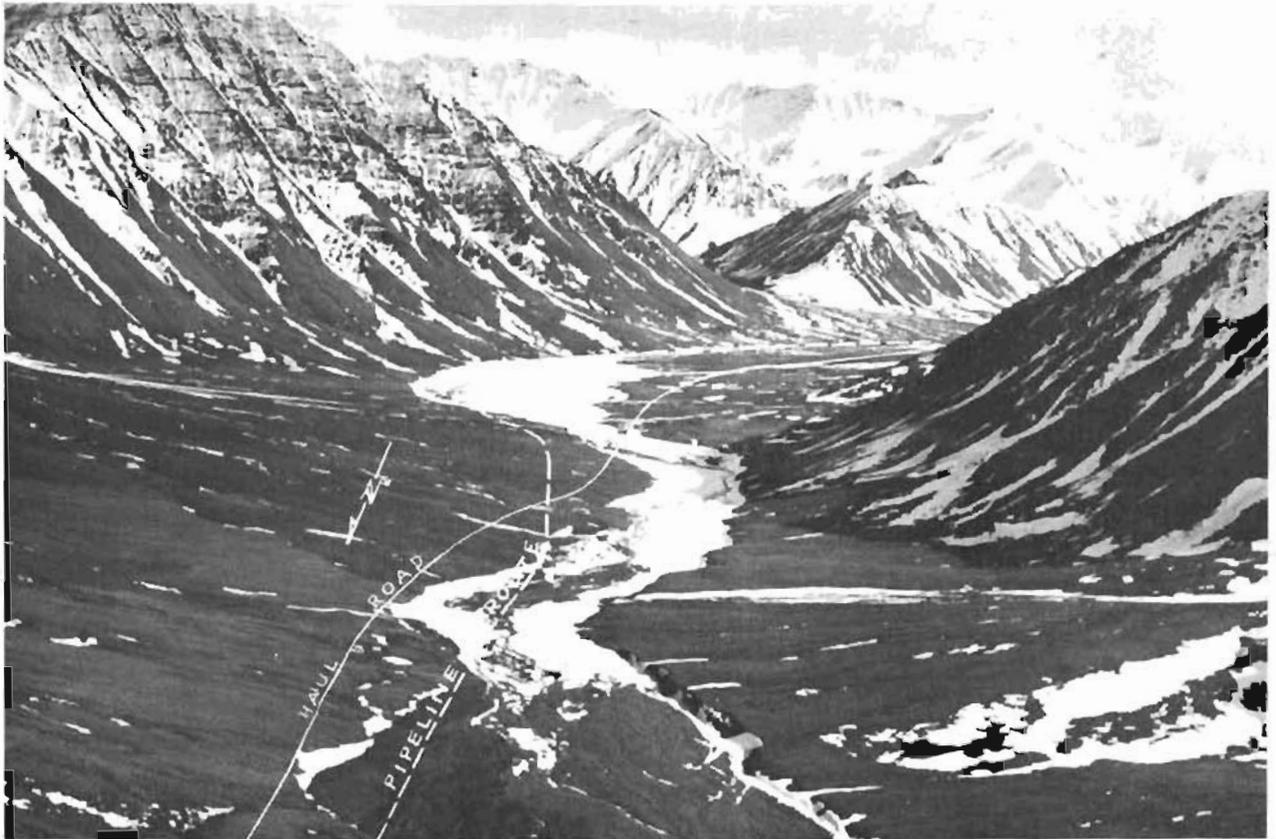
Figure 13.--Icinas in braided reaches of Atigun River, May 29, 1973.

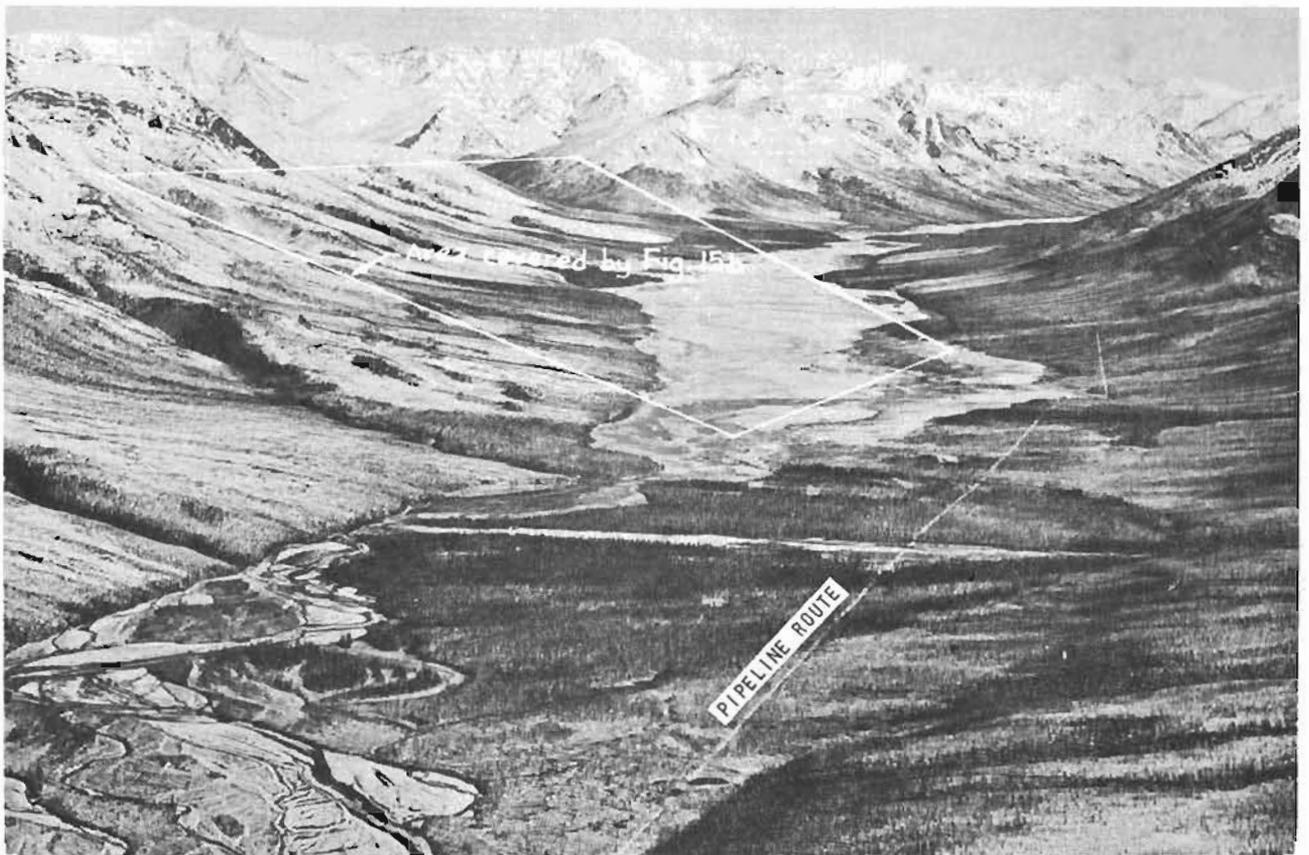
Figure 15a.--Icing in Dietrich River valley upstream from Snowden Creek, May 1, 1974.

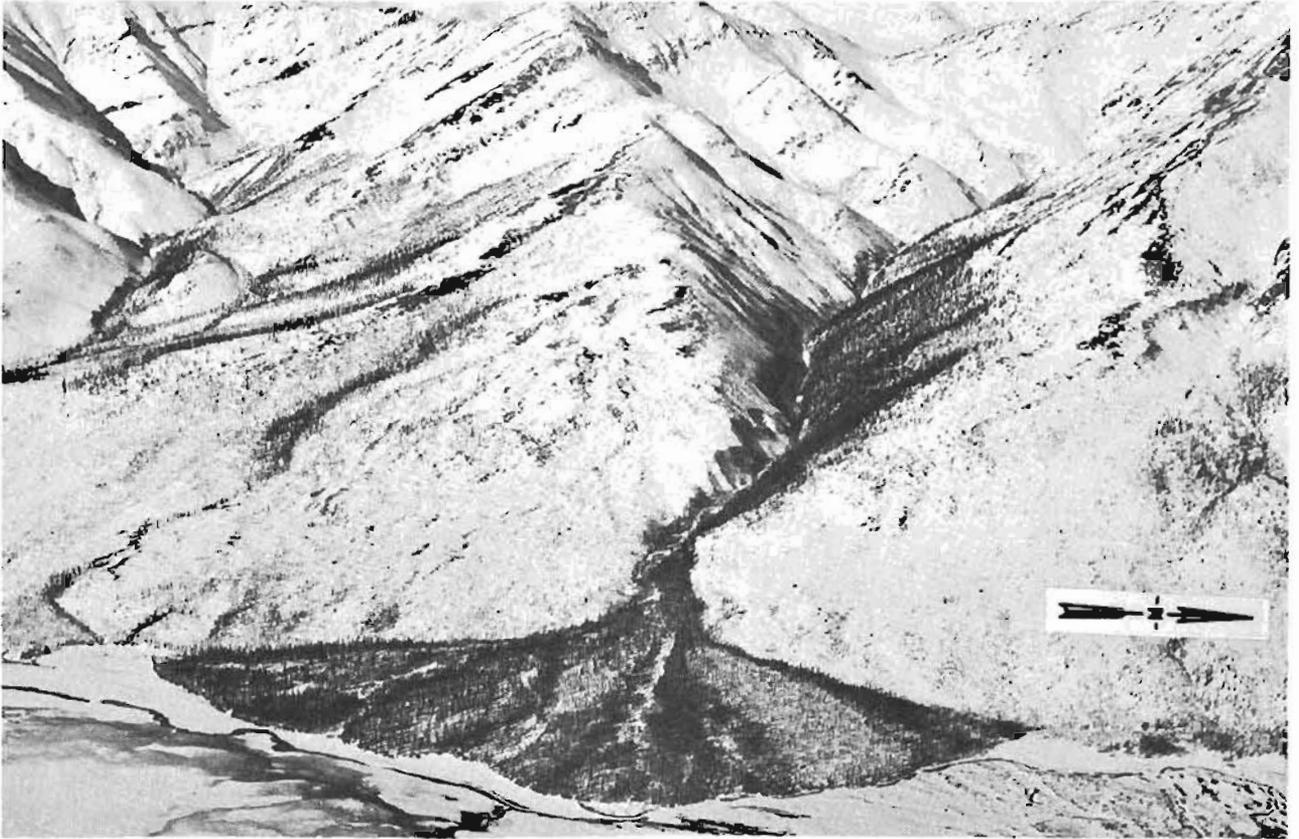
Figure 16.--Alluvial fan in Dietrich River valley upstream from Snowden Creek, May 1, 1974. Open leads at toe of fan are source of water for downstream icings.

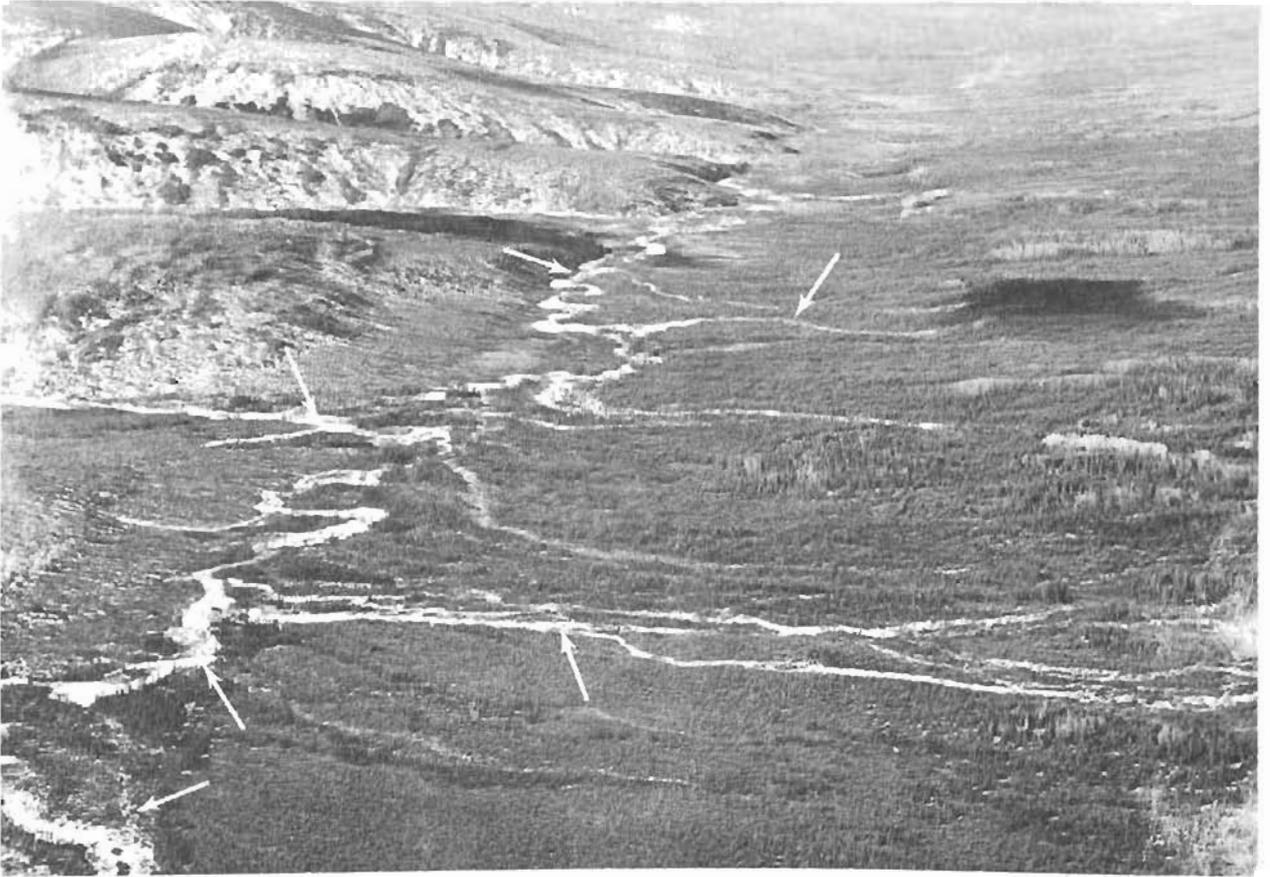
South of the Yukon River, narrow channel icings form on the small streams in the uplands (figs. 18 and 19). The source for these icings may be artesian water from bedrock drainage or from unfrozen ground above permafrost. The water emerges in small depressions or gullies that drain to the larger stream valleys.

Figure 19.--Channel and hillside icings along Aggie Creek in Yukon-Tanana Uplands north of Fairbanks, May 23, 1973.

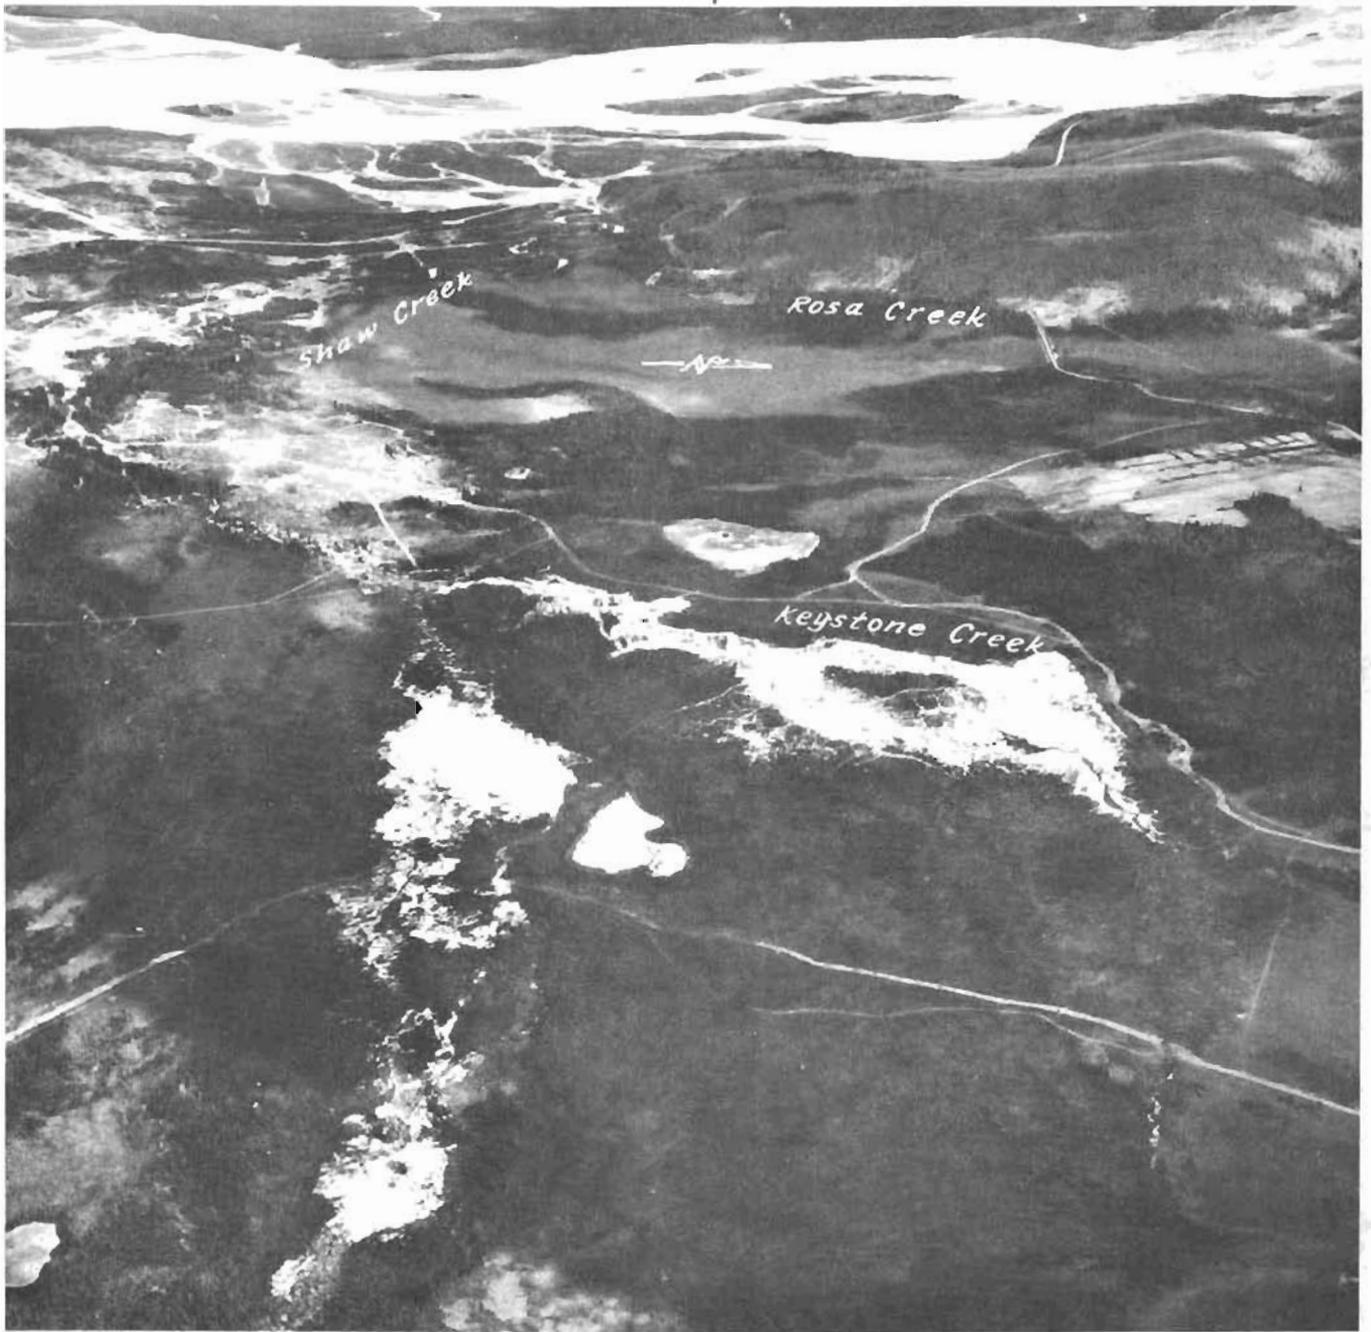
Figure 23.--Icings in flats north of Shaw Creek, May 22, 1972.

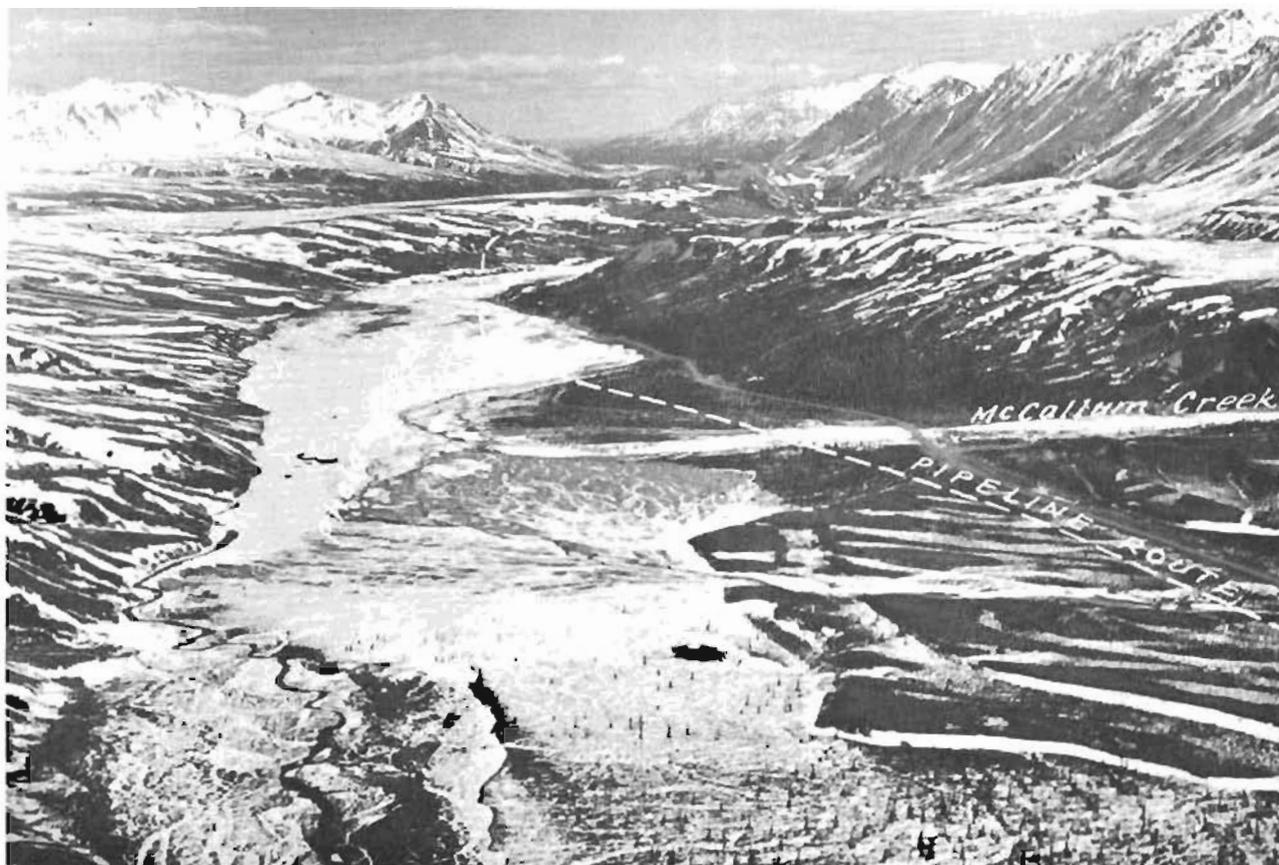
Figure 27.--Icing in Phelan and McCallum Creeks, May 29, 1973.

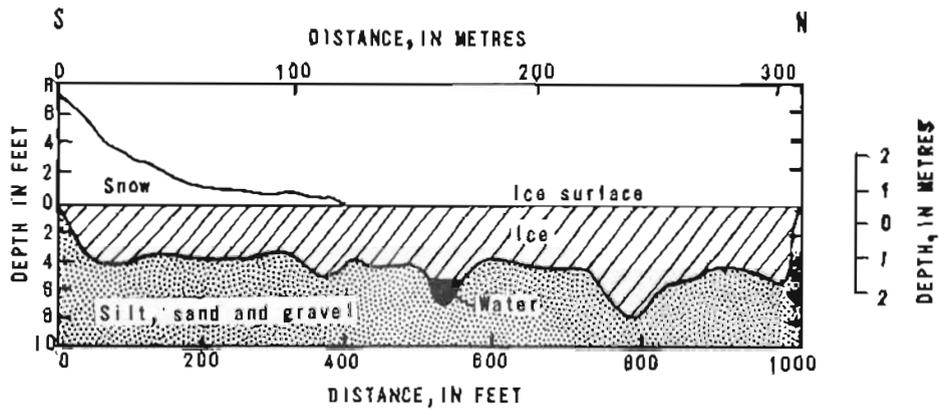
Borings were made through the Phelan Creek icing at the confluence of the Delta River and Phelan Creek on April 27, 1972 (fig. 28). The ice averaged about 5 feet (1.5 m) thick and of 31 holes drilled along a 1,000-foot (305-m) section, only one reached water in a channel under the ice. In the remainder of the holes, ice was resting directly on sand and gravel channel deposits.

Figure 28.-- Cross section through icing at mouth of Phelan Creek, April 27 1972. (See location of section in figure 2.)

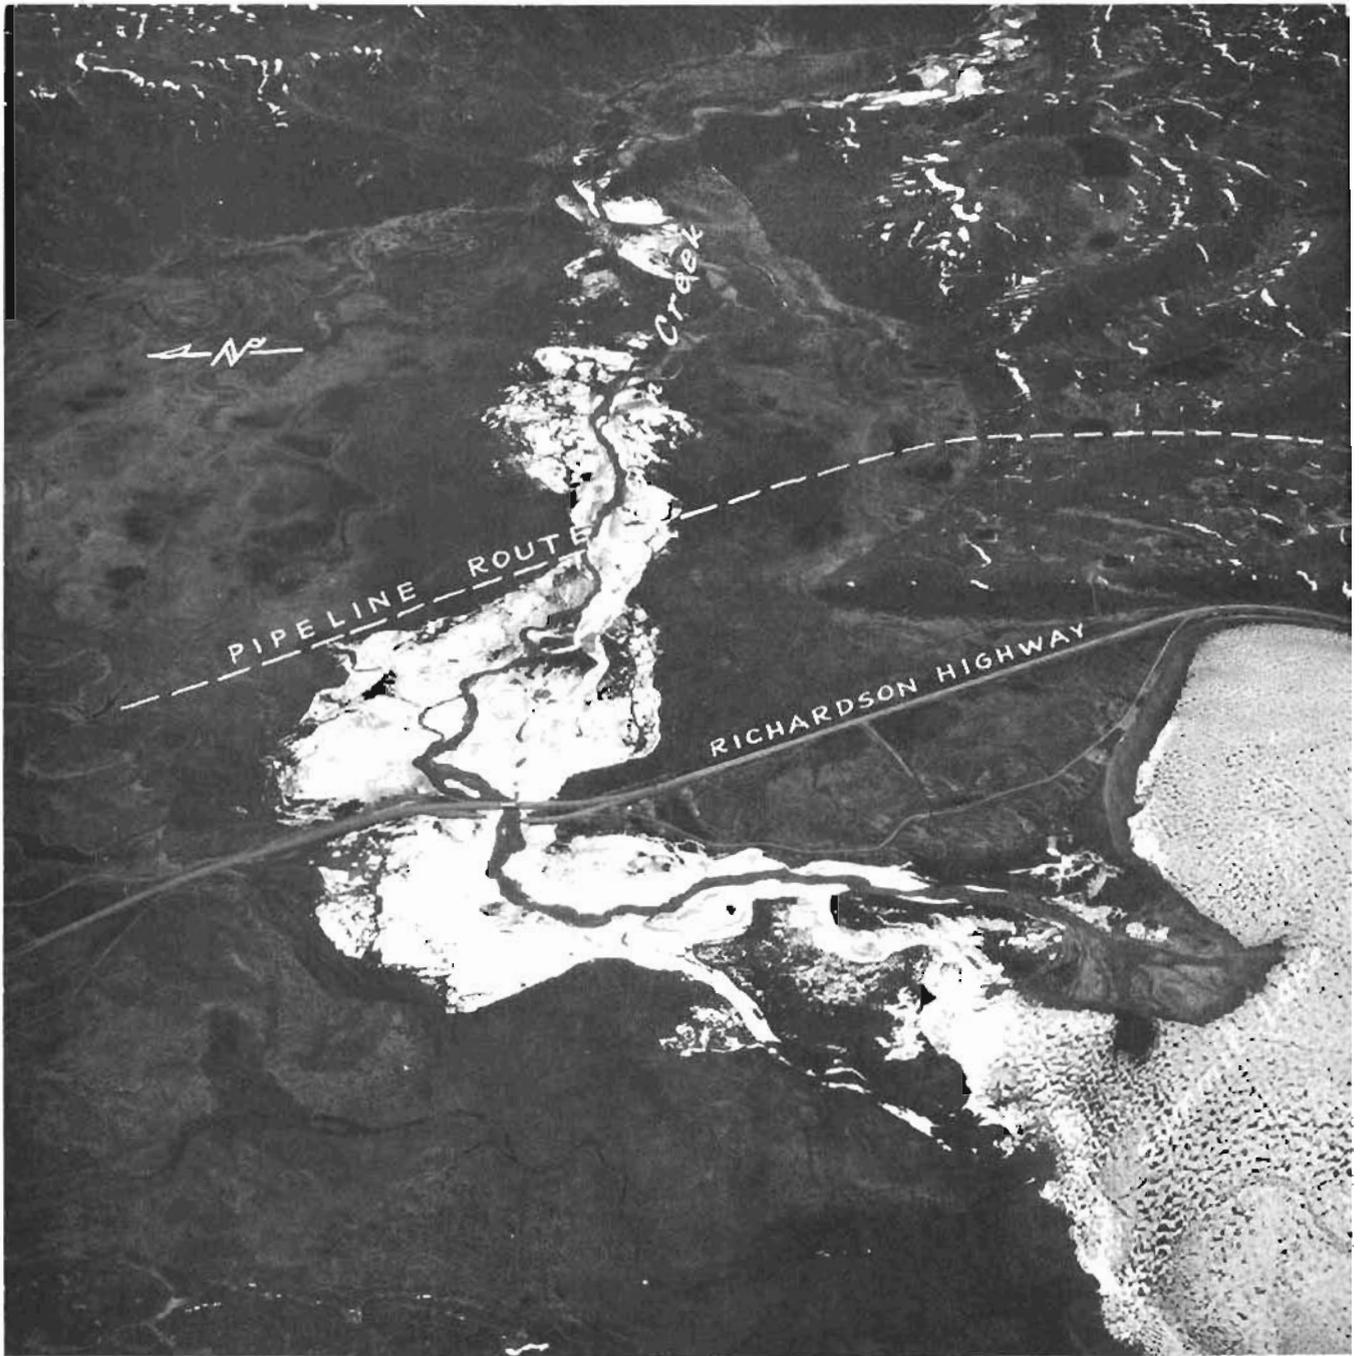
Near Isabel Pass a large icing forms annually on Gunn Creek at the Richardson Highway bridge (fig. 29).

Figure 29.--Icing on Gunn Creek at Richardson Highway and pipeline crossing, June 6, 1970.

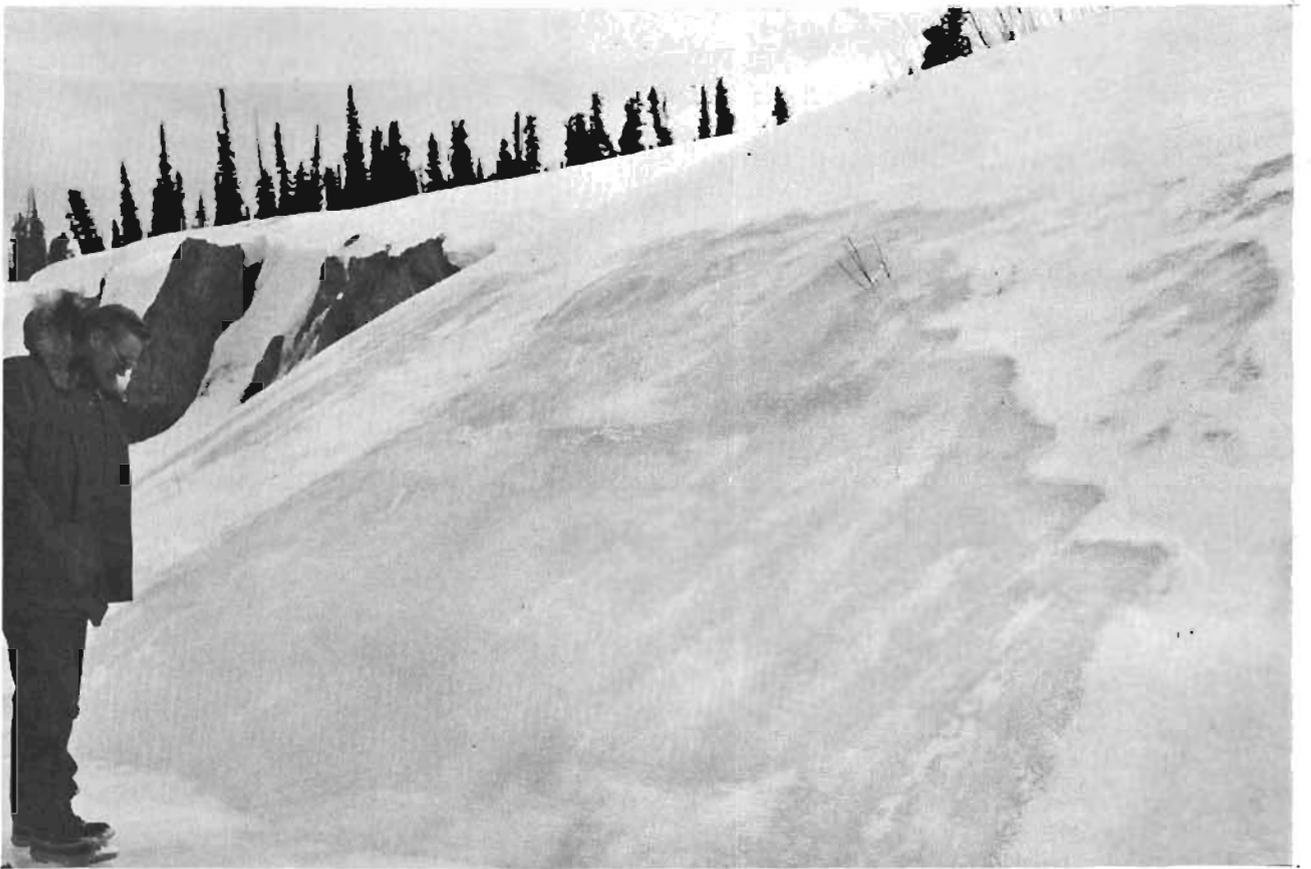
Hillside icings formed by seeps and springs in the Little Tonsina valley (fig. 32) have been particularly bothersome requiring repeated culvert maintenance by the Alaska Department of Highways. The occurrence of icings in the Chugach Mountains indicates that icings are not unique to the northern parts of Alaska. They are scattered along the entire length of the trans-Alaska pipeline route.

Figure 32.--Icing formed from ground-water seepage at face of gravel pit near Little Tonsina River, April 1, 1971.
