Department of Geology & Mineral Industries
800 NE Oregon St, Suite 965
Portland, OR 97232

Alaska DNR LIDAR Project, 2010 – Delivery 1 QC Analysis
LIDAR QC Report – April 6th, 2011

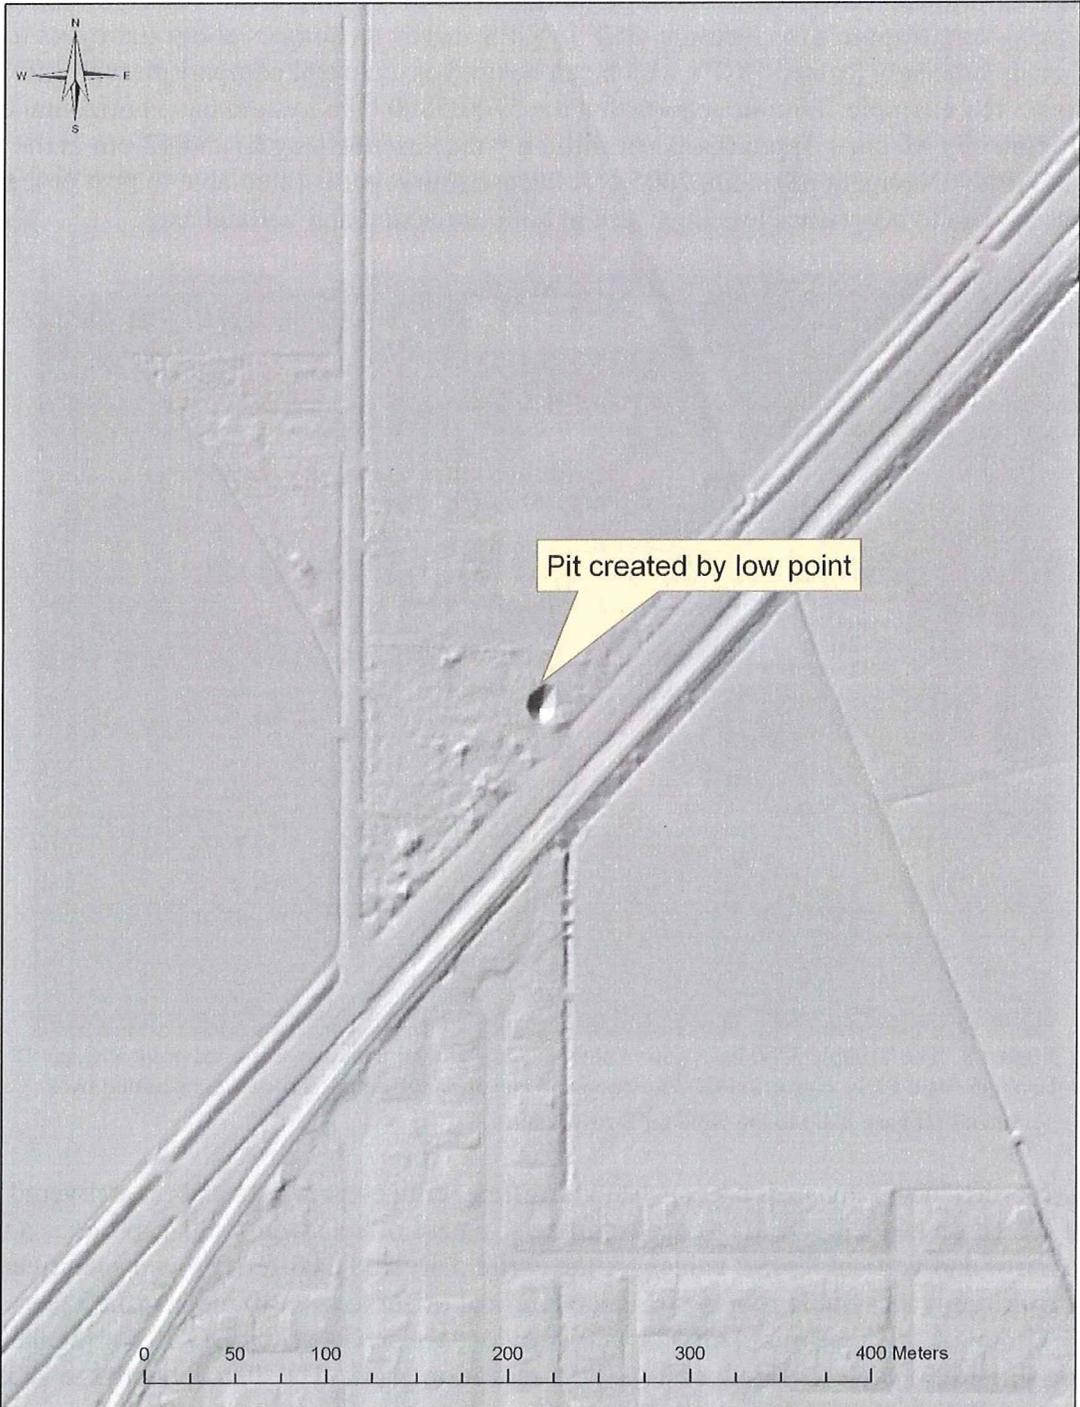
Figure 7. Example of “Pit” caused by low point in ground model. Pits are caused when standing water absorbs the lidar pulse. Pits are evident in ground model as the lowest point elevation is assigned to the grid cell value. Inversely the pit is not observable in the highest hit model as the highest point elevation is assigned to the grid value

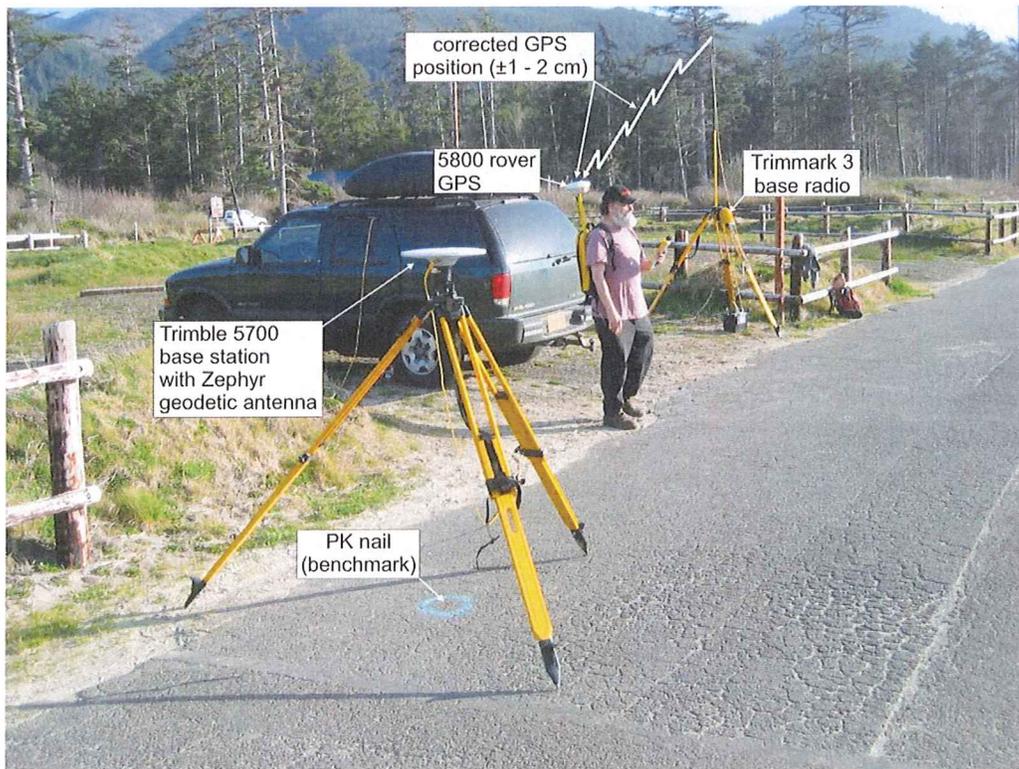
Figure 8. The Trimble 5700 base station antenna located over a known reference point at Cape Lookout State Park. Corrected GPS position and elevation information is then transmitted by a Trimmark III base radio to the 5800 GPS rover unit.

Absolute accuracy refers to the mean vertical offset of lidar data relative to measured ground-control points (GCP) obtained throughout the lidar sampling area. The contractor used a surveying system (Figure 8) to measure GCP's. GPS survey techniques allow surveyors to collect many precisely located GCP's which can be used as a control comparison with LiDAR elevations. For example, Trimble reports that the 5700/5800 GPS system have horizontal errors of approximately $\pm 1\text{-cm} + 1\text{ppm}$ (parts per million * the baseline length) and $\pm 2\text{-cm}$ in the vertical (TrimbleNavigationSystem, 2005). A licensed surveyor is often able to post process GPS survey data to accuracies less than 1cm in both horizontal and vertical axes.

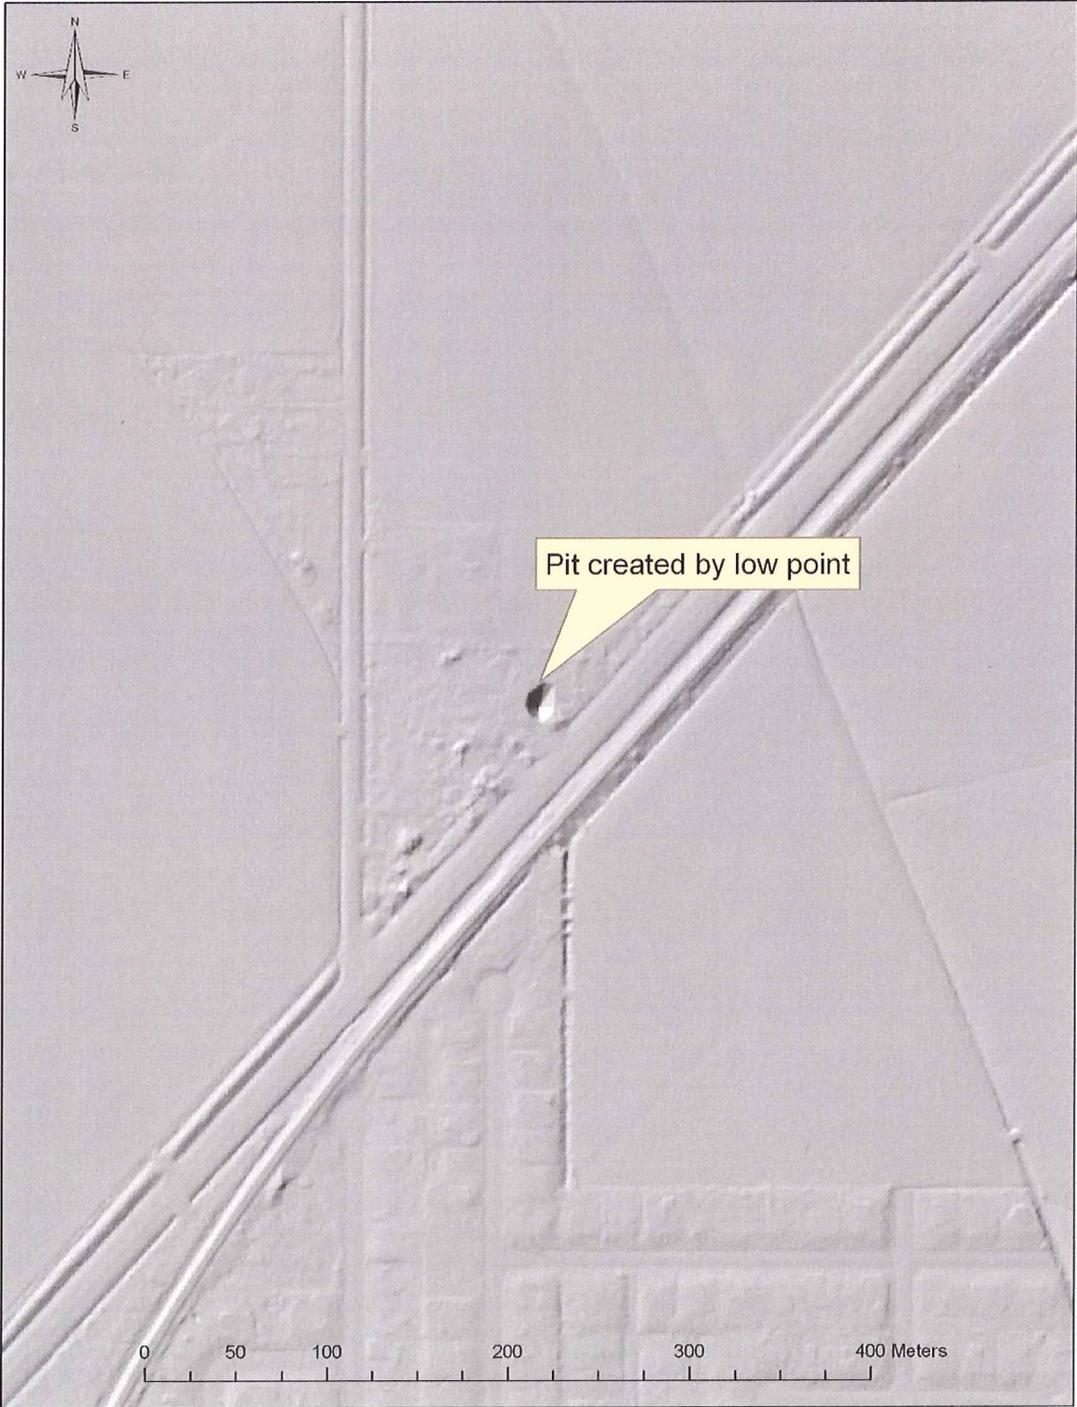
Figure 7. Example of “Pit” caused by low point in ground model. Pits are caused when standing water absorbs the lidar pulse. Pits are evident in ground model as the lowest point elevation is assigned to the grid cell value. Inversely the pit is not observable in the highest hit model as the highest point elevation is assigned to the grid value

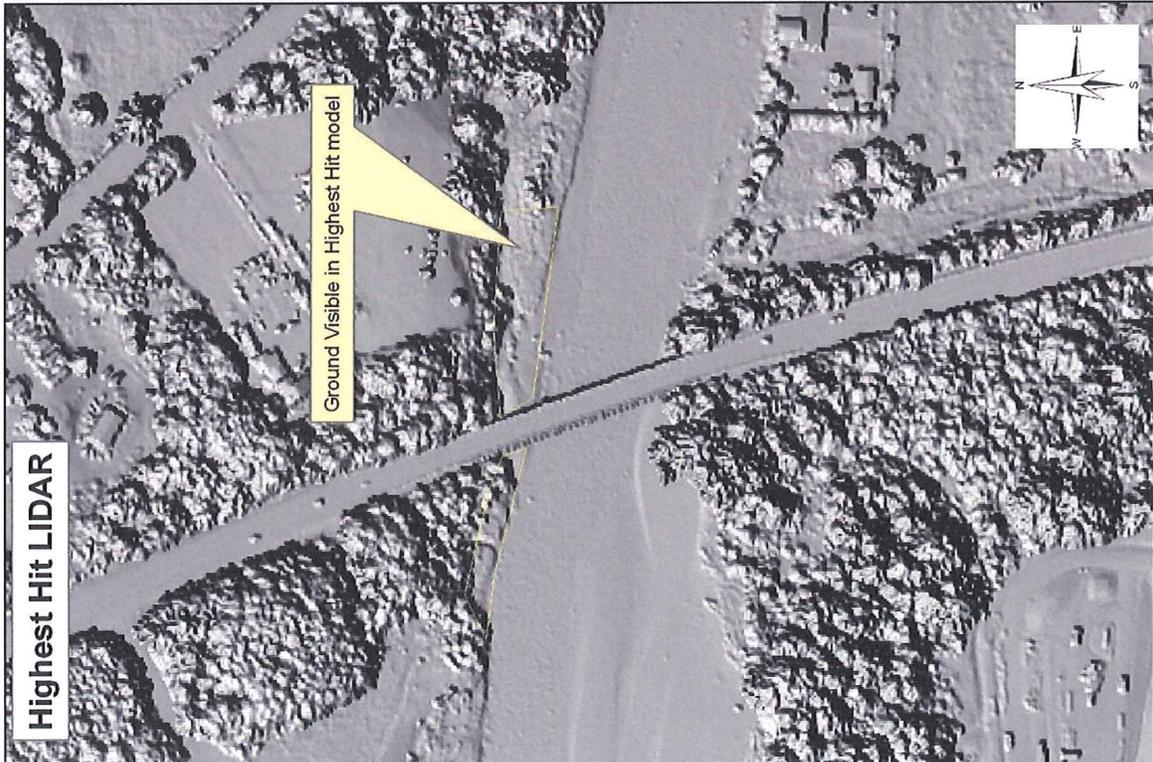
Figure 5. Example of missing ground in lidar bare earth data. Ground is clearly visible in highest hit model, but has been removed from the bare earth model. This type of classification error is common near water body features.

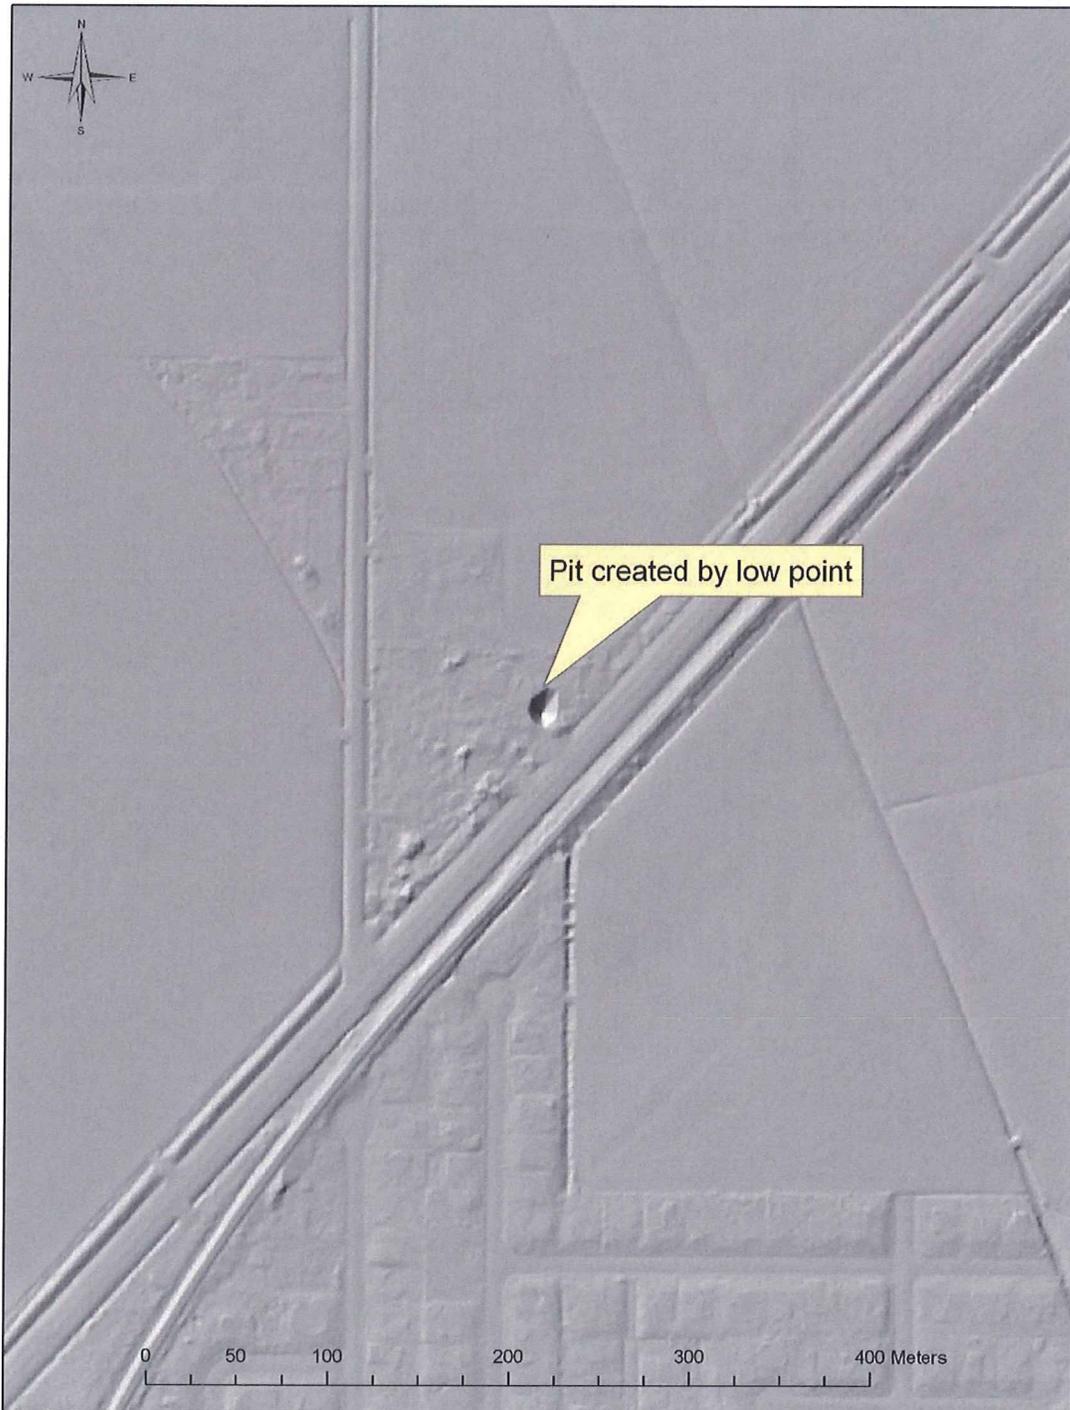
Figure 7. Example of “Pit” caused by low point in ground model. Pits are caused when standing water absorbs the lidar pulse. Pits are evident in ground model as the lowest point elevation is assigned to the grid cell value. Inversely the pit is not observable in the highest hit model as the highest point elevation is assigned to the grid value

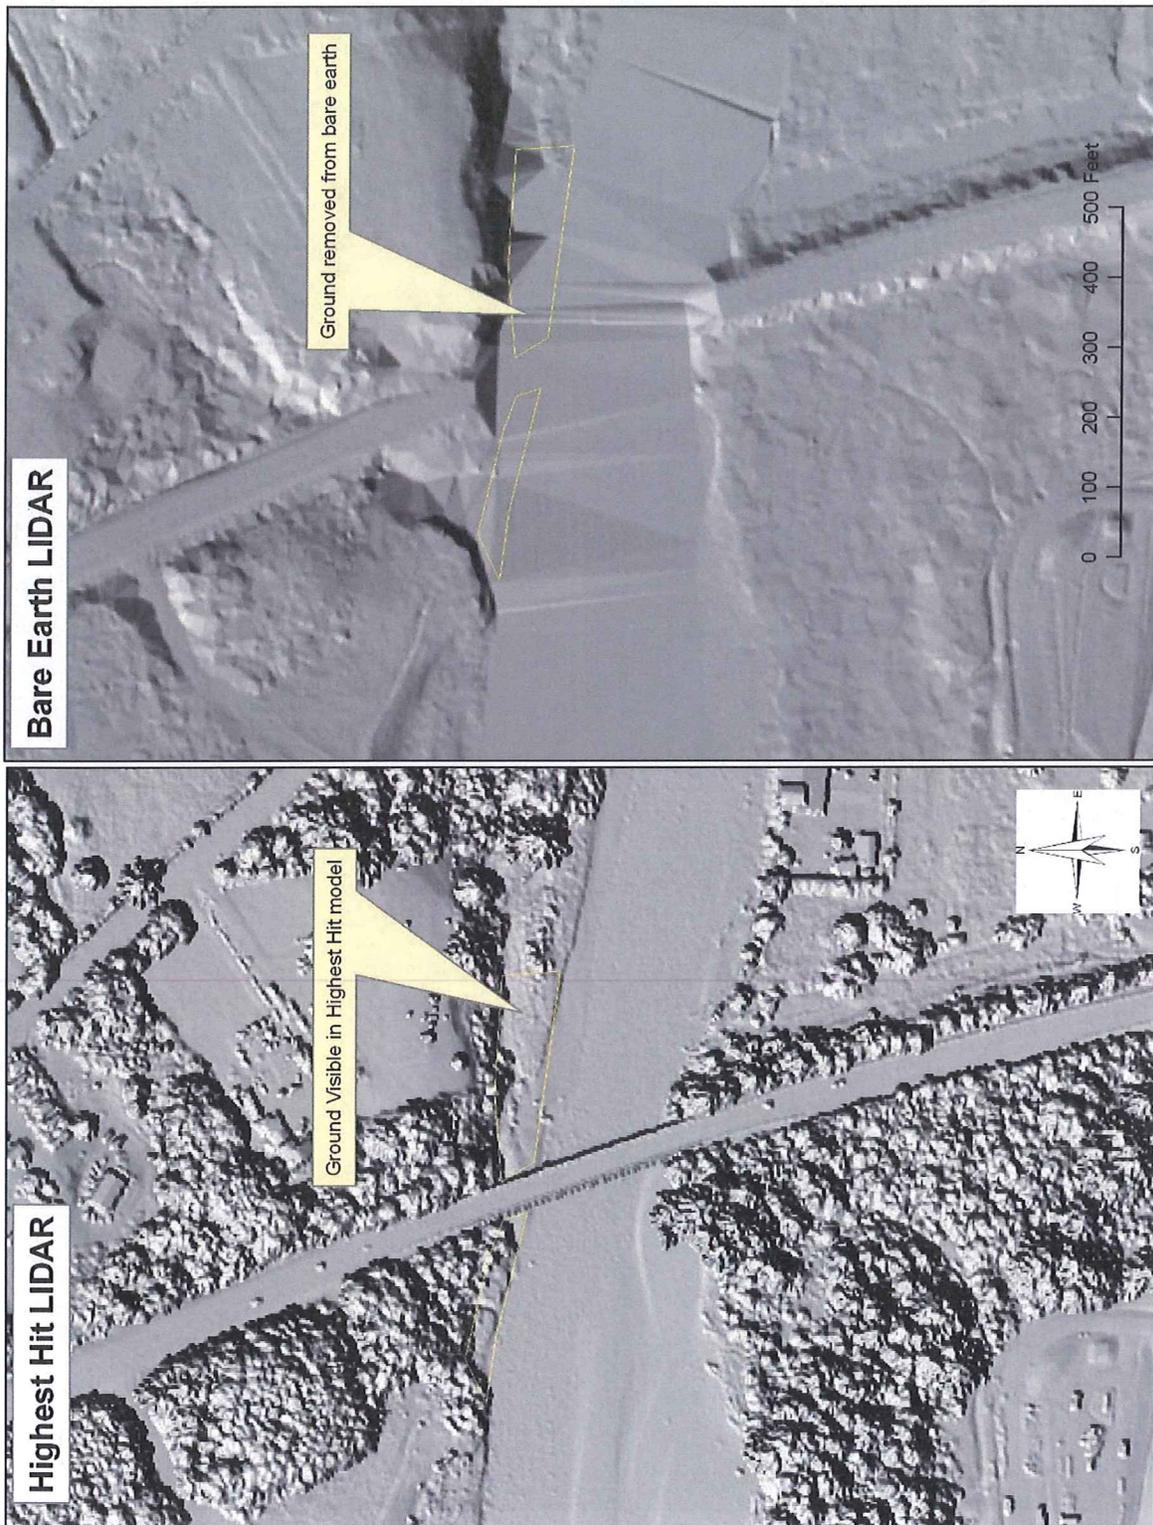
Figure 5. Example of missing ground in lidar bare earth data. Ground is clearly visible in highest hit model, but has been removed from the bare earth model. This type of classification error is common near water body features.

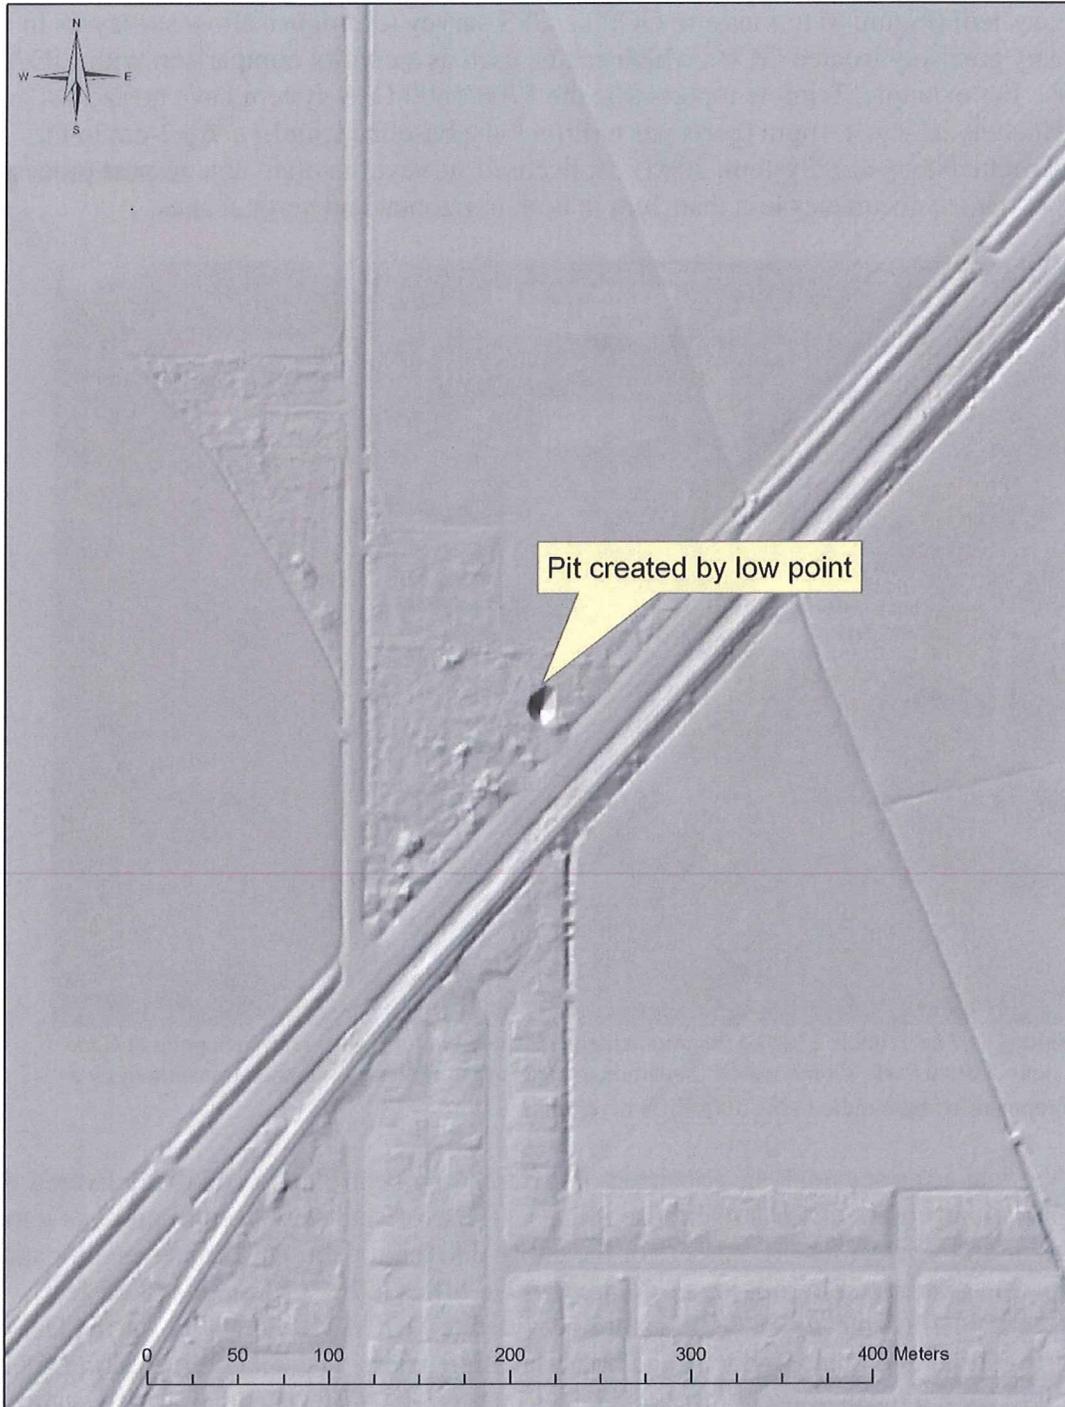
Figure 7. Example of “Pit” caused by low point in ground model. Pits are caused when standing water absorbs the lidar pulse. Pits are evident in ground model as the lowest point elevation is assigned to the grid cell value. Inversely the pit is not observable in the highest hit model as the highest point elevation is assigned to the grid value

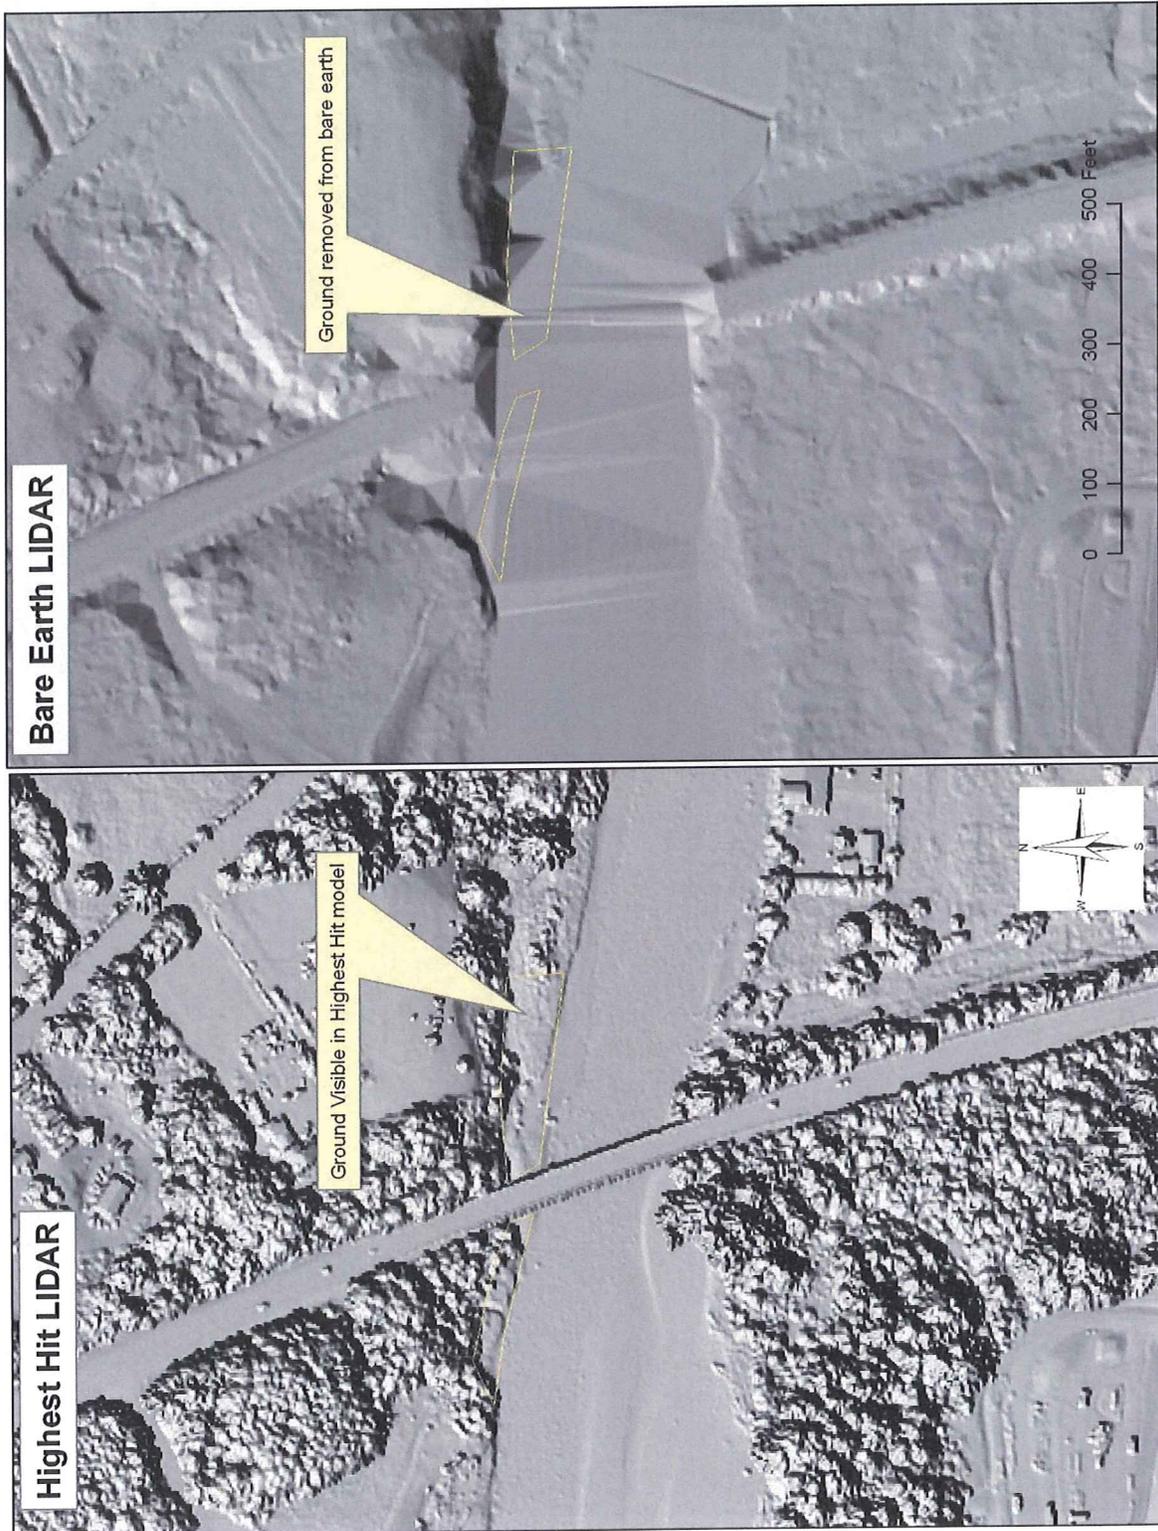
Figure 5. Example of missing ground in lidar bare earth data. Ground is clearly visible in highest hit model, but has been removed from the bare earth model. This type of classification error is common near water body features.

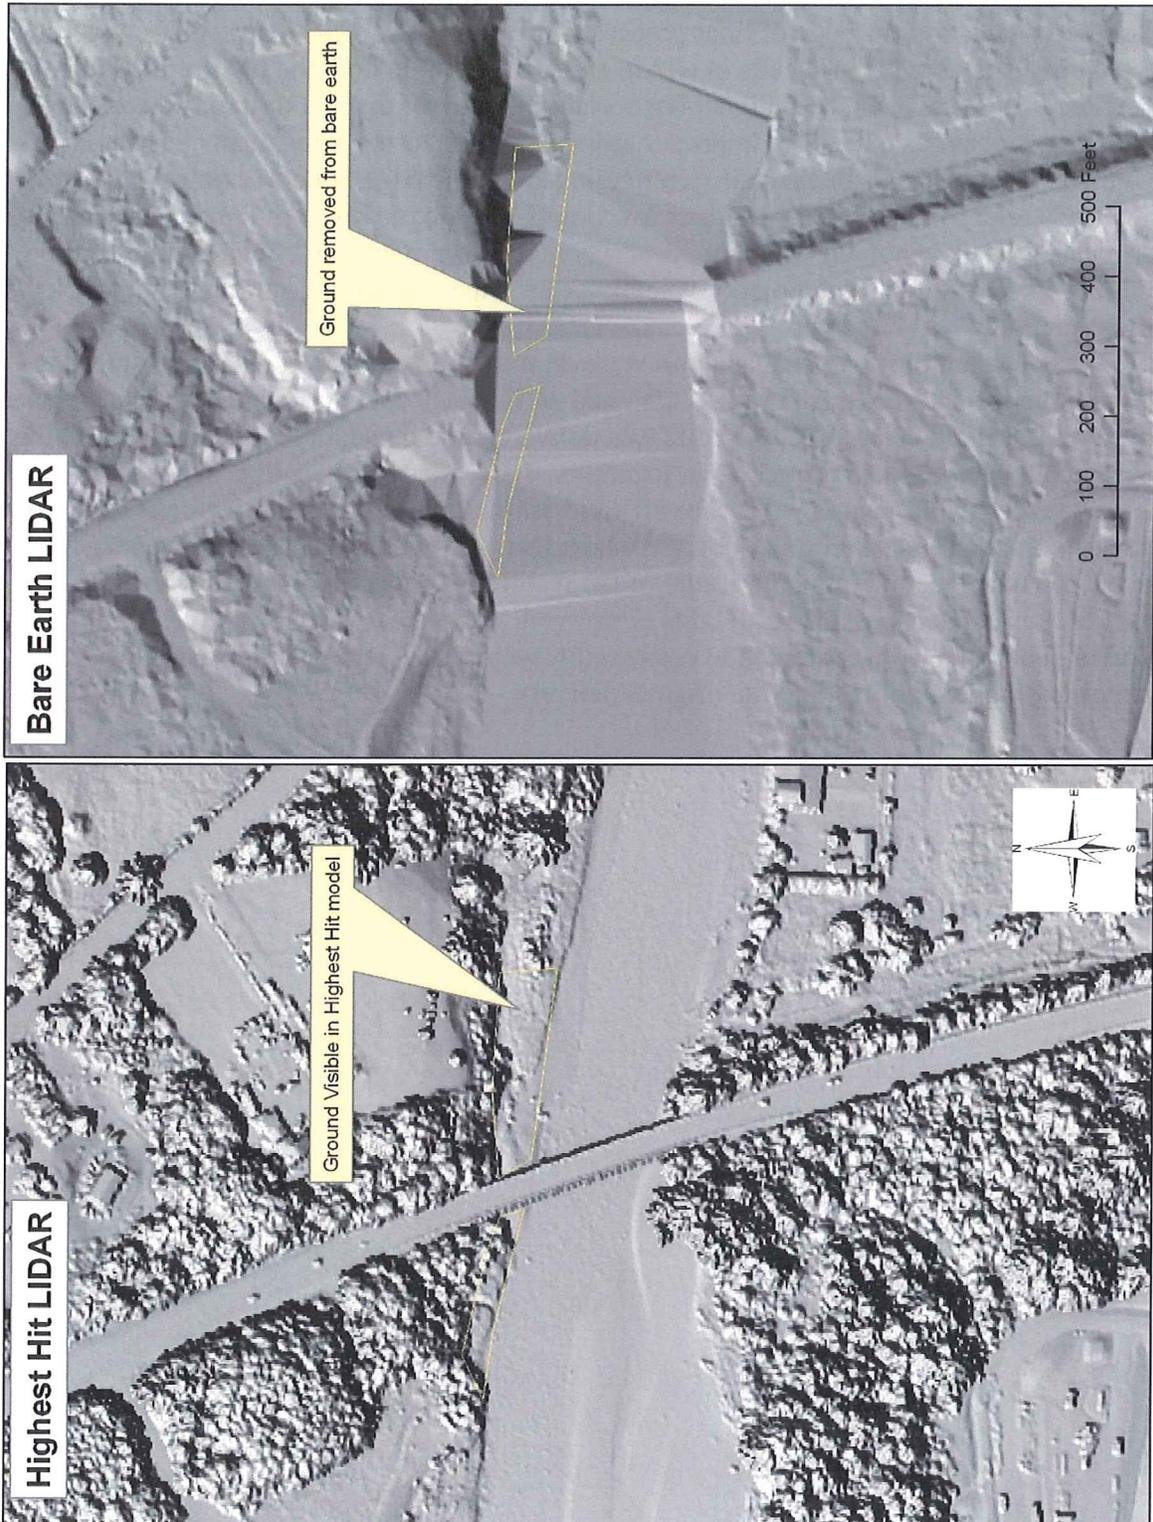
Figure 5. Example of missing ground in lidar bare earth data. Ground is clearly visible in highest hit model, but has been removed from the bare earth model. This type of classification error is common near water body features.

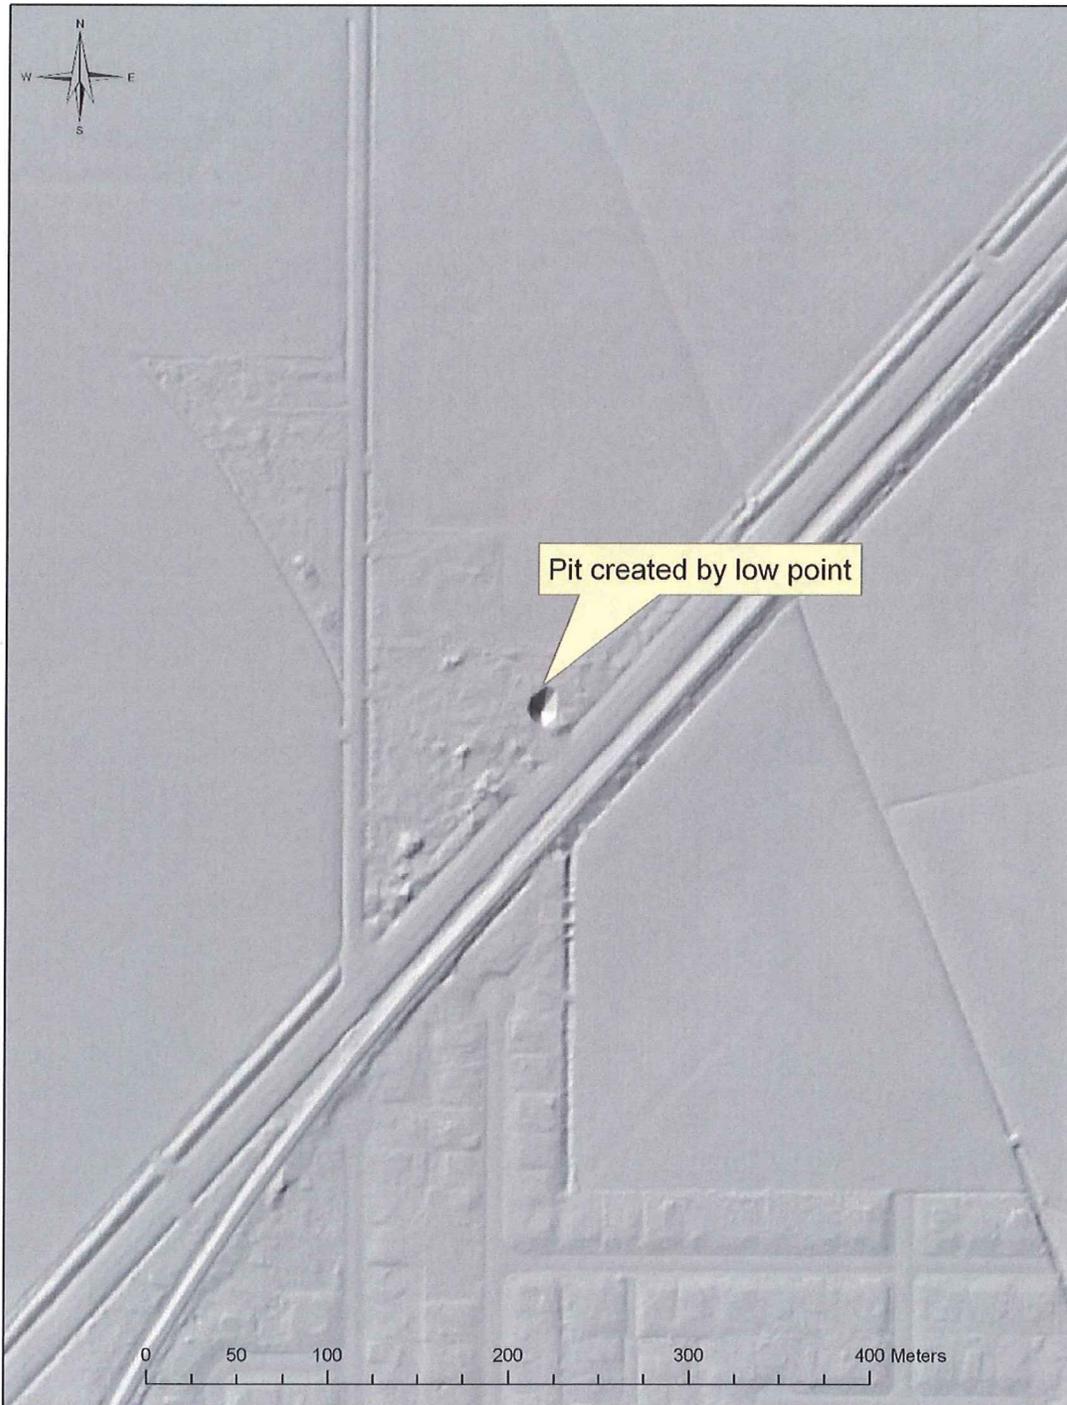
Figure 7. Example of “Pit” caused by low point in ground model. Pits are caused when standing water absorbs the lidar pulse. Pits are evident in ground model as the lowest point elevation is assigned to the grid cell value. Inversely the pit is not observable in the highest hit model as the highest point elevation is assigned to the grid value

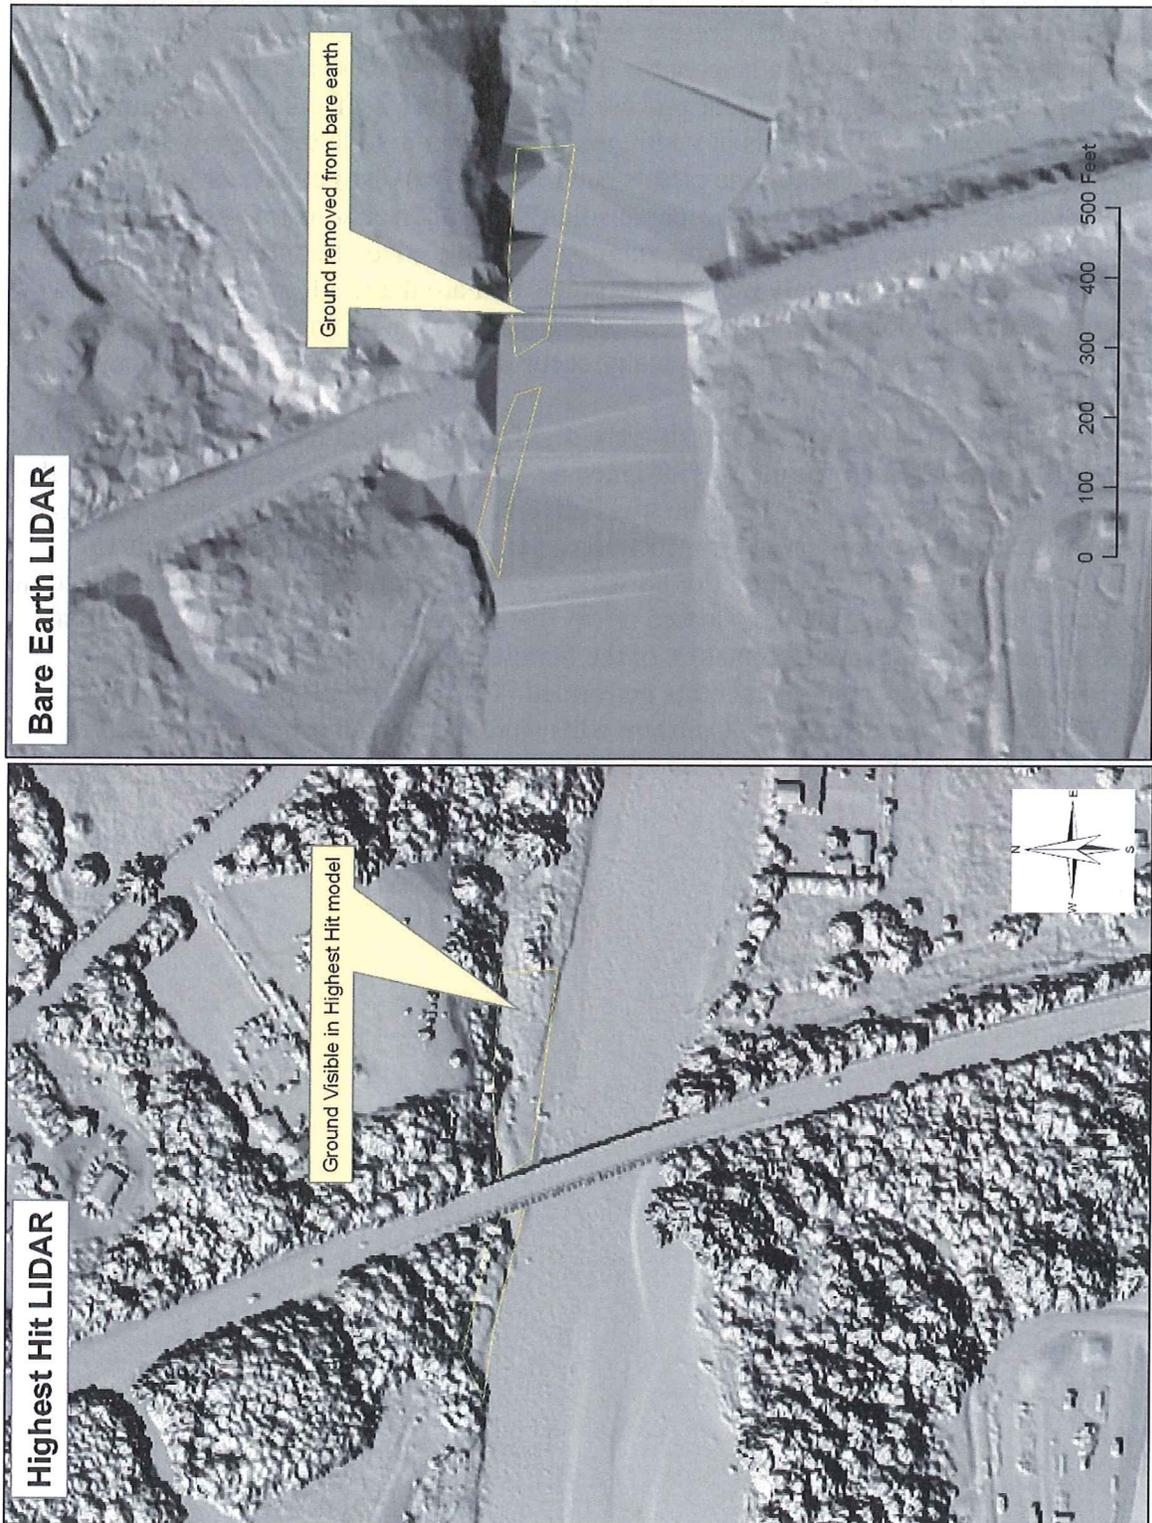
Figure 5. Example of missing ground in lidar bare earth data. Ground is clearly visible in highest hit model, but has been removed from the bare earth model. This type of classification error is common near water body features.

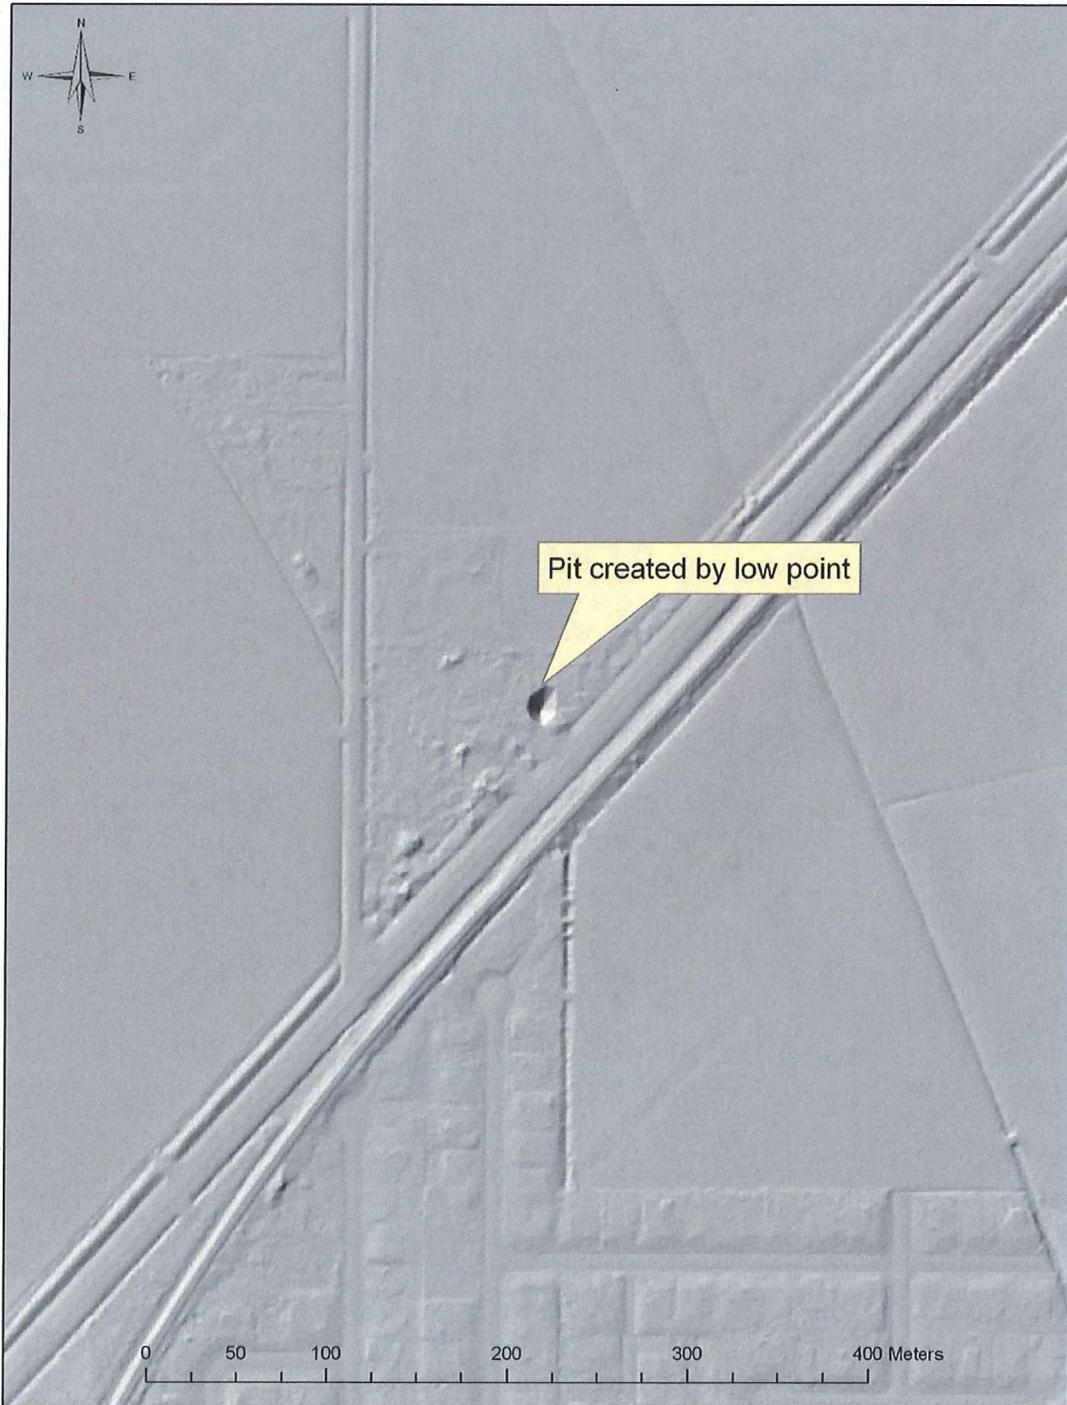
Figure 7. Example of “Pit” caused by low point in ground model. Pits are caused when standing water absorbs the lidar pulse. Pits are evident in ground model as the lowest point elevation is assigned to the grid cell value. Inversely the pit is not observable in the highest hit model as the highest point elevation is assigned to the grid value

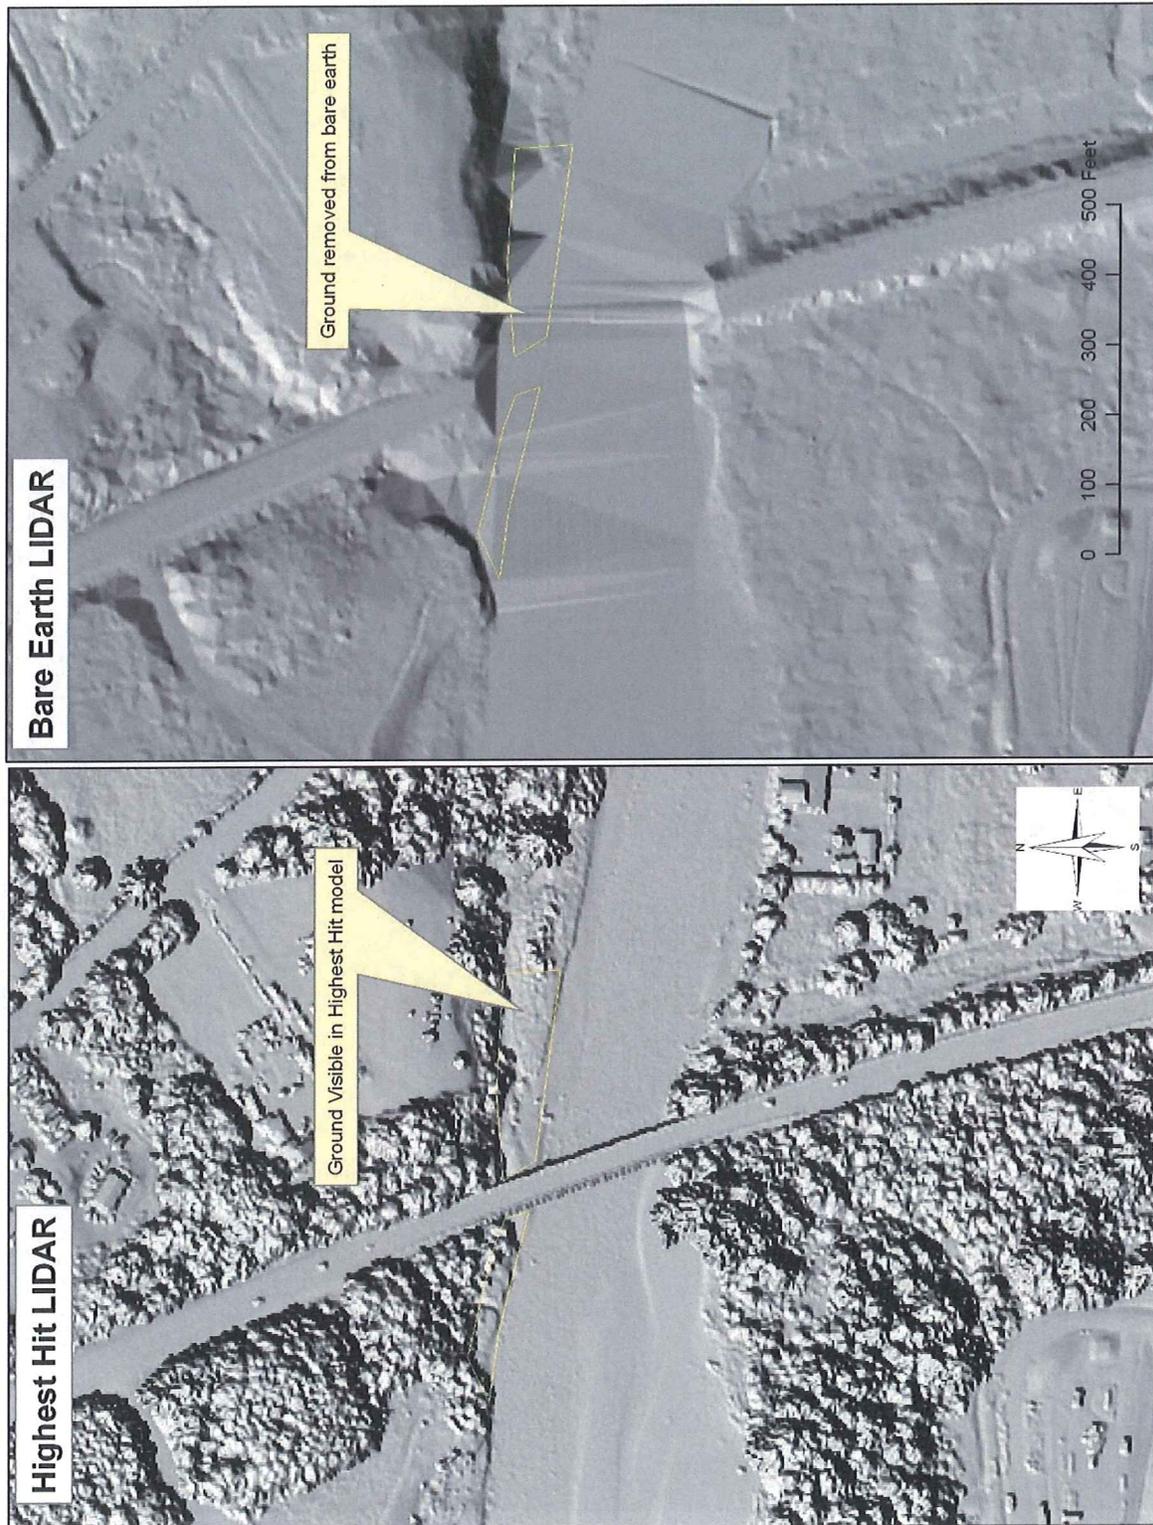
Figure 5. Example of missing ground in lidar bare earth data. Ground is clearly visible in highest hit model, but has been removed from the bare earth model. This type of classification error is common near water body features.

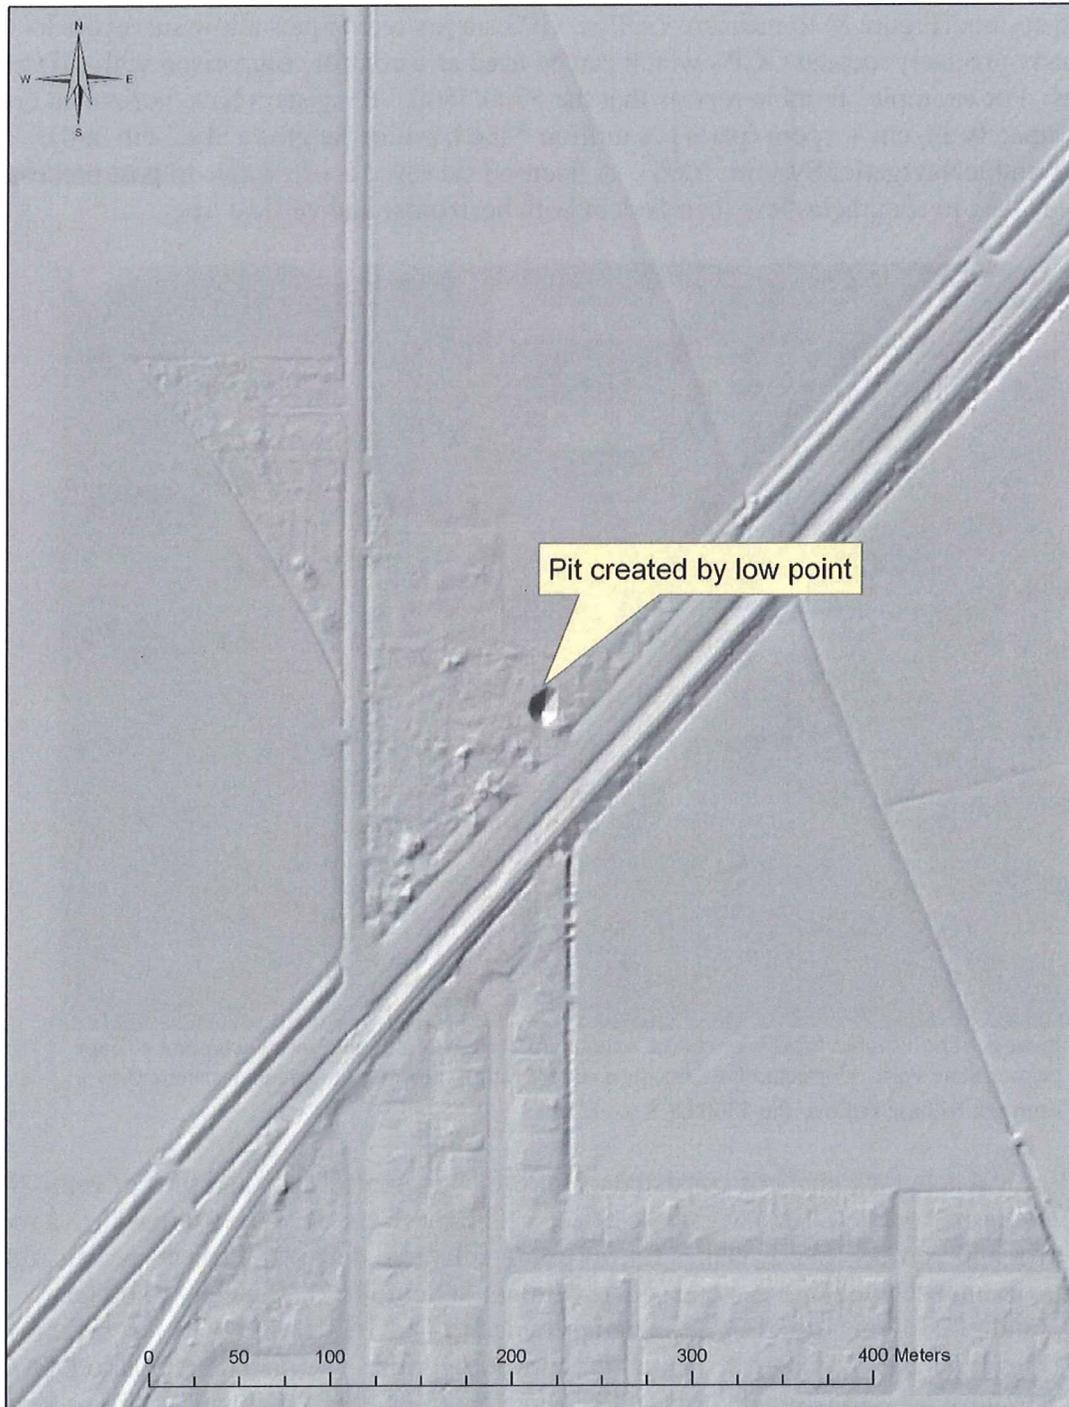
Figure 7. Example of “Pit” caused by low point in ground model. Pits are caused when standing water absorbs the lidar pulse. Pits are evident in ground model as the lowest point elevation is assigned to the grid cell value. Inversely the pit is not observable in the highest hit model as the highest point elevation is assigned to the grid value
