Department of Geology & Mineral Industries
800 NE Oregon St, Suite 965
Portland, OR 97232

Alaska DNR LIDAR Project, 2010 – Delivery 1 QC Analysis
LIDAR QC Report – April 6th, 2011

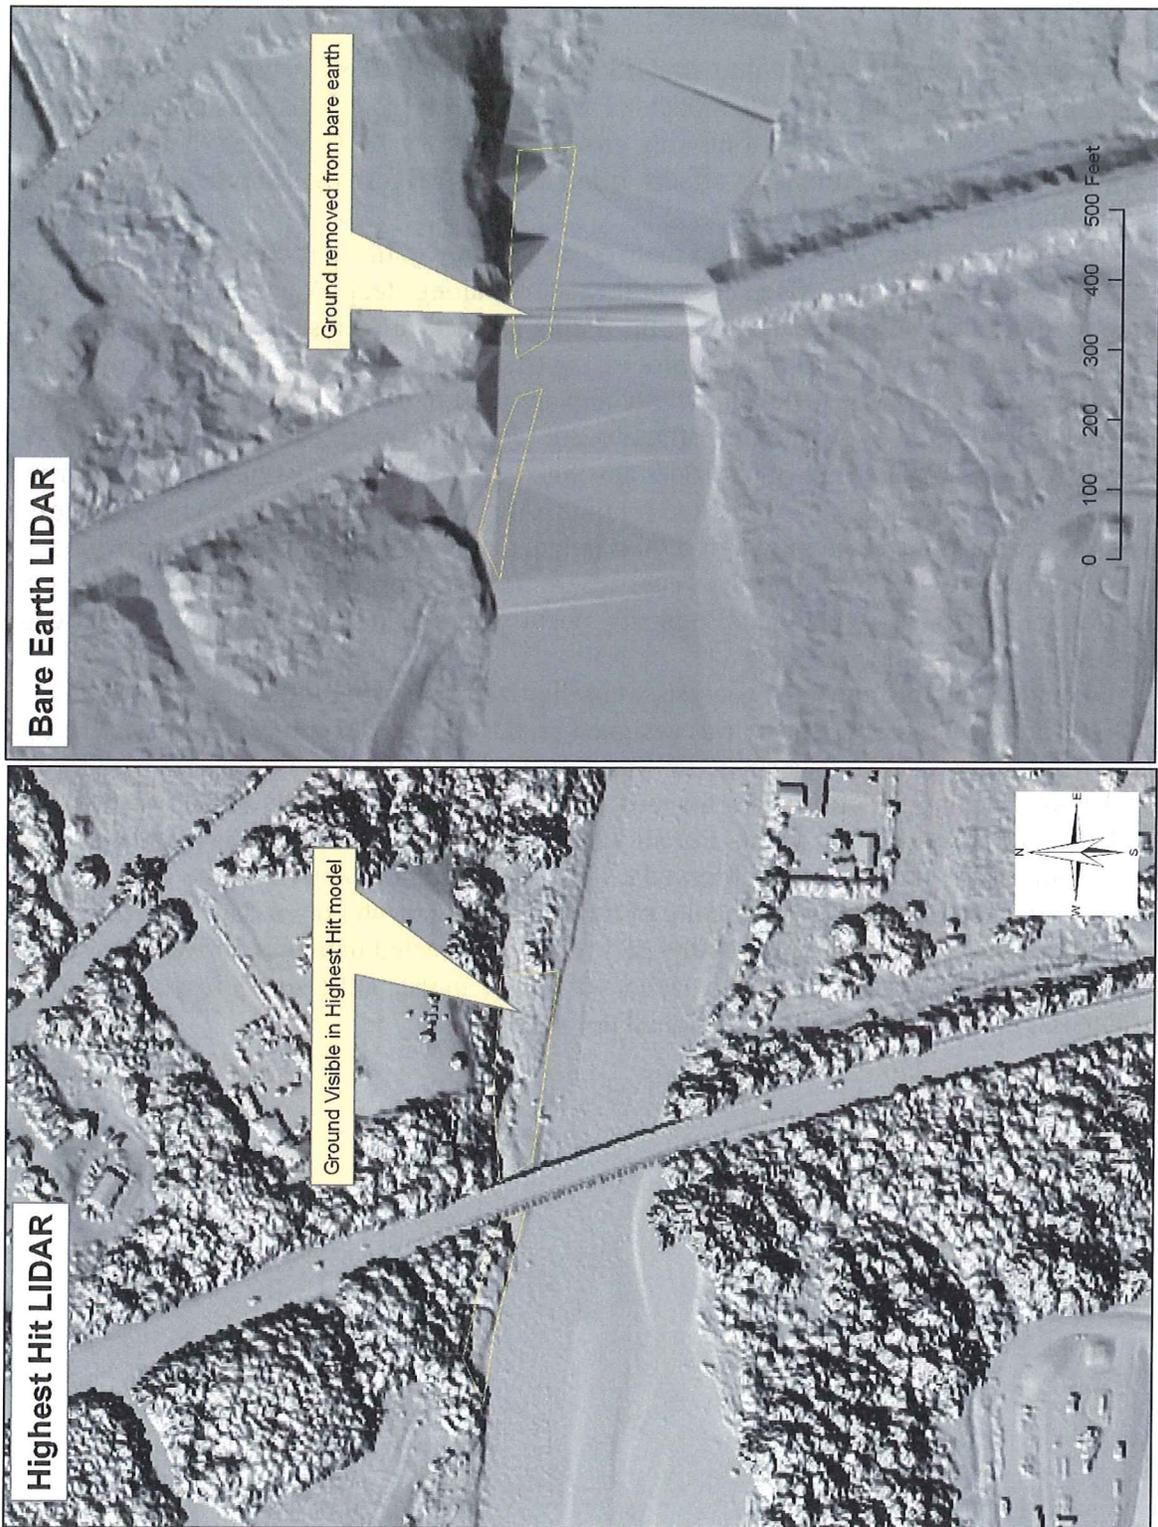
Figure 5. Example of missing ground in lidar bare earth data. Ground is clearly visible in highest hit model, but has been removed from the bare earth model. This type of classification error is common near water body features.

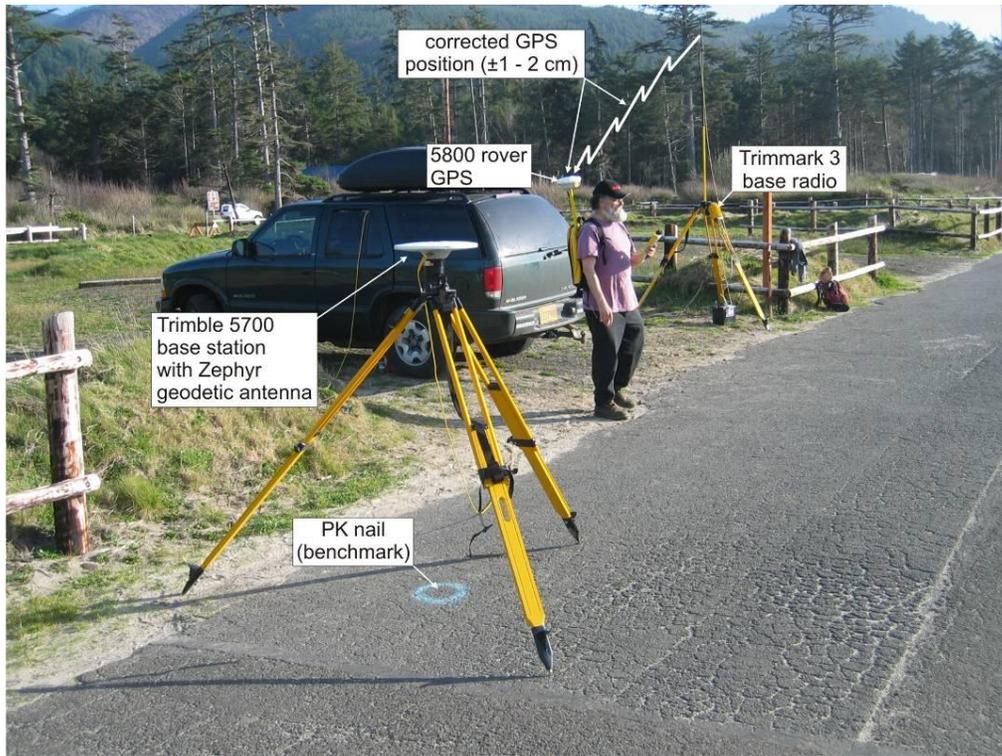
Figure 8. The Trimble 5700 base station antenna located over a known reference point at Cape Lookout State Park. Corrected GPS position and elevation information is then transmitted by a Trimmark III base radio to the 5800 GPS rover unit.

Absolute accuracy refers to the mean vertical offset of lidar data relative to measured ground-control points (GCP) obtained throughout the lidar sampling area. The contractor used a surveying system (Figure 8) to measure GCP's. GPS survey techniques allow surveyors to collect many precisely located GCP's which can be used as a control comparison with LiDAR elevations. For example, Trimble reports that the 5700/5800 GPS system have horizontal errors of approximately $\pm 1\text{-cm} + 1\text{ppm}$ (parts per million * the baseline length) and $\pm 2\text{-cm}$ in the vertical (TrimbleNavigationSystem, 2005). A licensed surveyor is often able to post process GPS survey data to accuracies less than 1cm in both horizontal and vertical axes.
