## Coastal Flooding in Golovin, Alaska, following the November 2011 Bering Sea Storm

N. Kinsman<sup>1</sup> and M. DeRaps<sup>2</sup>

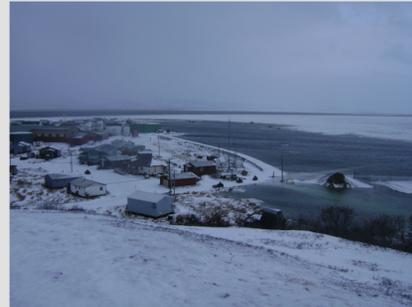
Lower portion of Golovin  
~11:30 am 11/9/11  
Photo by Debbie Anungazuk

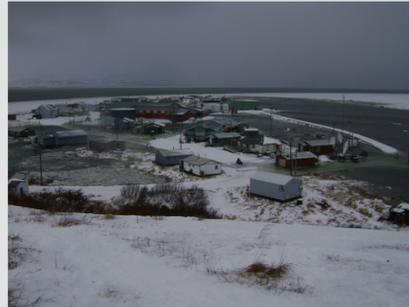
Lower portion of Golovin  
~2:00 pm 11/9/11  
Photo by Debbie Anungazuk

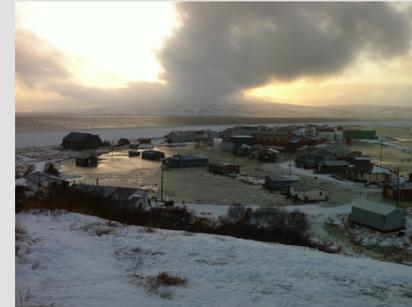
Lower portion of Golovin  
4:15 pm 11/9/11  
Photo by John Peterson

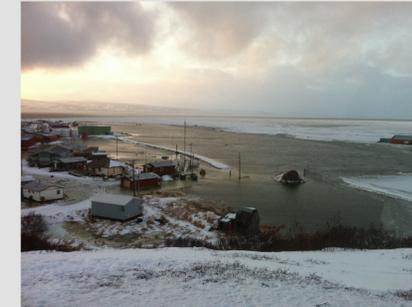
Lower portion of Golovin  
4:15 pm 11/9/11  
Photo by John Peterson

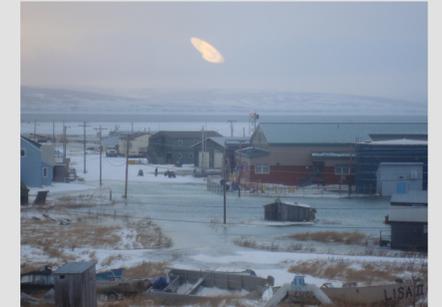
Highest water in front of school  
5:00 pm 11/9/11  
Photo by Rachel Olson

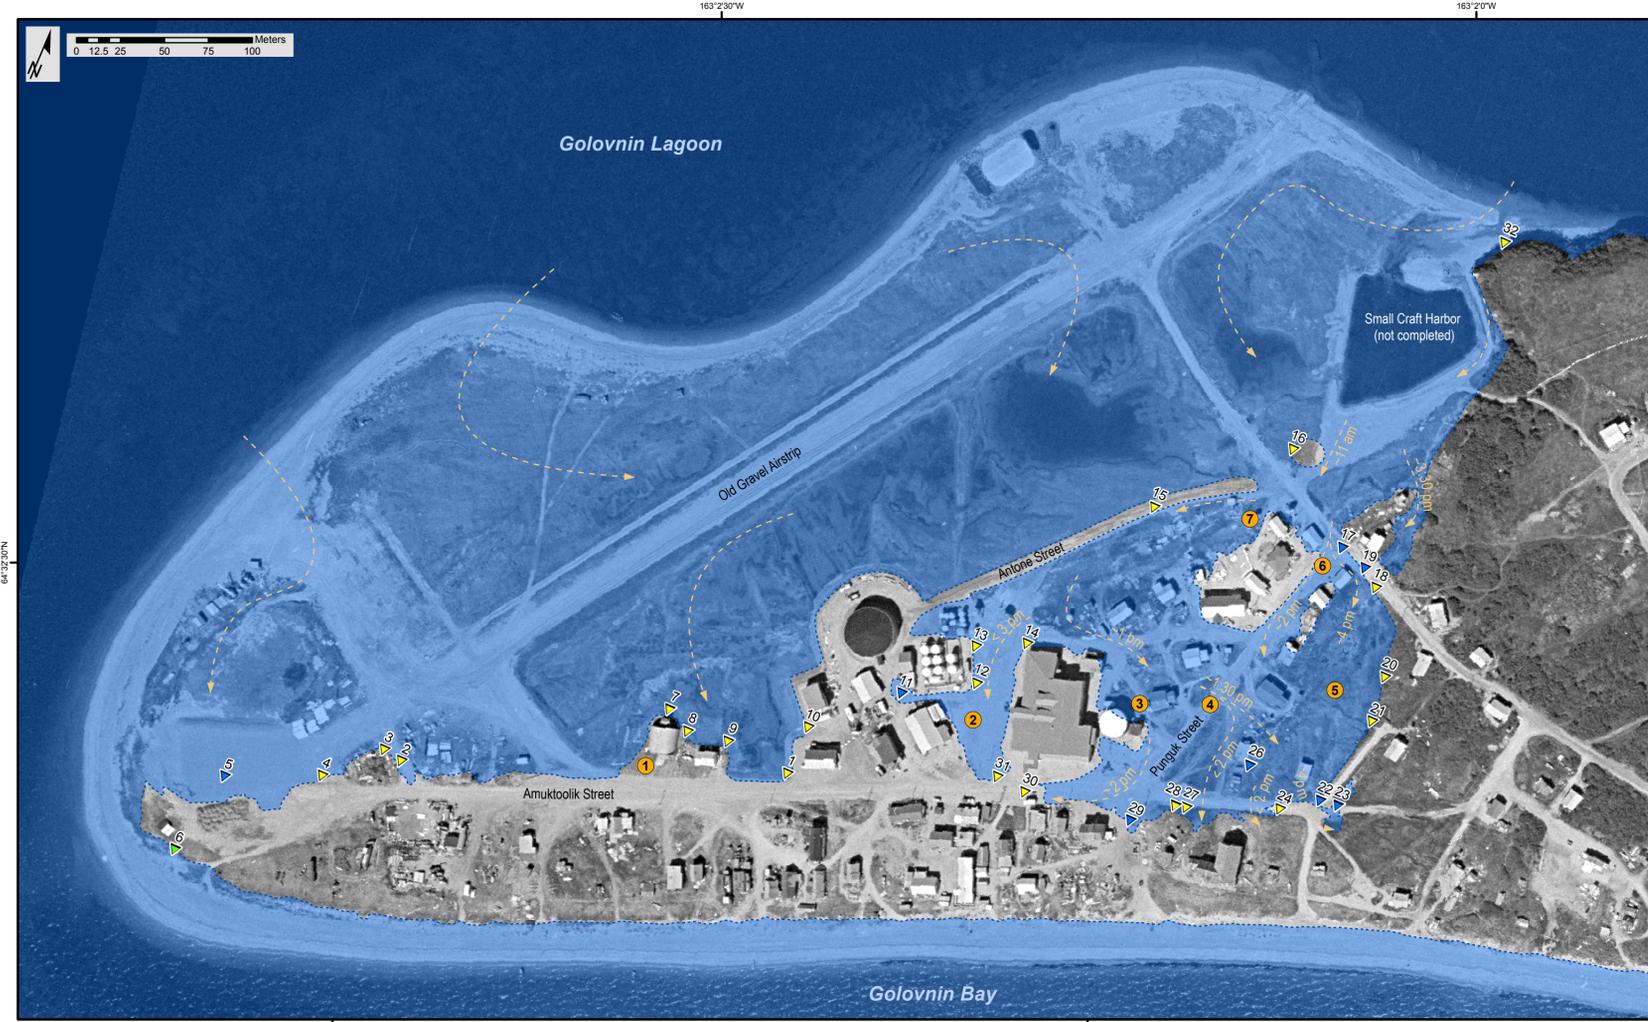
A team of Alaska Division of Geological & Geophysical Surveys (DGGS) scientists visited Golovin on November 15, 2011, to document peak water levels, runup elevations, and inundation extents caused by this event. This map summarizes the extent of the November 9, 2011, flooding and was created from DGGS measurements of flood indicators in combination with elevations on the 2004 Alaska Department of Commerce, Community & Economic Development (DCCED) community map and photographs taken by local residents during the storm. General flow directions are based on eyewitness accounts and a vertical model of static inundation to the elevations presented on the DCCED map. Approximate times of inundation in different parts of the community are based on the timestamps of the photographs that were provided by residents. A draft version of this map was reviewed by community members for accuracy and to resolve gaps in observed inundation extents as well as discrepancies between 2004 DCCED elevations and present-day conditions. The DGGS team would like to extend their deepest gratitude to all of the community members who took the time to share their videos, photographs, and observations and to those who provided the feedback that improved this map.

Elevations and Descriptions of Flood Indicators Measured in Golovin on November 15, 2011

Point Number	Measurement Type	Confidence level	Elevation in Meters (NAVD88)	Description
GLV_14	Inundation limit	Lowest	3.18 ±0.58	Slush line near the corner of the school (modified)
GLV_18	Inundation limit	Lowest	3.27 ±0.58	Elevation of tension cracking in snow surface near road
GLV_15	Inundation limit	High	3.58 ±0.60	Truncated snow and slush line along raised Antonie Street
GLV_13	Inundation limit	High	3.66 ±0.59	Slush line visible on dike surrounding tank farm
GLV_17	Inundated area	High	3.78 ±0.59	Location of overflow across the road to low-lying area
GLV_04	Inundation limit	High	3.93 ±0.66	Slush line near sewer drain field (minor snow cover)
GLV_02	Inundation limit	Lowest	4.02 ±0.58	Transition in slush surface near the old runway
GLV_05	Inundated area	Medium	4.07 ±0.59	Slush-covered area near sewer drain field
GLV_09	Inundation limit	Medium	4.10 ±0.58	Slush line along a berm that was raised up in 2008

GLV_26	Inundated area	High	4.02 ±0.66	Area by homes that were surrounded with water
GLV_01	Inundation limit	Medium	4.12 ±0.58	Slush line along road near generators; ice present
GLV_11	Inundated area	Medium	4.11 ±0.61	Slush-covered area by water holding tank (modified)
GLV_23	Inundated area	Medium	4.16 ±0.57	Low-lying portion of road that was flooded (modified)
GLV_27	Inundation limit	Lowest	4.19 ±0.57	Slush line along the road near Dexter Roadhouse
GLV_20	Inundation limit	Lowest	4.20 ±0.57	Slush line along hillside edge of a low-lying area
GLV_12	Inundation limit	Medium	4.22 ±0.58	Slush line between school and the tank farm
GLV_24	Inundation limit	Lowest	4.27 ±0.58	Elevation of tension cracking in snow surface along road edge, exact slush limit obscured by road clearing
GLV_19	Inundated area	Medium	4.32 ±0.58	Location of overflow across road into low-lying area
GLV_16	Peak flood level	High	4.32 ±0.60	Water level as preserved on the sides of a soil fill pile between Antonie Street and the small craft harbor fence

GLV_28	Inundation limit	Medium	4.42 ±0.58	Slush line on a mound near road at Dexter Roadhouse
GLV_07	Inundation limit	Medium	4.46 ±0.58	Slush line on side of earth foundation below hangar
GLV_08	Inundation limit	High	4.44 ±0.60	Elevation of tension cracking in snow surface
GLV_21	Inundation limit	Medium	4.49 ±0.57	Slush line along hillside edge of a low-lying area
GLV_03	Inundation limit	Lowest	4.56 ±0.58	Transition in slush surface near the old runway
GLV_22	Inundated area	Lowest	4.66 ±0.60	Location of overflow forming a pool across the road
GLV_30	Inundation limit	Lowest	4.80 ±0.58	limit of floodwater on road in front of school, as determined by an in situ consensus of residents
GLV_10	Inundation limit	High	4.83 ±0.58	Slush line between the washeteria and the power plant
GLV_31	Inundation limit	Lowest	4.99 ±0.58	limit of floodwater on road in front of school, as determined by an in situ consensus of residents

GLV_29	Inundated area	Lowest	5.30 ±0.58	Slush-covered area on road by church (modified)
GLV_06	Overtopped area	High	5.29 ±0.60	Crest elevation of ice ridge overtopped by waves (frozen puddle behind) at south tip of community
GLV_32	Peak flood level	High	5.59 ±0.59	Water level as observed in a truncated snowdrift on the cliffs on the north side of community

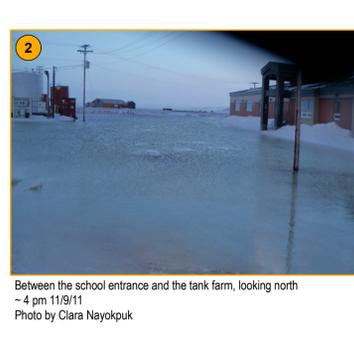
Between the school entrance and the tank farm, looking north  
~4 pm 11/9/11  
Photo by Clara Nayokpuk

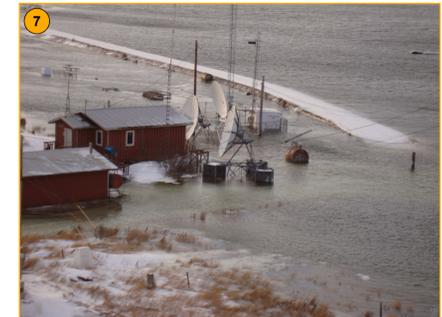
Flooded communication towers, looking west  
4:30 pm 11/9/11  
Photo by Rachel Olson

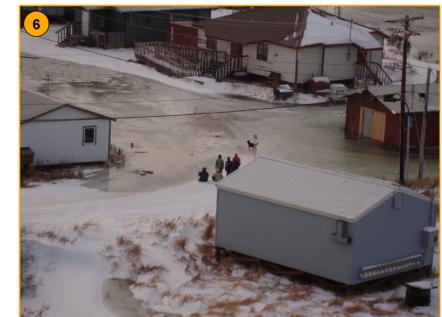
Overtopped portion of road, looking west  
4:30 pm 11/9/11  
Photo by Rachel Olson

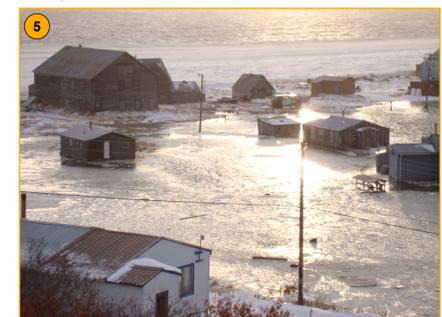
Low area looking south towards Dexter Roadhouse  
4:30 pm 11/9/11  
Photo by Rachel Olson
