THE ALASKA EARTHQUAKE, MARCH 27, 1964:
EFFECTS ON COMMUNITIES

Effects of the Earthquake Of March 27, 1964 In the Homer Area, Alaska

*A description of the damage caused by landmass
subsidence, earthflows, landslides, seiche waves,
and submarine landslides resulting from the
earthquake in the Homer area, Alaska*

GEOLOGICAL SURVEY PROFESSIONAL PAPER 542-D

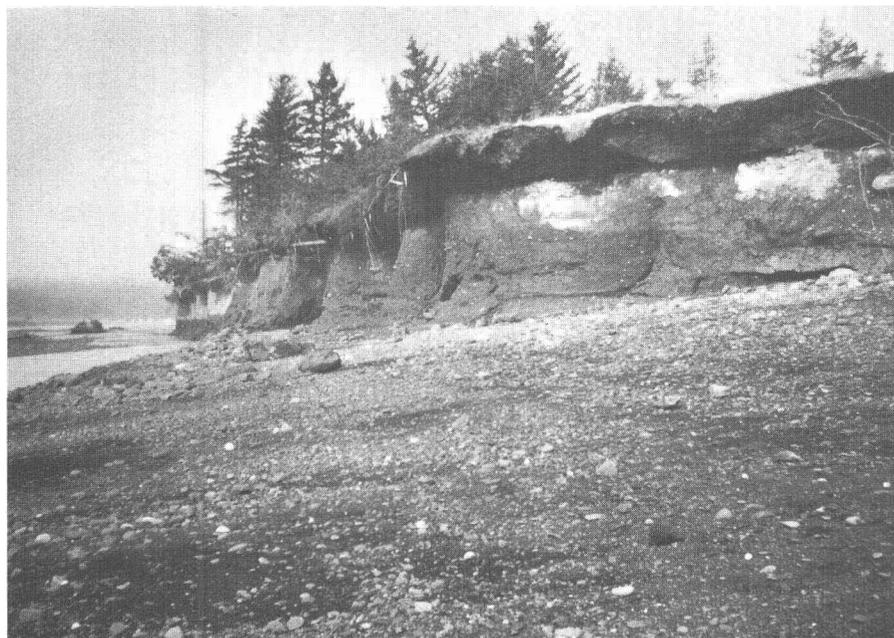
4.—Postearthquake erosion at Munson Point as of April 13, 1964. About 5 feet of the overhanging vegetal mat attests to recent erosion of the underlying glacial till as a result of higher water levels relative to land.

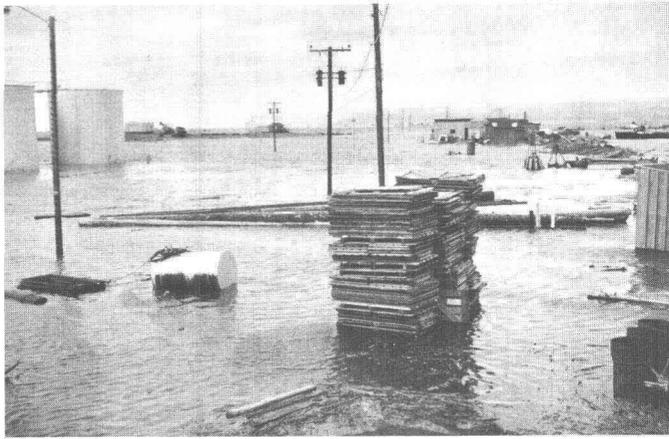
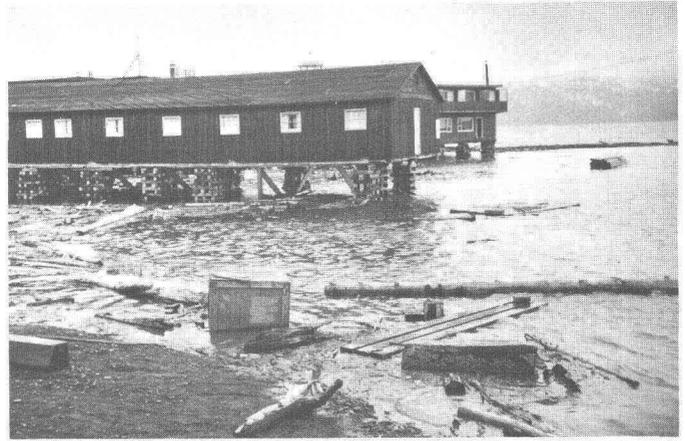
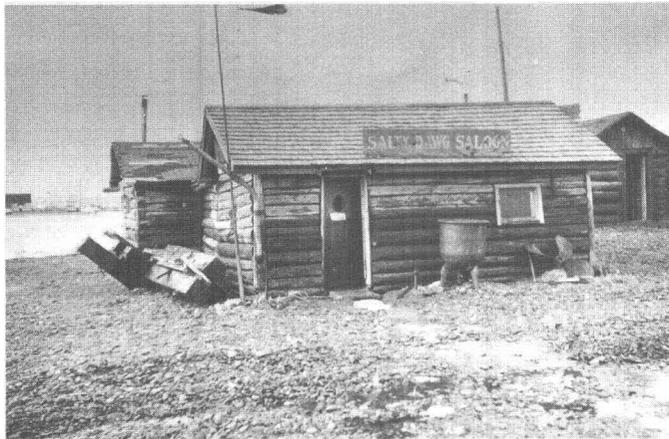
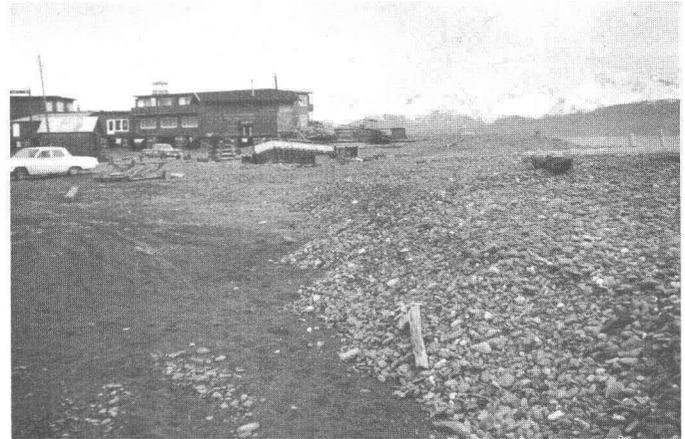
9.—Effects of the high tides submerging the end of Homer Spit on April 12, 1964. *A*, Standard Oil Co. tank farm awash in as much as 6 feet of water. *B*, Lands End Hotel raised on jacks. *C*, Water rose high enough to flow through the windows of the Salty Dawg Saloon. *D*, New storm berm encroaching on spit southwest of the Land's End Hotel.

covered in a matter of days by a new berm (fig. 9*D*) that prevented observation.

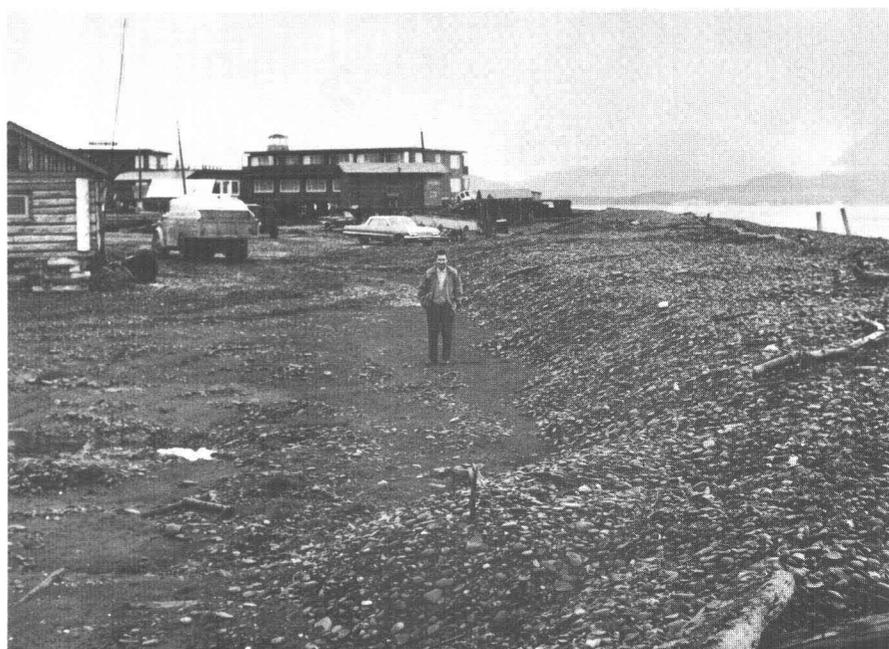
18.—Storm berm developed along spit within 6 months after subsidence. Berm before subsidence was less than 3 feet high and 4–5 feet wide at the base.

As an illustration of berm growth, the preearthquake berm at the distal end of the spit was less than 3 feet high, and 4-5 feet wide at the base. Six months after the earthquake, the berm, as shown by figure 18, had built up to 6 feet in height and had widened to nearly 60 feet. The same berm after another 6-month period had widened an additional 20 feet. Elsewhere the berm has migrated around buildings and covered and blocked roads.

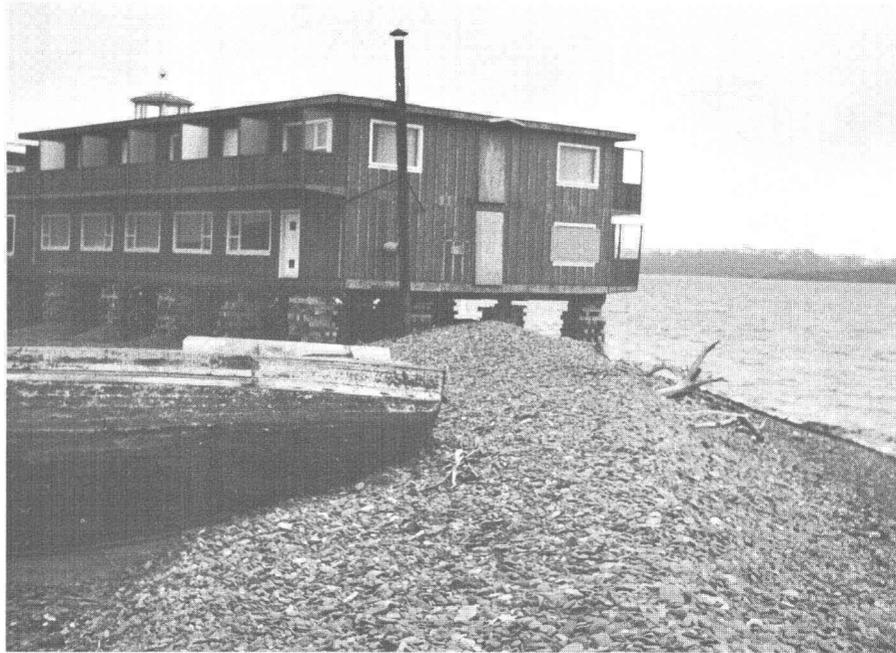
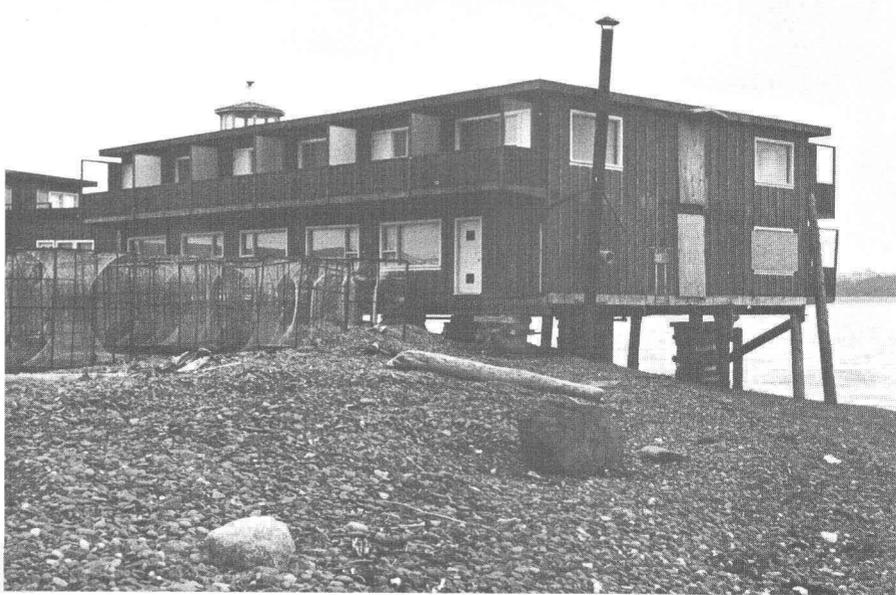
19.—Photographs taken 6 months after subsidence (top) and a year after subsidence (bottom) show that the size of frontal berm is not proportional to the recession of the beach face.

The size of the new berm is not in proportion to material lost from, nor to the recession of, the adjacent beach face. Figure 19

shows an example of this disparity. Such examples show that a large part of the material scoured from the beach face was not carried onto the spit and deposited as part of the berm. According to King (1959, p.

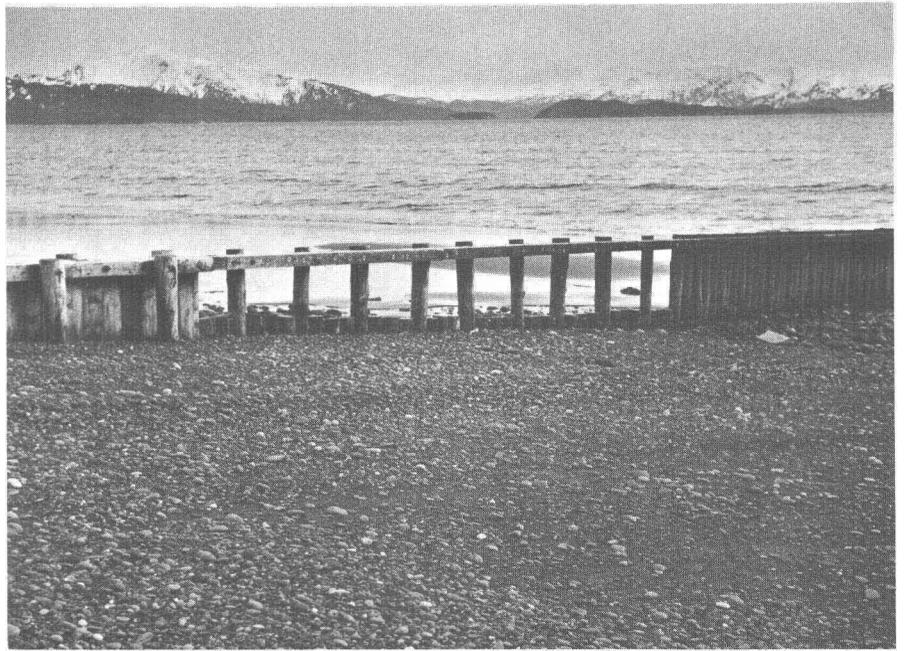
20.—Section removed from seaward end of groin to allow bypassing of material.

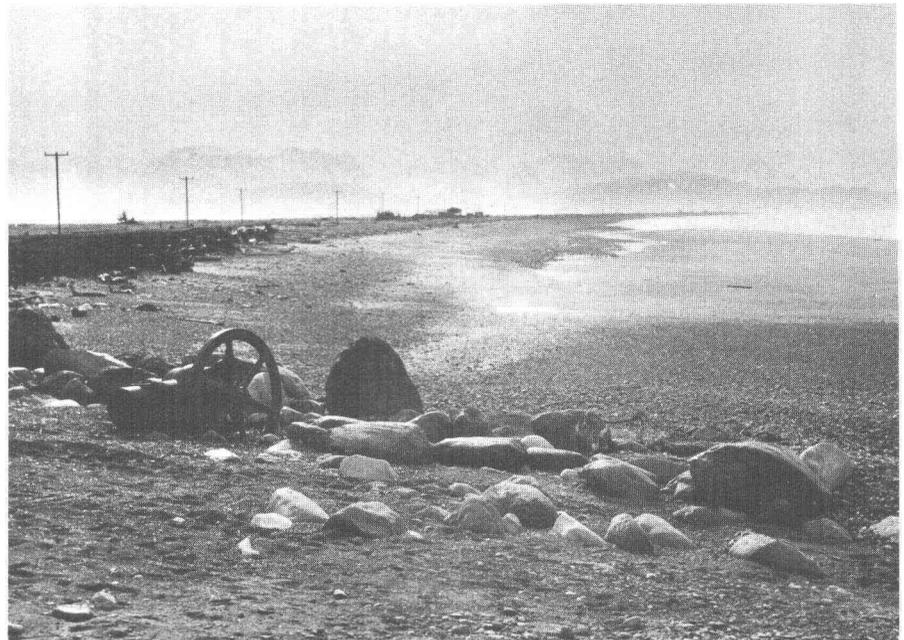
21.—Erosion on the lee side of the last of a series of four groins, a few days after the earthquake.

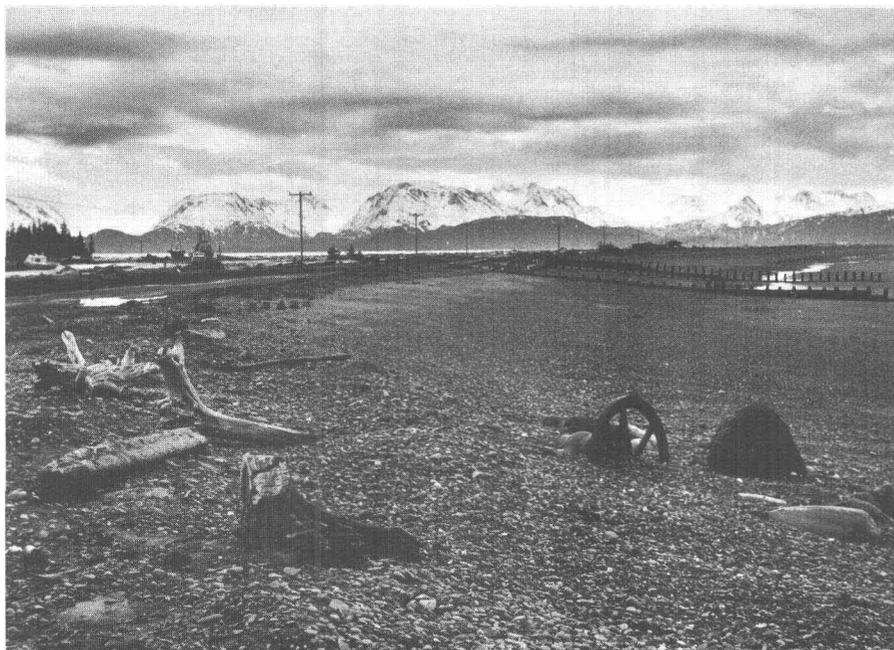
22.—The same area as shown in figure 21, 1 year later, after construction of two new groins (right background).

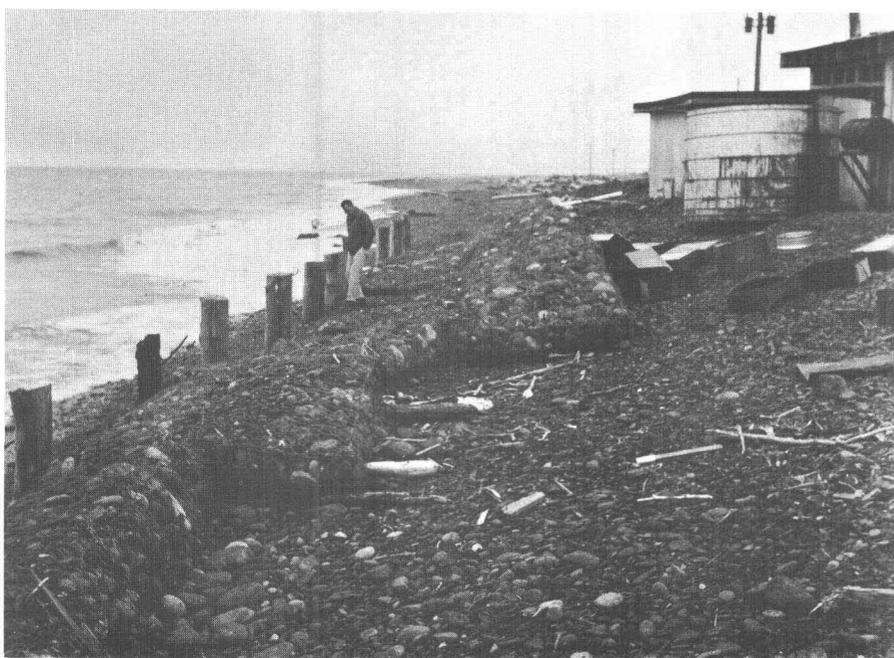
23.—Cobble-filled baskets placed on beach face to prevent erosion.

At one location a small cannery was endangered by undermining. Specially manufactured and prefabricated wire baskets were filled with cobbles and placed along the beach face (fig. 23). After 1 year the beach has built up and has shown no tendency to scour in front of the cobble-filled baskets.

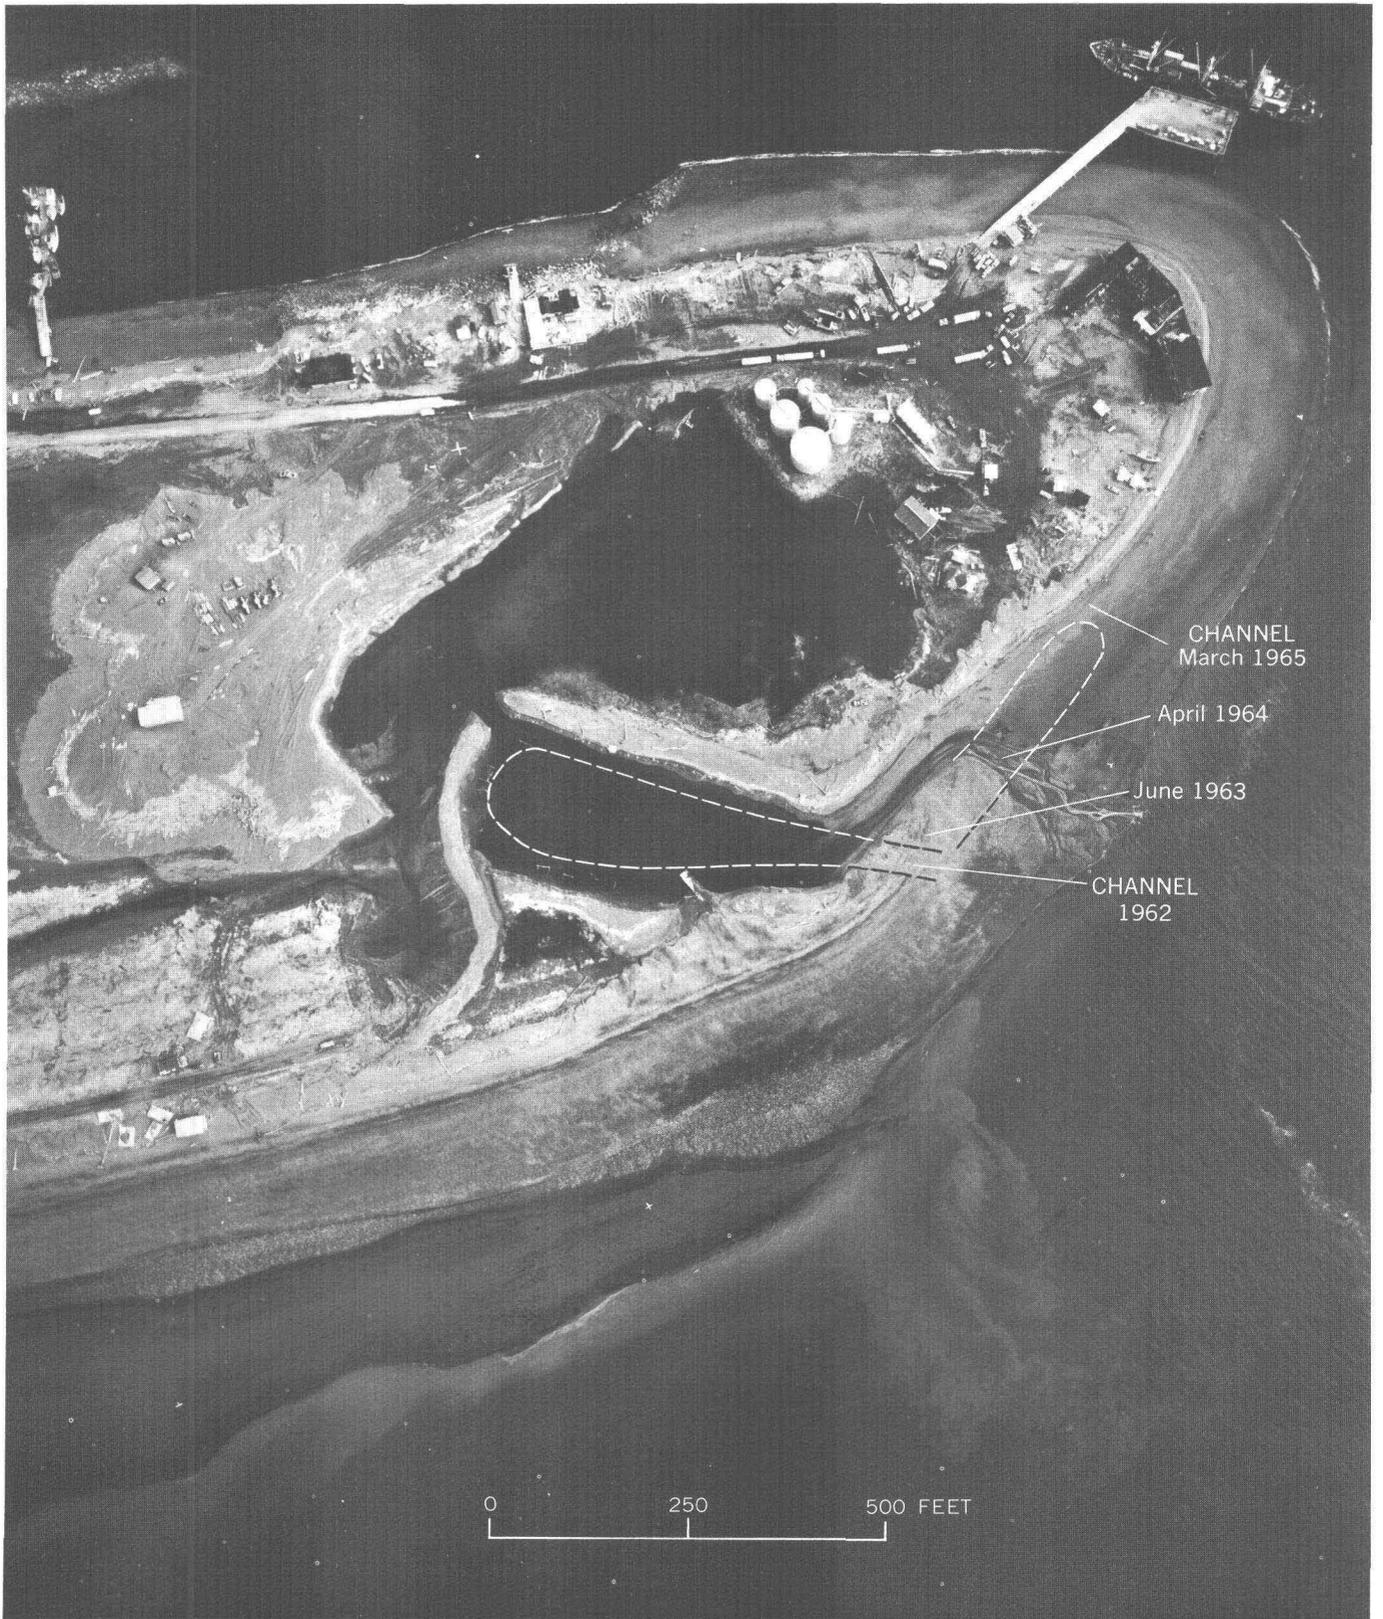
24.—Bar being built across the entrance of a tidal inlet at distal end of Homer Spit. Photograph by U.S. Army Corps of Engineers, April 30, 1964.
