ICINGS ALONG THE TRANS-ALASKA PIPELINE ROUTE

OPEN-FILE REPORT 75-87

By Charles E. Sloan, Chester Zenone,
and Lawrence R. Mayo

Anchorage, Alaska
1975

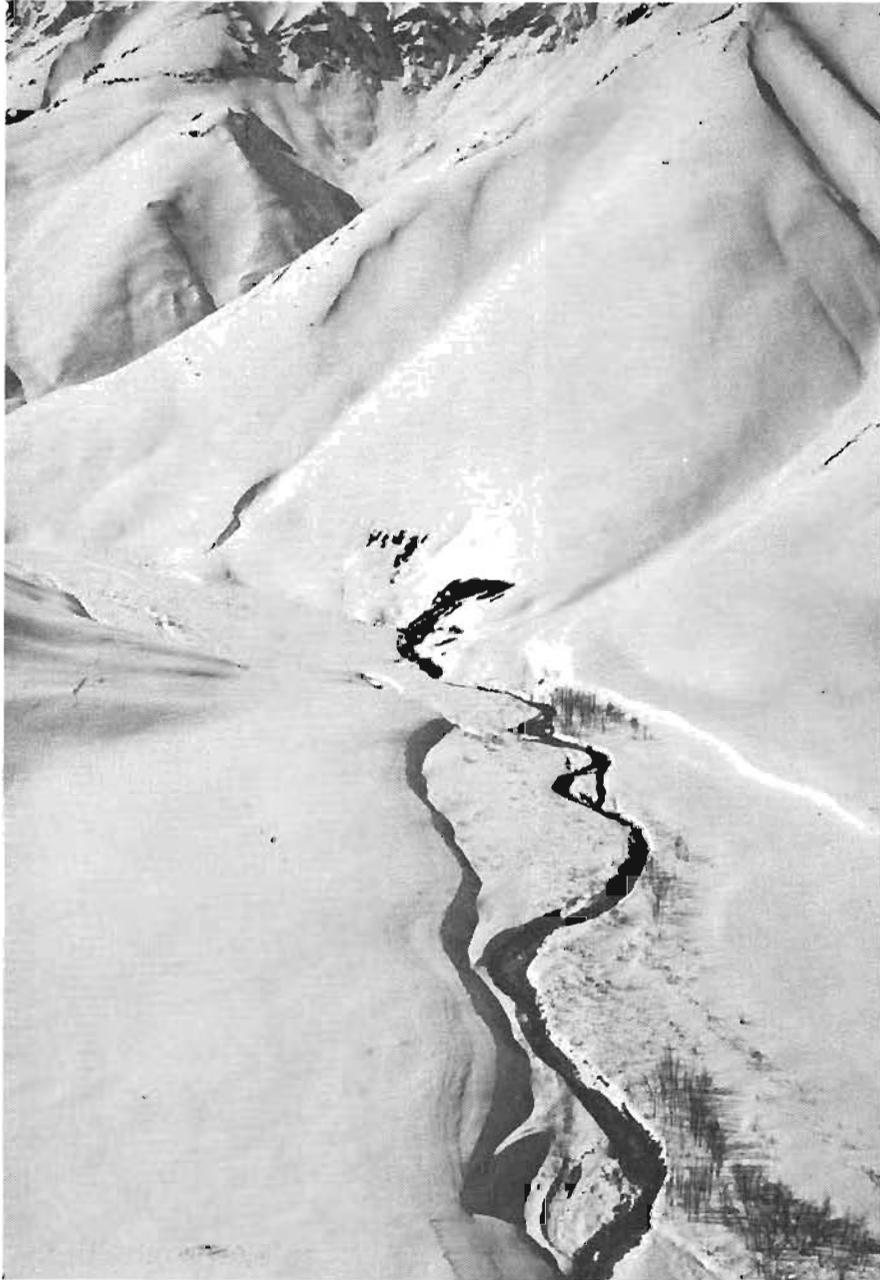
Large icings near the front of the Brooks Range are fed by springs discharging from carbonate bedrock directly to the river or alluvium in the river bed (fig. 6).

Figure 6.--Hillside spring in Brooks Range near Ivishak River, May 11, 1973. Balsam poplar are 30 to 40 feet (10 to 12 m) tall.

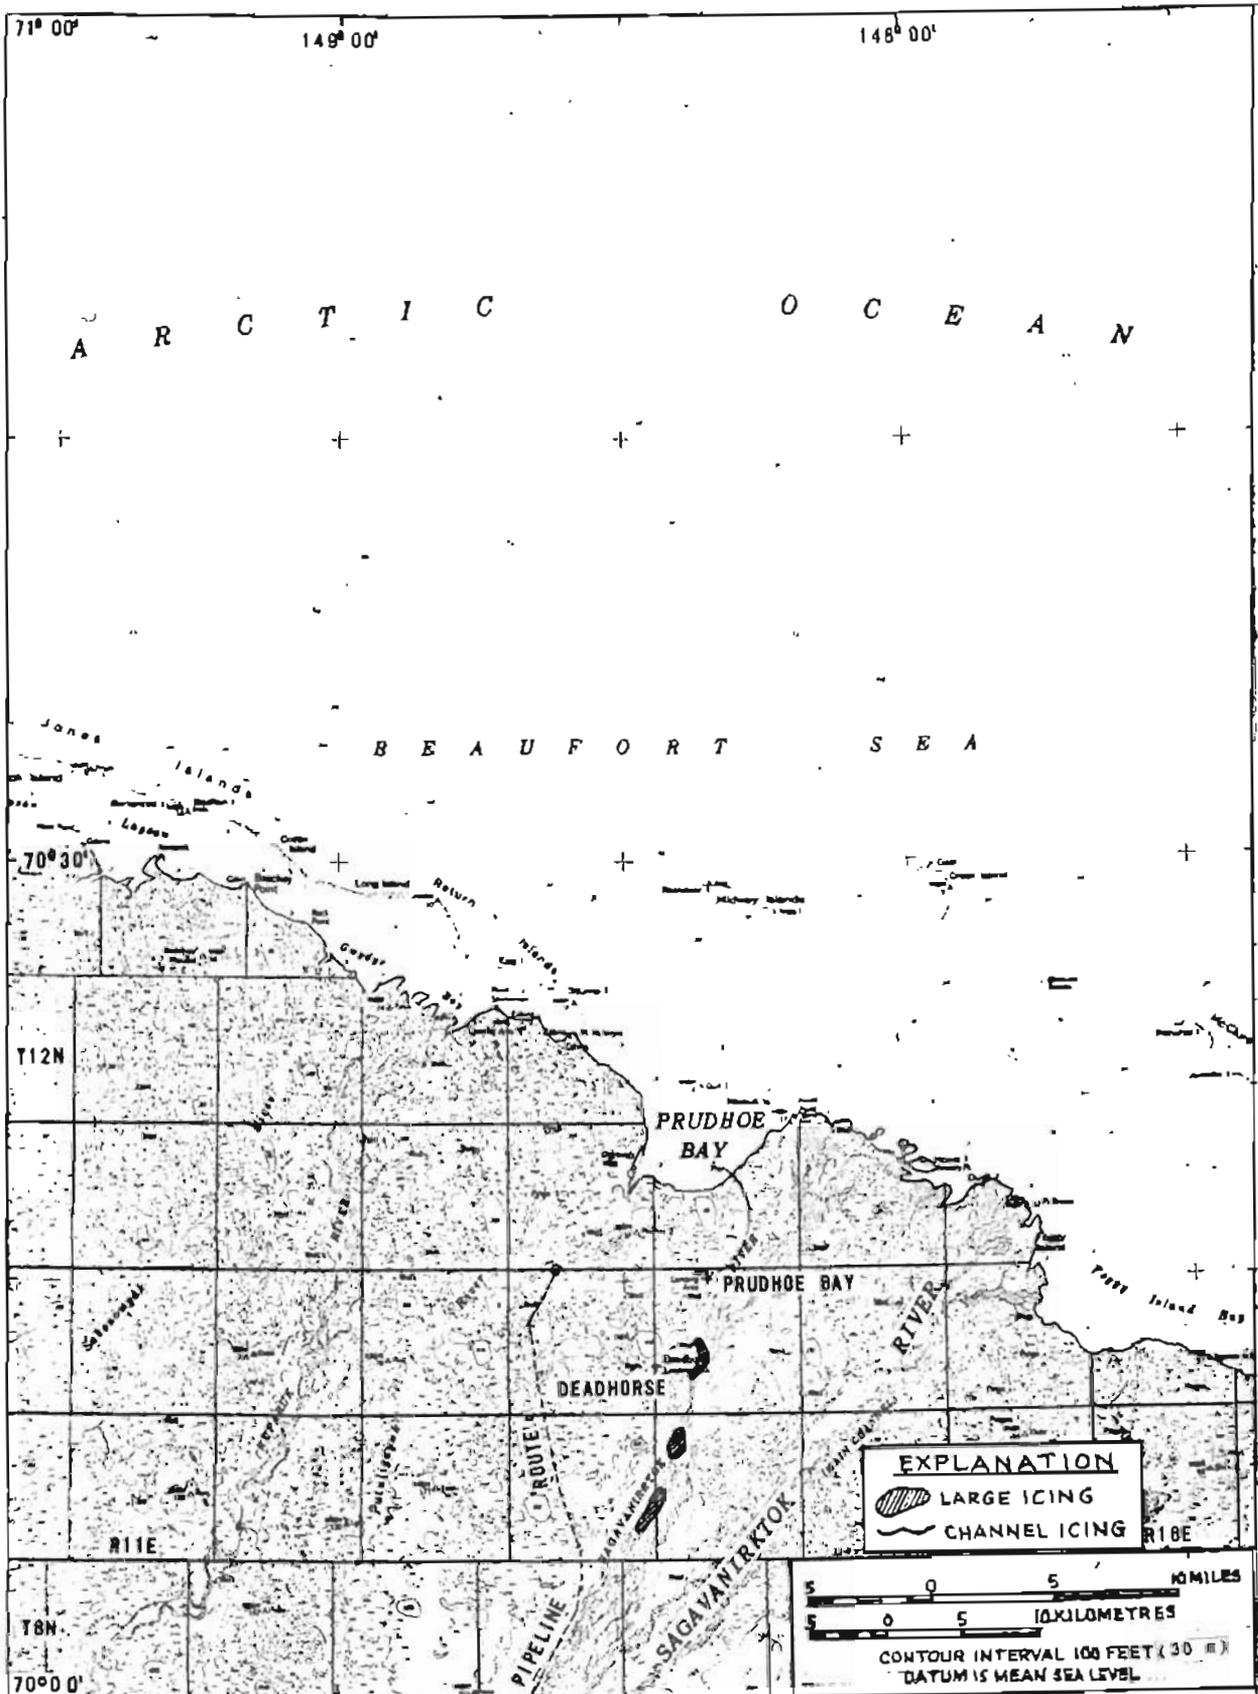
Broad flood-plain icings form on many of the braided reaches of the Sagavanirktok and Ivishak Rivers (figs. 7 and 8). An ERTS-1 (Earth Resources Technological Satellite) near-infrared image taken on March 31, 1973, shows the icing activity in the Sagavanirktok River basin. Water absorbs infrared radiation and is shown as black on the image (fig. 9a) in contrast to the white snow and ice. Broad overflow can be seen (fig. 9a) on the icings of the Echooka and Ivishak Rivers near the front of the Brooks Range and extending some distance downstream. An ERTS-1 scene of the same area on August 4, 1973, shows remnants of ice on the Echooka, Shaviovik, and Ivishak Rivers (fig. 9b). The large icing on the Echooka River may not melt entirely from year to year (fig. 10).

Figure 7.--Distribution of icings along the trans-Alaska pipeline route in the Beechey Point quadrangle.

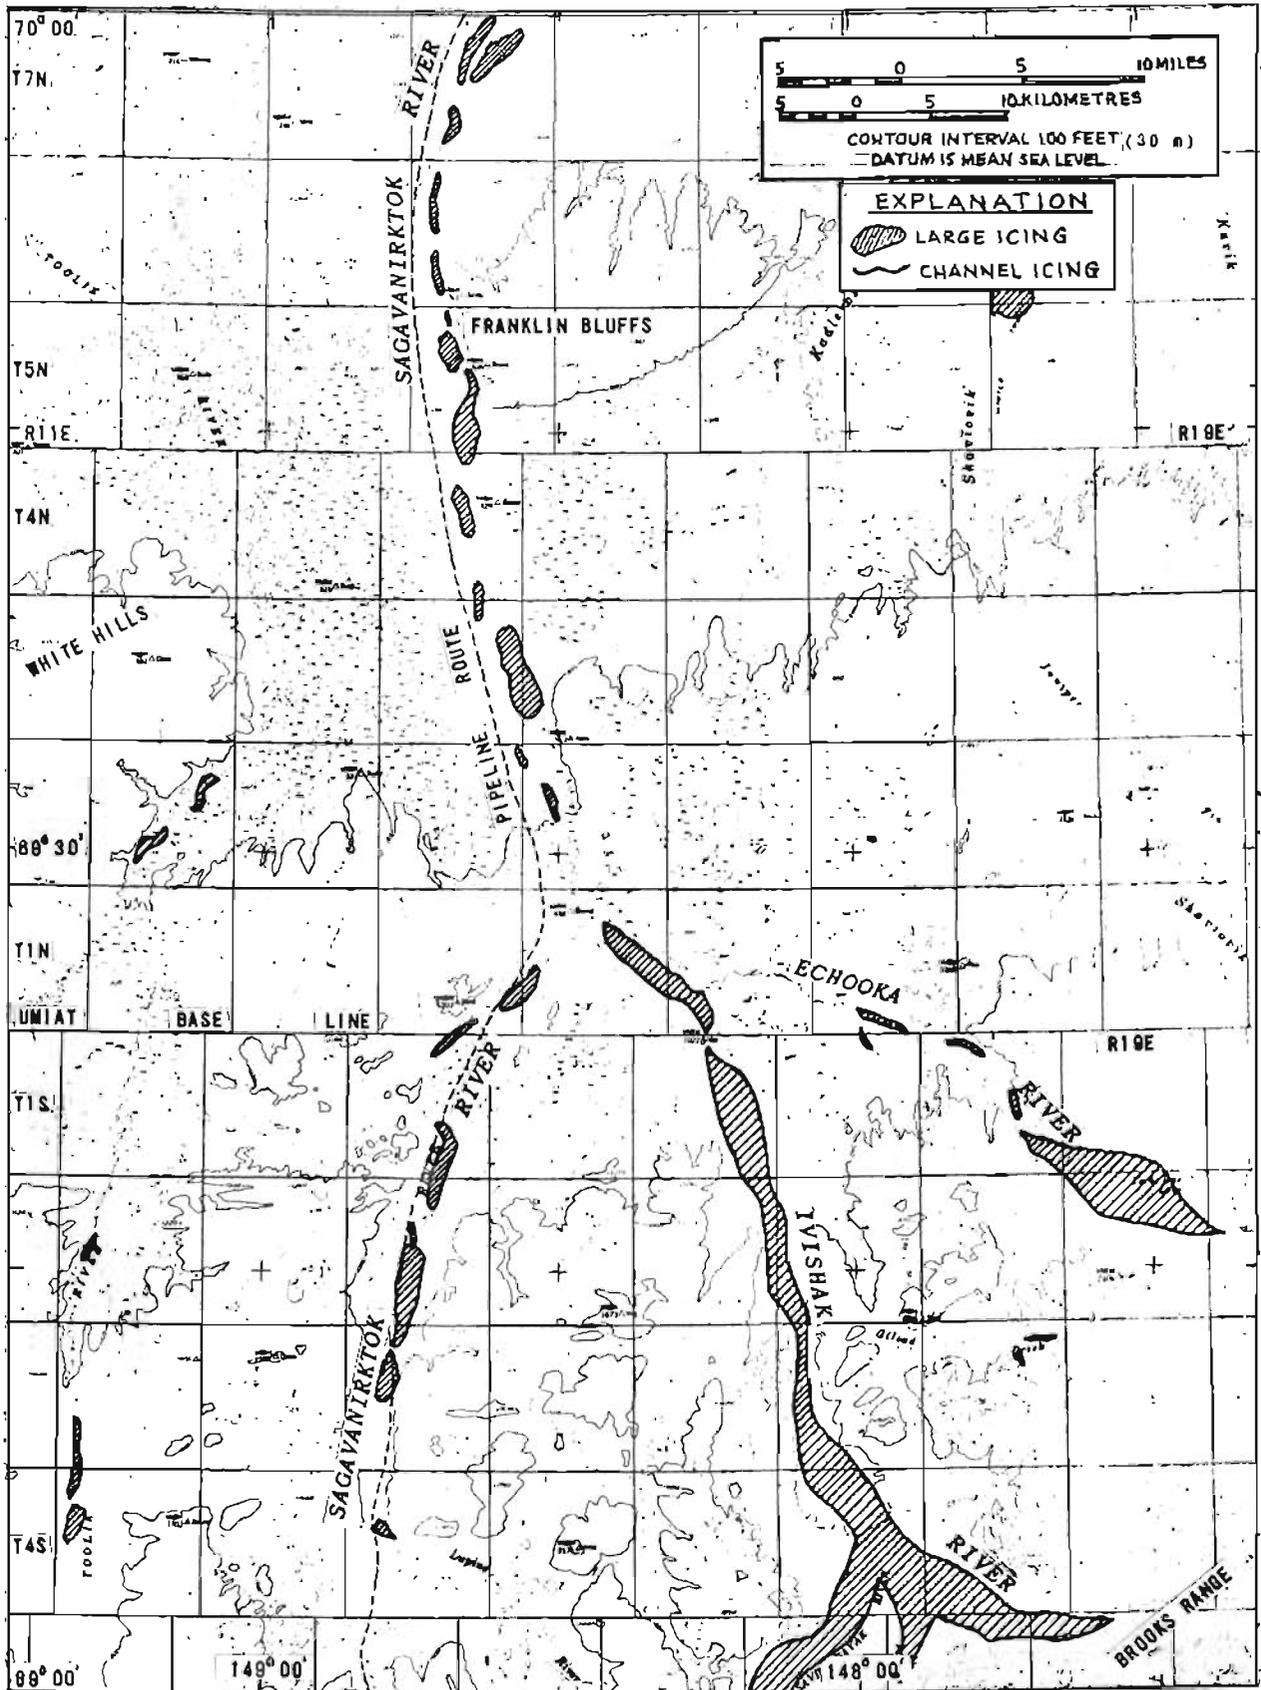
Figure 8.--Distribution of icings along the trans-Alaska pipeline route in the Sagavanirktok quadrangle.

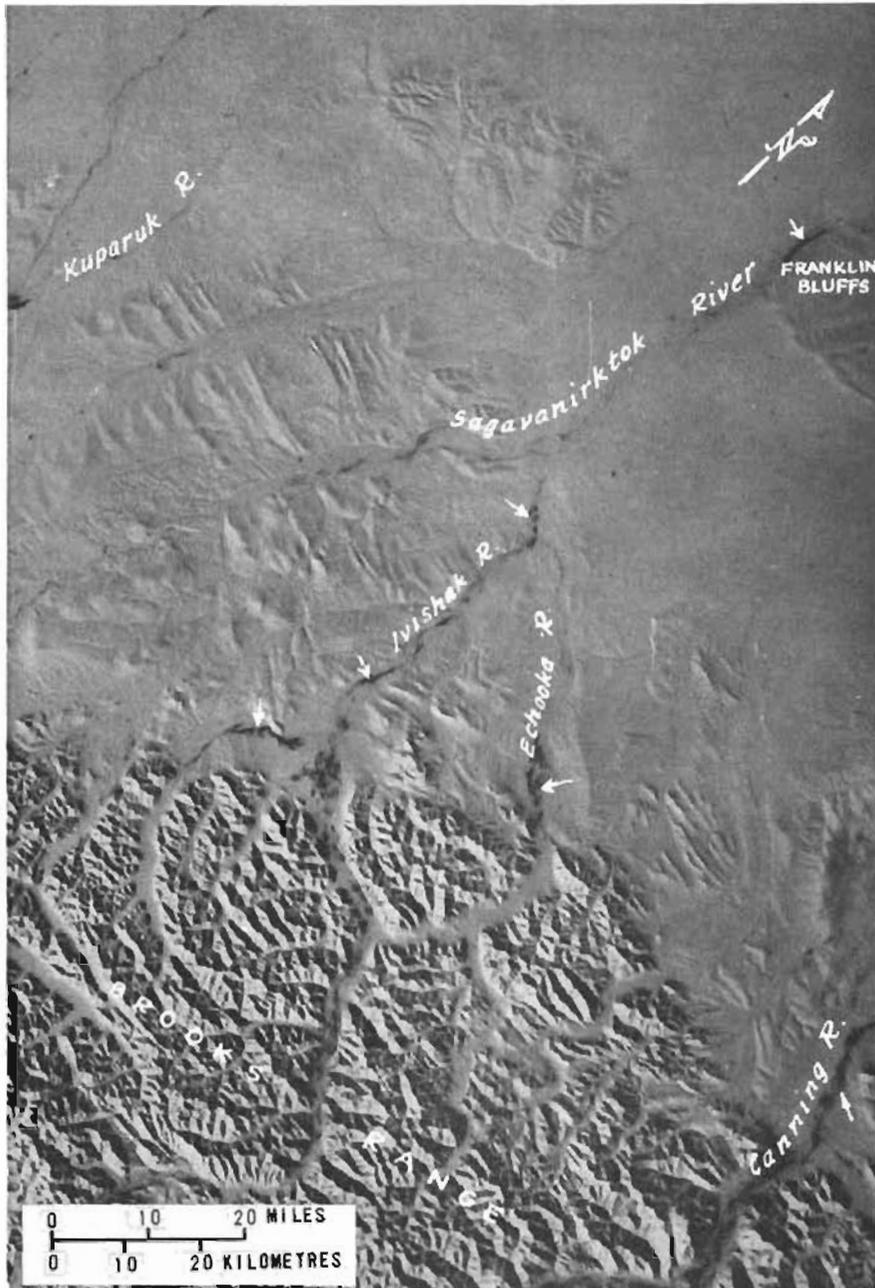
Figure 9a.--ERTS-1 image of Sagavanirktok River basin showing water surfaces (arrows) in icing areas, March 31, 1973 (scene no. 12511-21123, band 7).

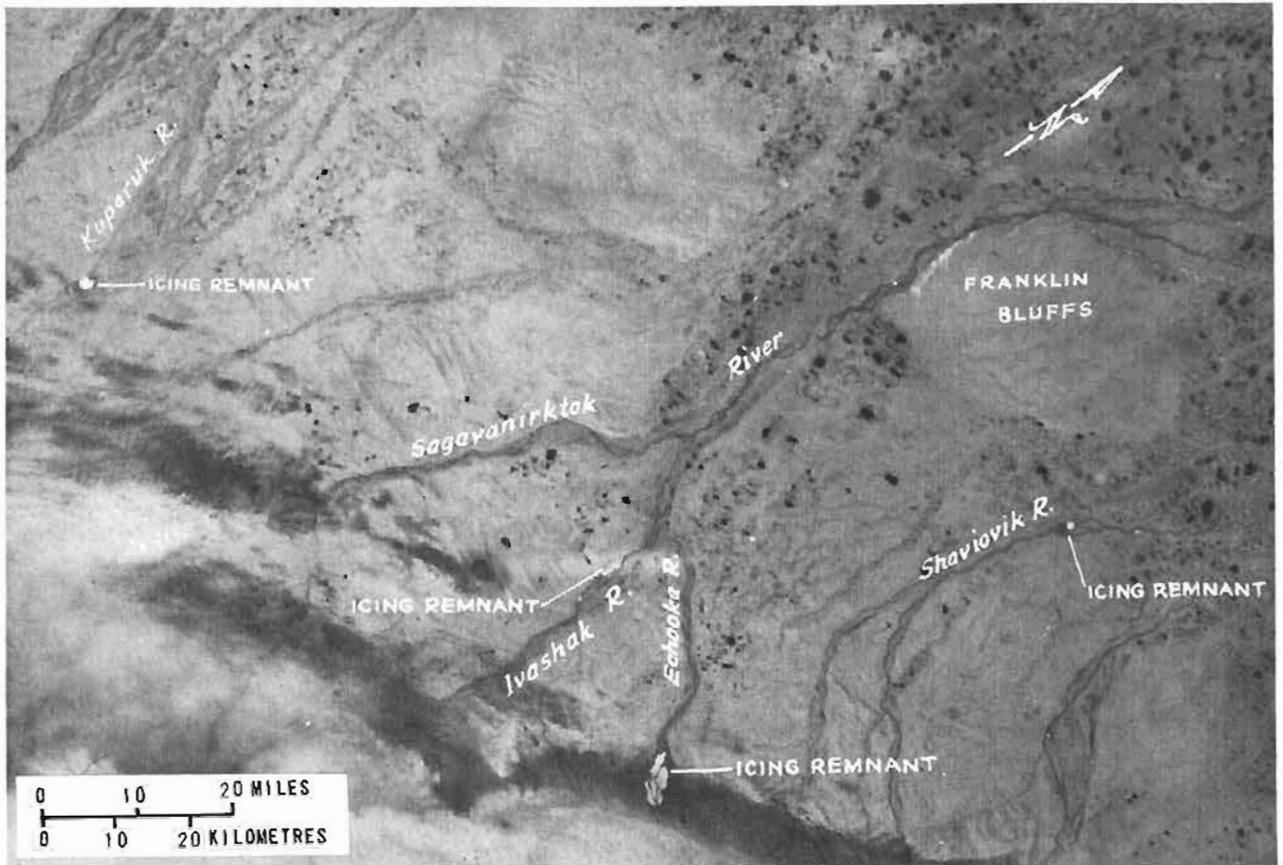
Figure 9b.--ERTS-1 image of same area as in figure 9a showing icing remnants on Echooka, Ivishak, and Shaviovik Rivers, August 4, 1973 (scene no. 1377-21112, band 6).

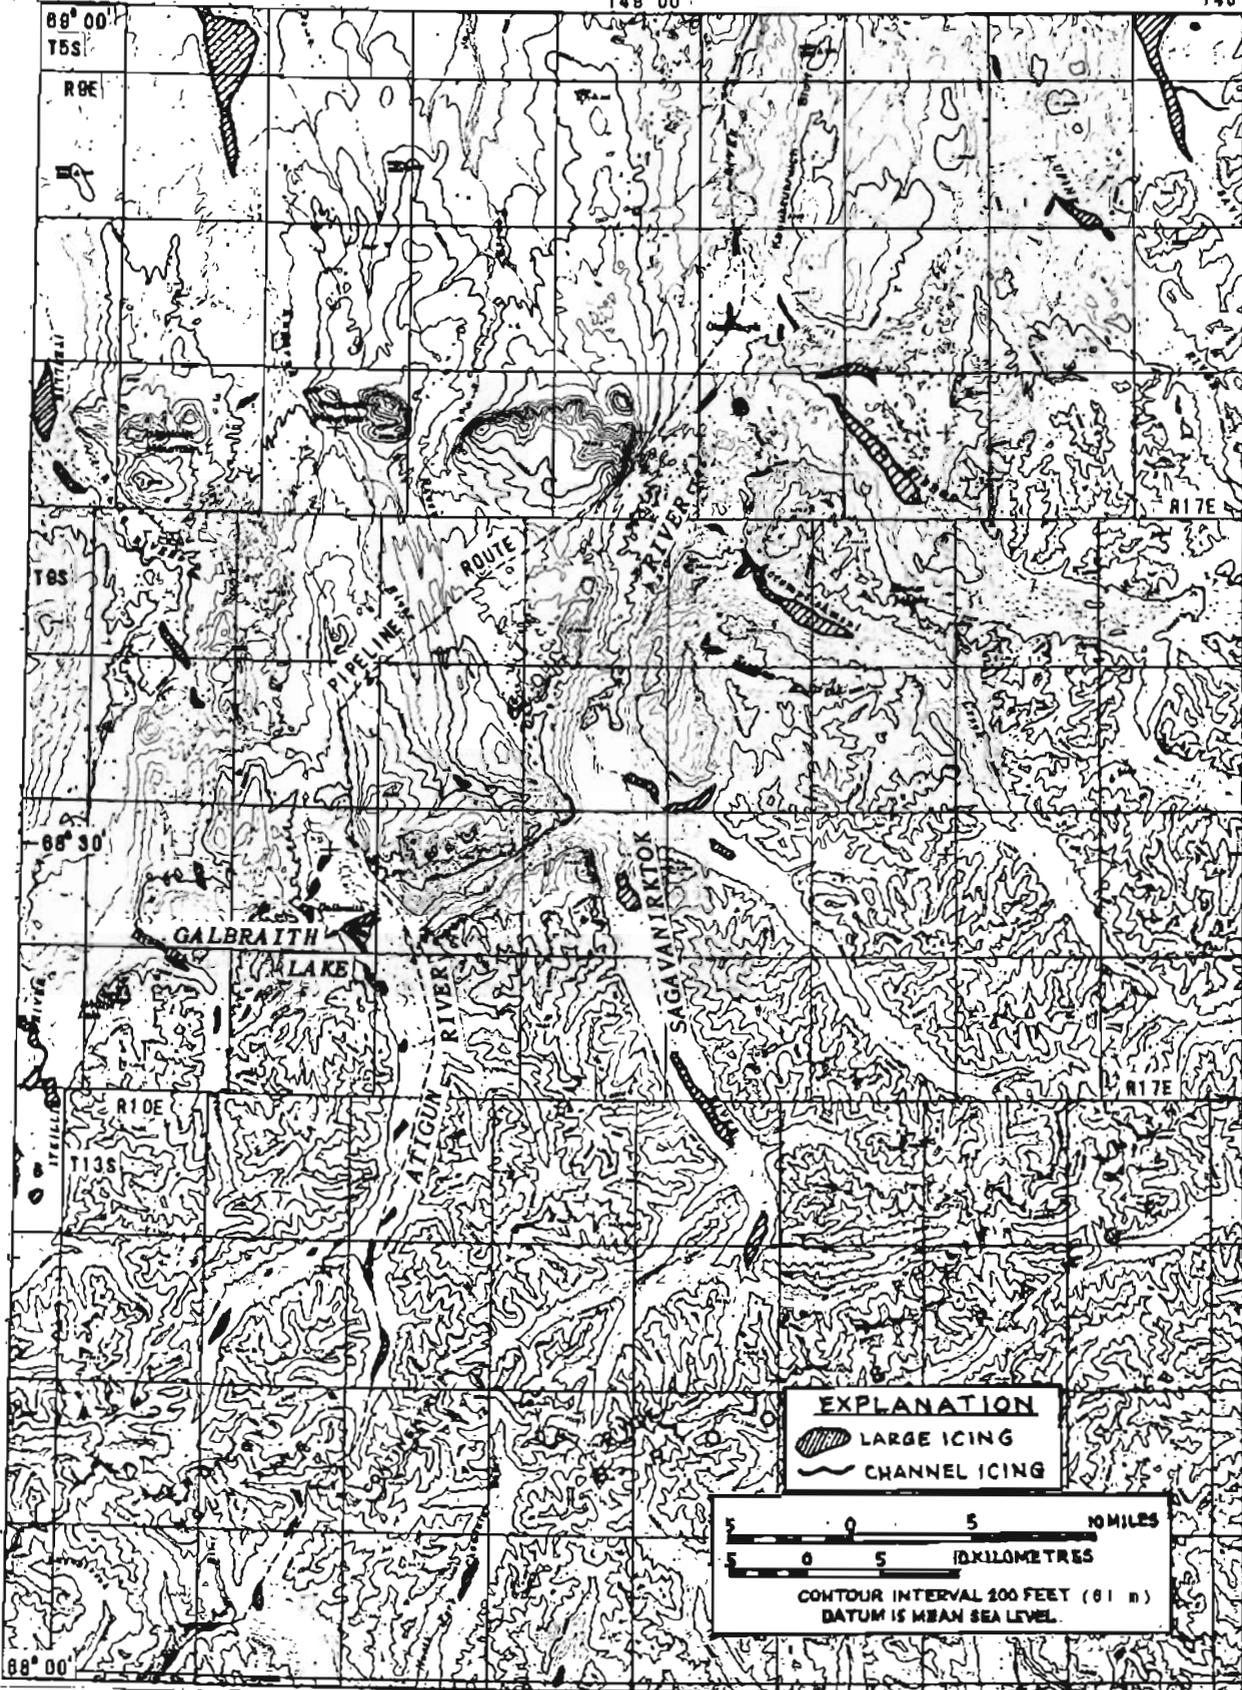
A large icing forms annually on the alluvial fan west of Galbraith Lake (figs. 11 and 12). Large icings also occur at wide, braided channel reaches of the upper Atigun River valley (figs. 11 and 13).

Figure 11.--Distribution of icings along the trans-Alaska pipeline route in the Philip Smith Mountains quadrangle.

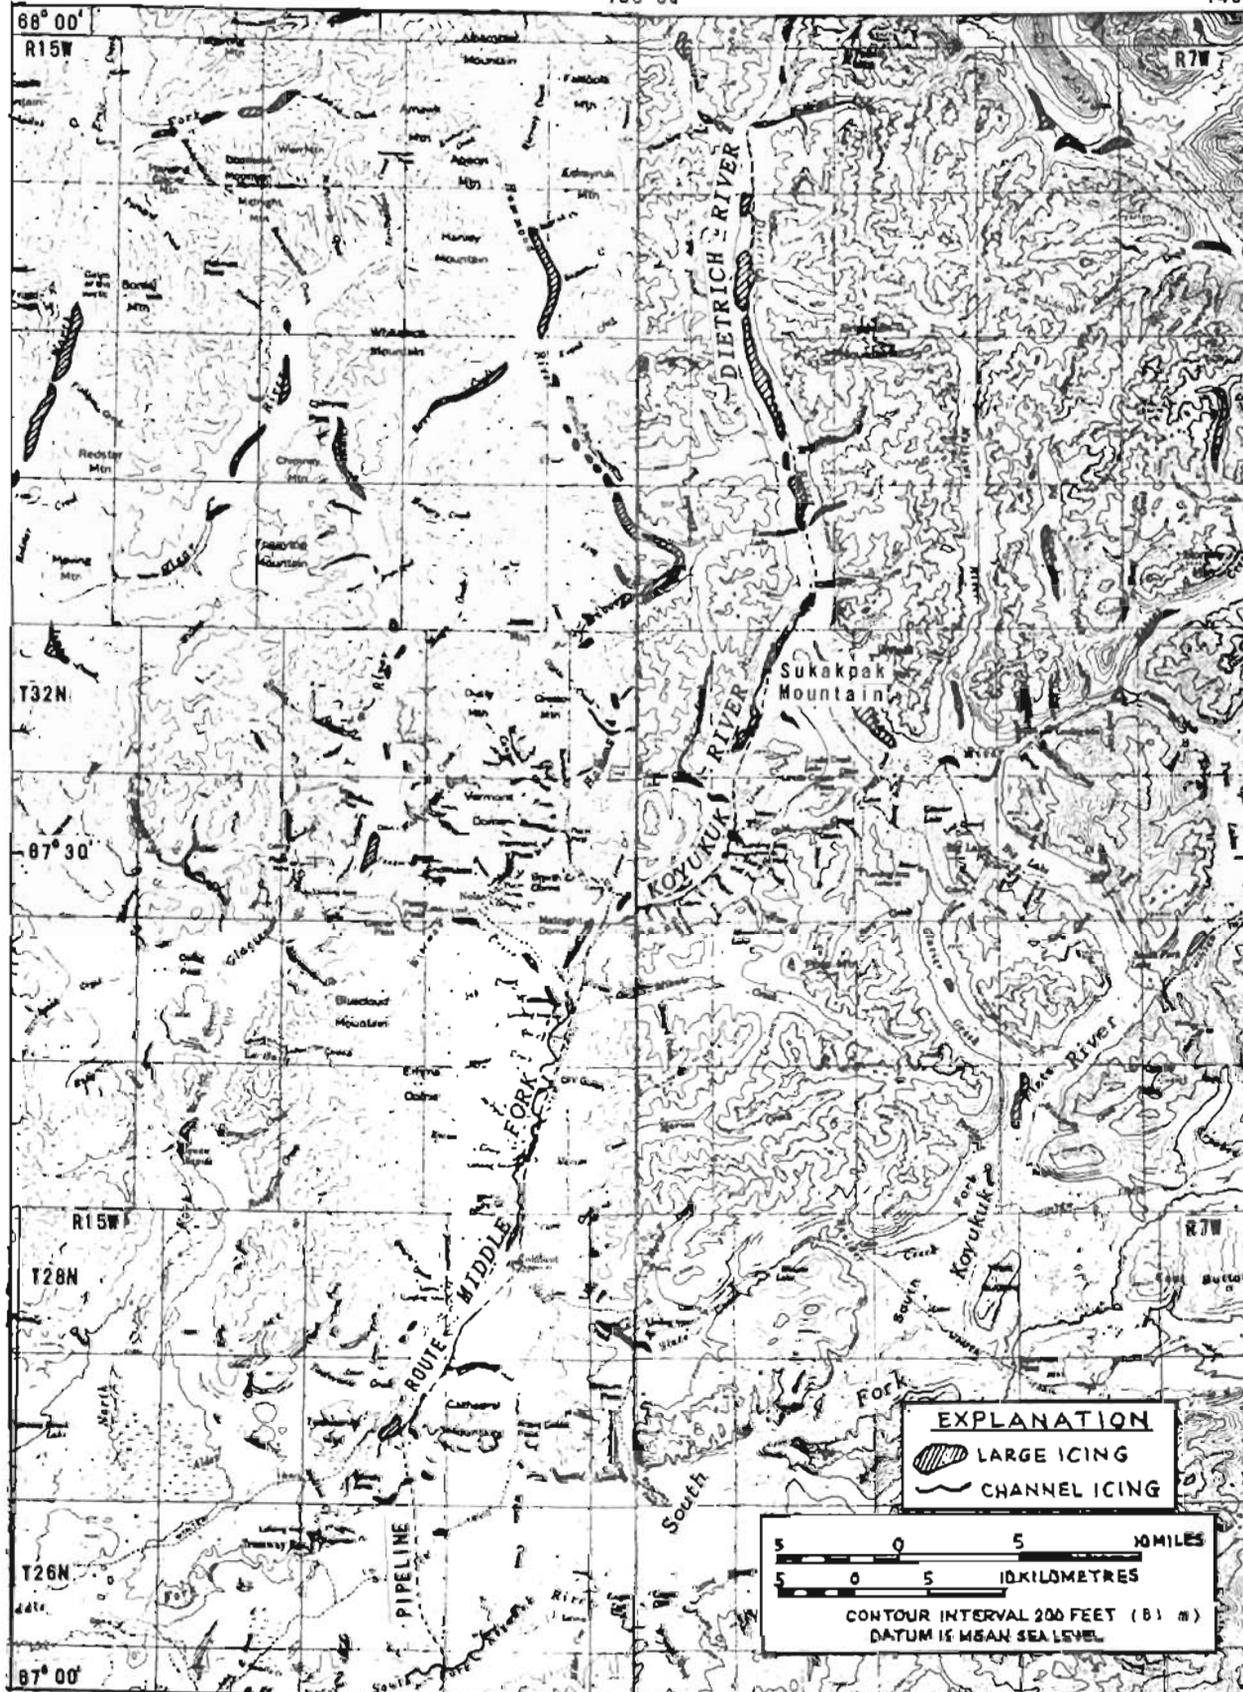
Icings inundate almost the entire active flood plain along braided channel reaches of the Dietrich River (fig. 14). Where the river channel is incised and the reach not braided, channel ice or only minor overflow icing occurs. The large icings on the Dietrich River seem to have their water source from the steep alluvial fans which have built out onto the Dietrich River flood plain (figs. 15a and 15b). Open leads in the Dietrich River icings can be seen at the base of the alluvial fans where ground water is emerging (fig. 16).

The ice on the Middle Fork Koyukuk River (fig. 14) generally is confined to the main channel, and small icings form at the mouths of some tributary streams. A few small hillside icings form on the west flank of Sukakpak Mountain.

Figure 14.--Distribution of icings along the trans-Alaska pipeline route in the Chandalar and Wiseman quadrangles.

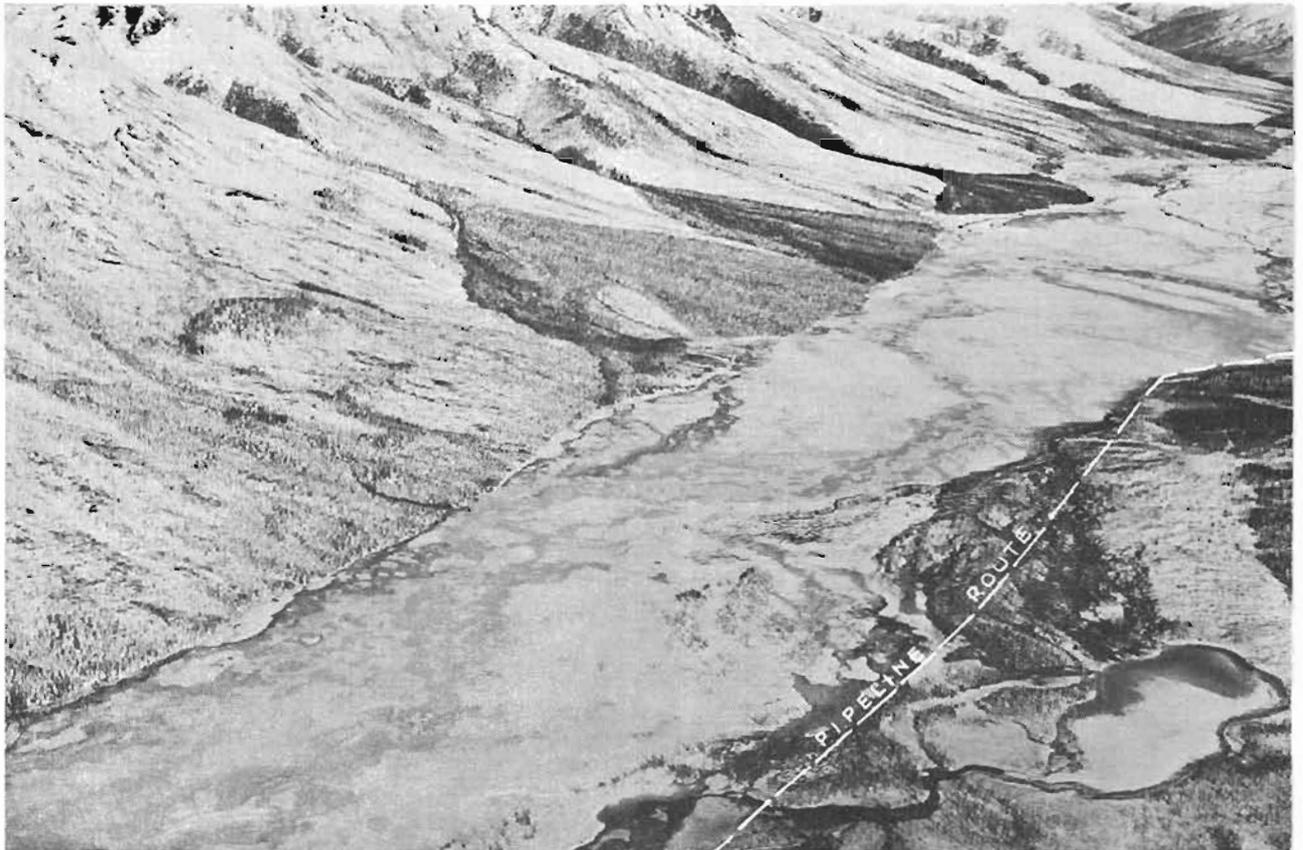
Figure 15b.--Close-up view of part of icing shown in figure 15a.

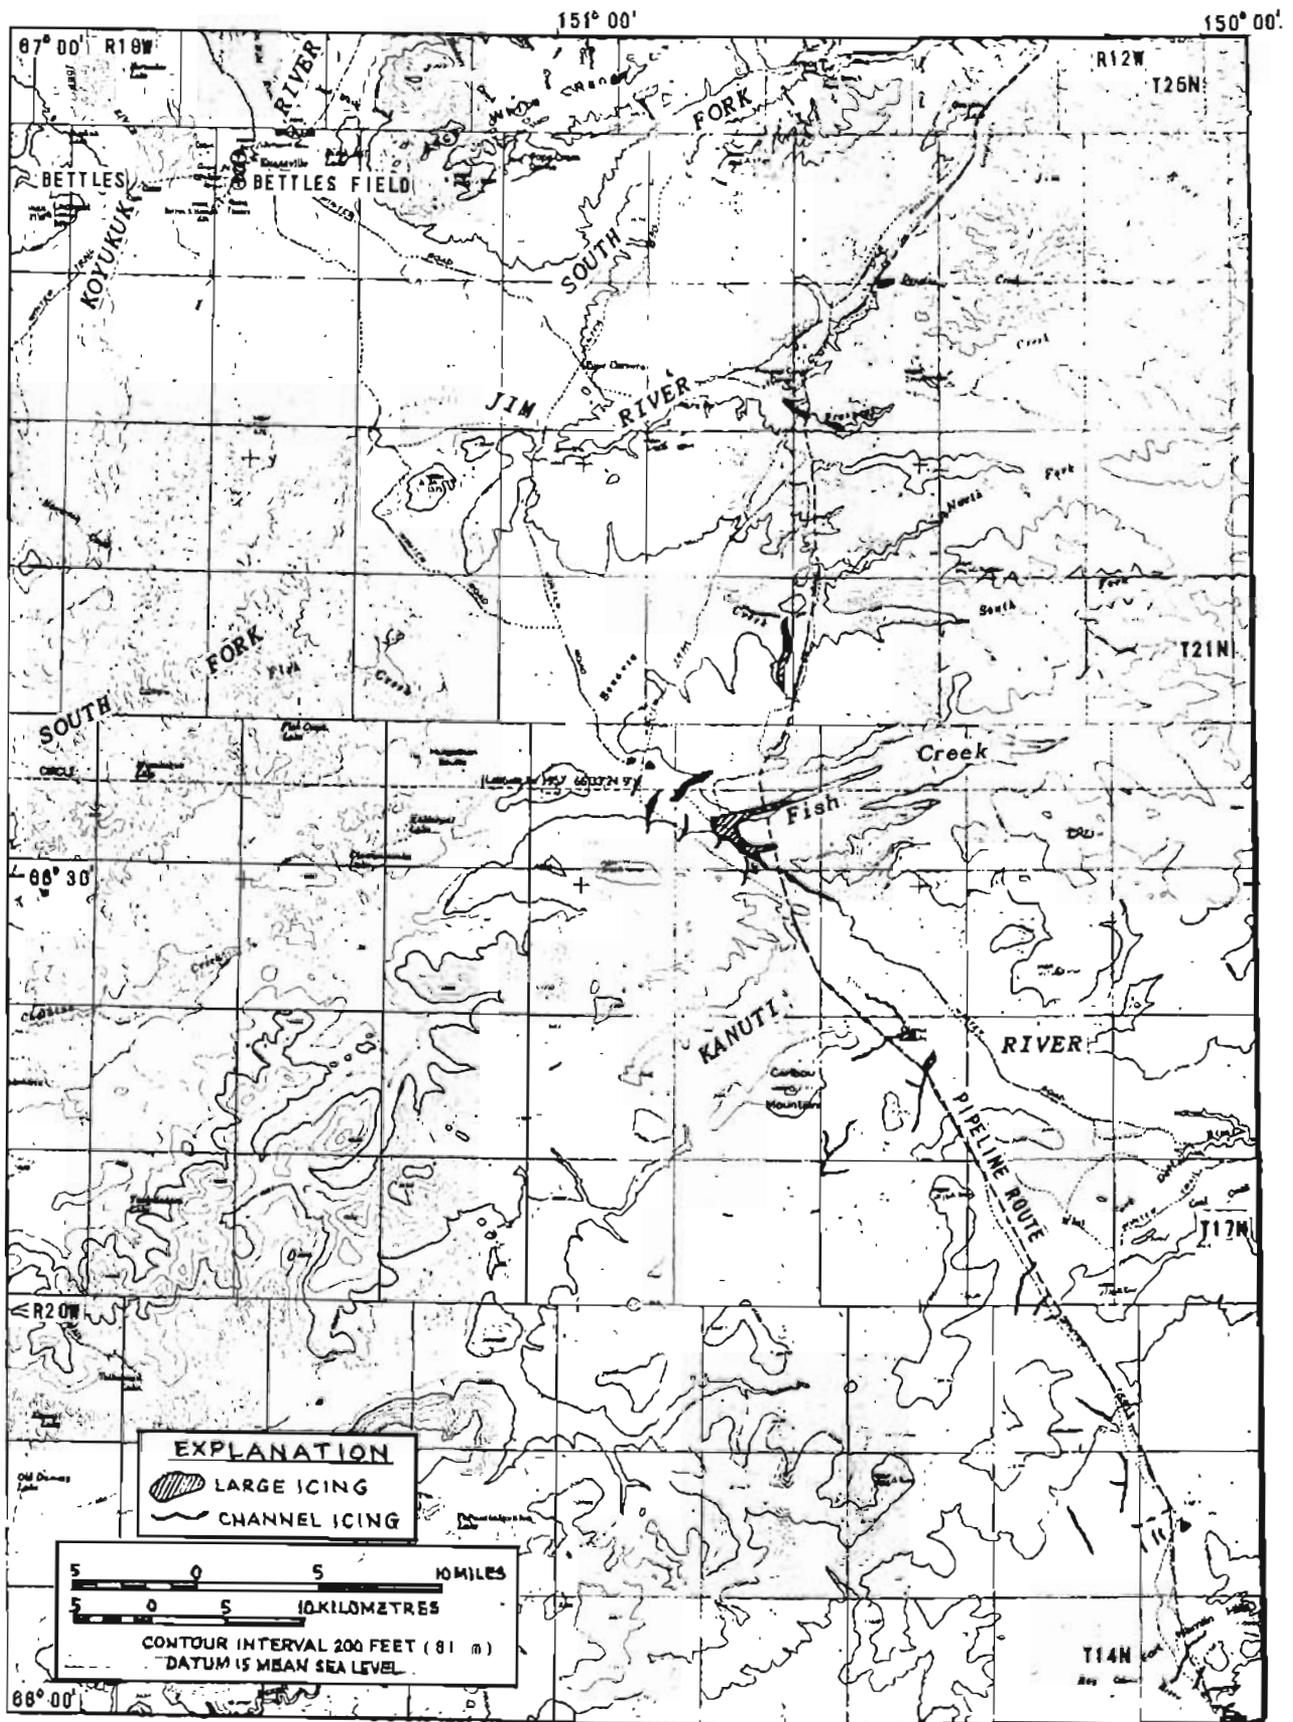
From the Middle Fork Koyukuk River to the Fairbanks area, the pipeline route transects rather than parallels the streams, valleys, and ridges. Channel icings occur in the South Fork Koyukuk River, Prospect Creek, and other large streams crossed by the pipeline route (fig. 17). Icings from springs in Fish Creek have caused several local reroutings of winter trails. Icings do not occur on the Yukon River at the pipeline bridge crossing.

Figure 17.--Distribution of icings along the trans-Alaska pipeline route in the Bettles quadrangle.

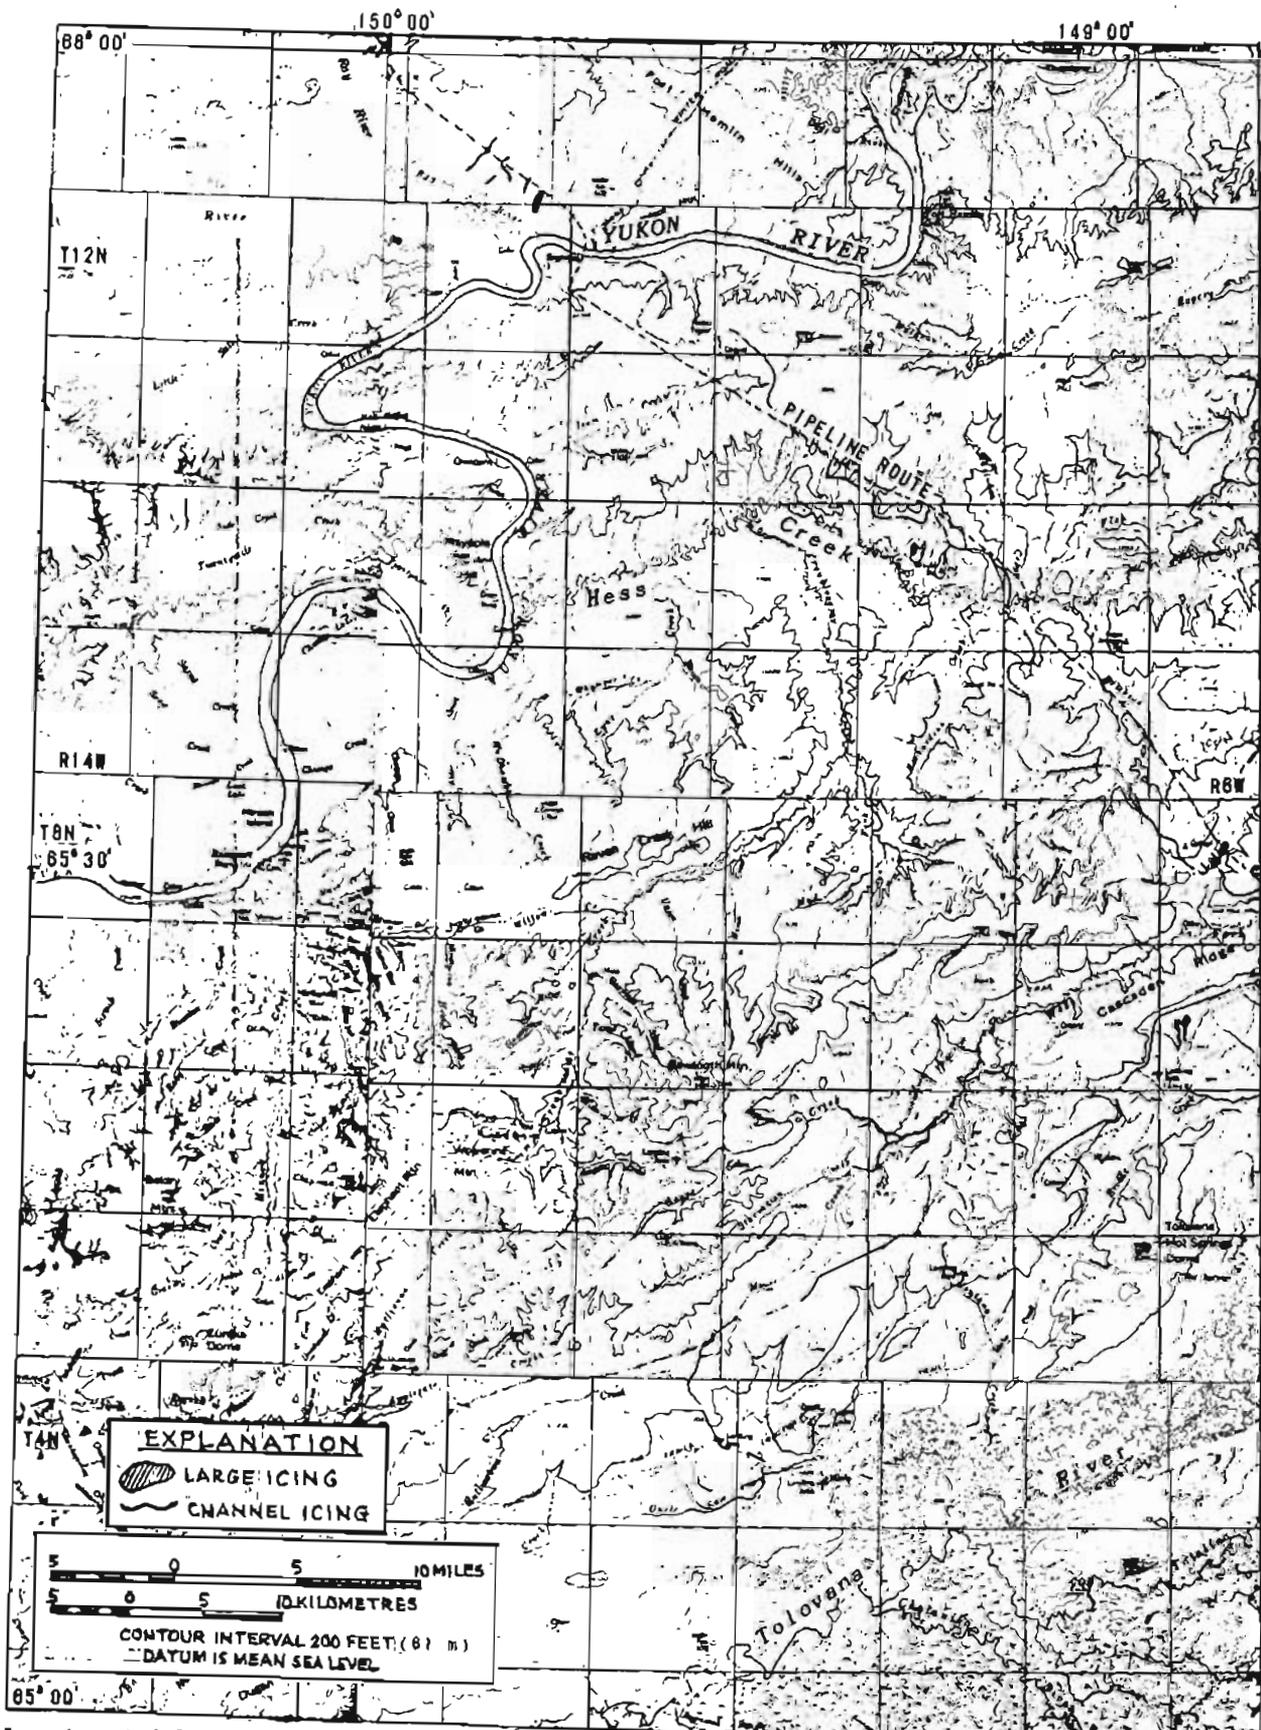
South of the Yukon River, narrow channel icings form on the small streams in the uplands (figs. 18 and 19). The source for these icings may be artesian water from bedrock drainage or from unfrozen ground above permafrost. The water emerges in small depressions or gullies that drain to the larger stream valleys.

Figure 18.--Distribution of icings along the trans-Alaska pipeline route in the Tanana and Livengood quadrangles.

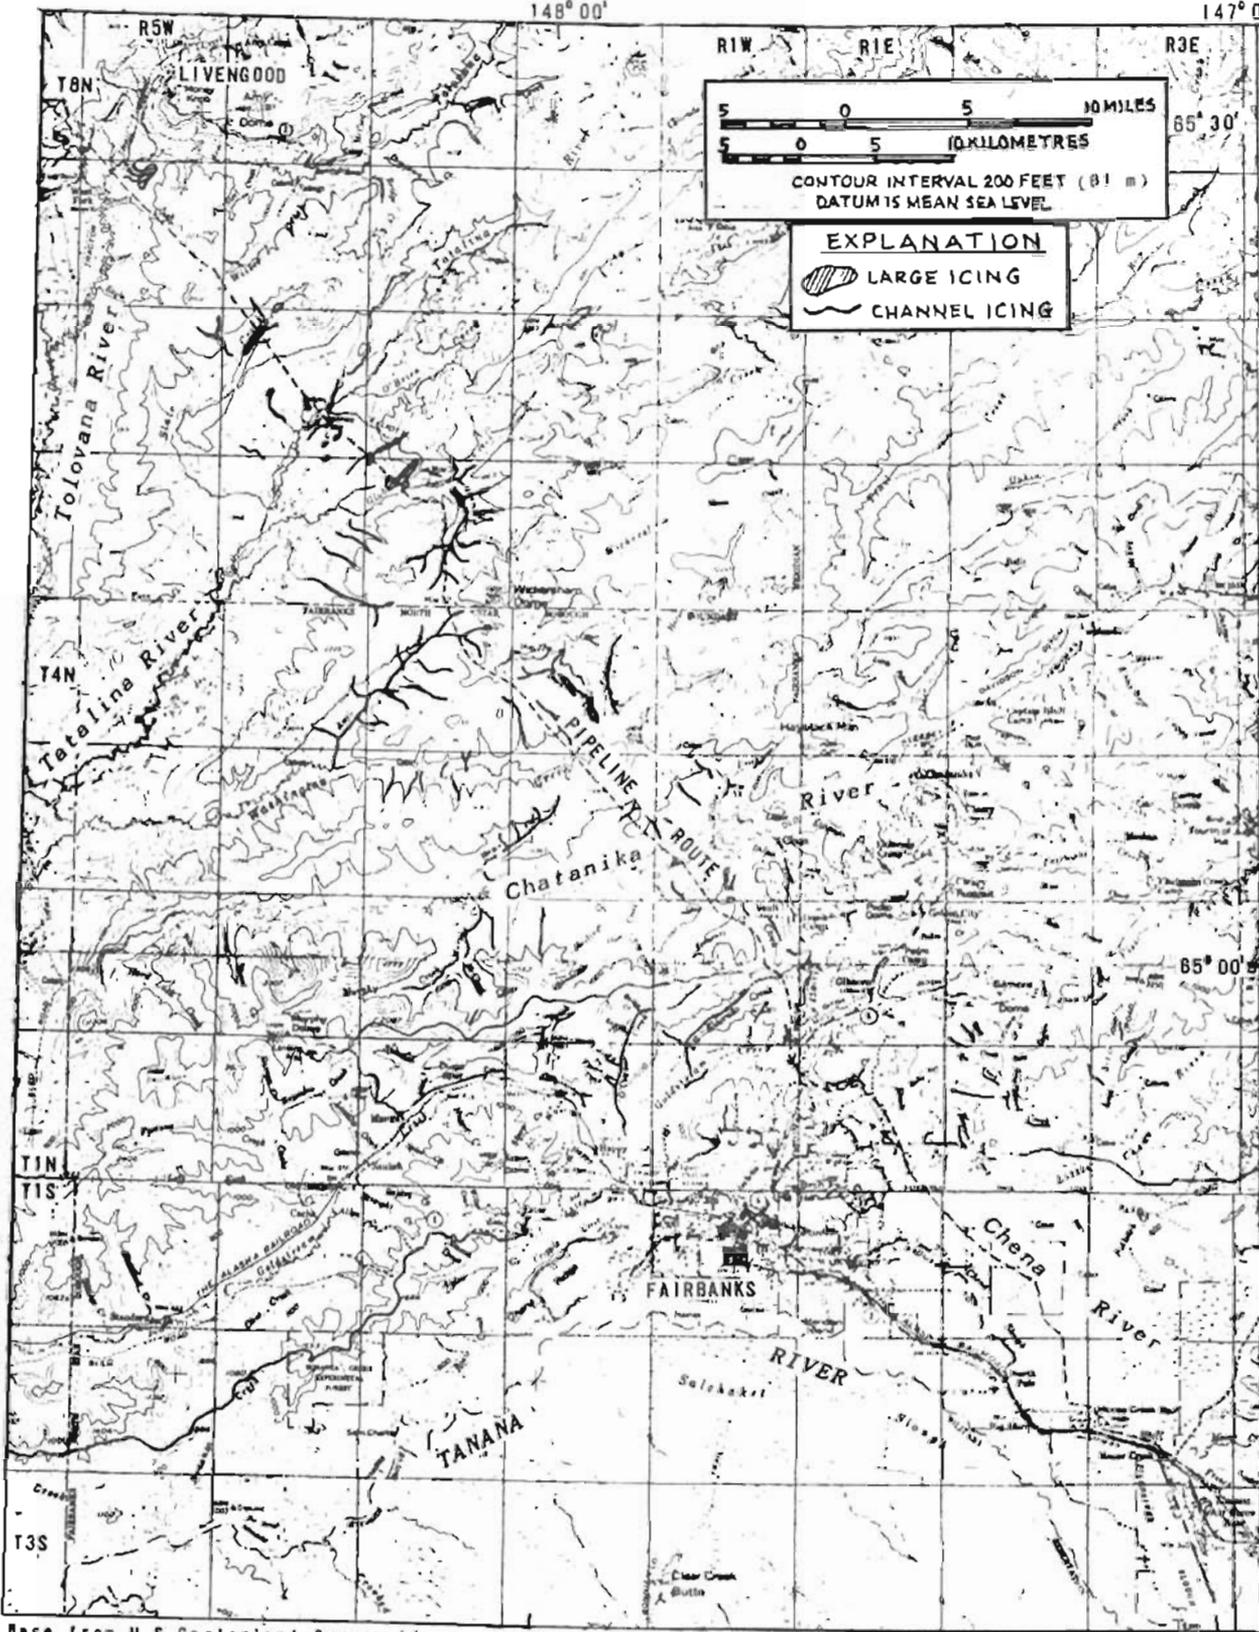
Channel ice and minor overflow icing occurs on the major streams crossed by the pipeline between Fairbanks (fig. 20) and Big Delta (fig. 21). Icings form on many smaller streams draining the Yukon-Tanana Uplands. Thermal infrared imagery obtained in February 1974 shows water overflowing the icings in the Minton Creek area (fig. 22). In this imagery, the presence of water is indicated by the white areas that signify relatively higher temperatures. A large icing occurs along the pipeline route in the flats north of Shaw Creek (fig. 23). An open channel is usually maintained along the Tanana River at the planned pipeline crossing because relatively warm ground water is discharged along the south bank.

Figure 20.--Distribution of icings along the trans-Alaska pipeline route in the Livengood and Fairbanks quadrangles.

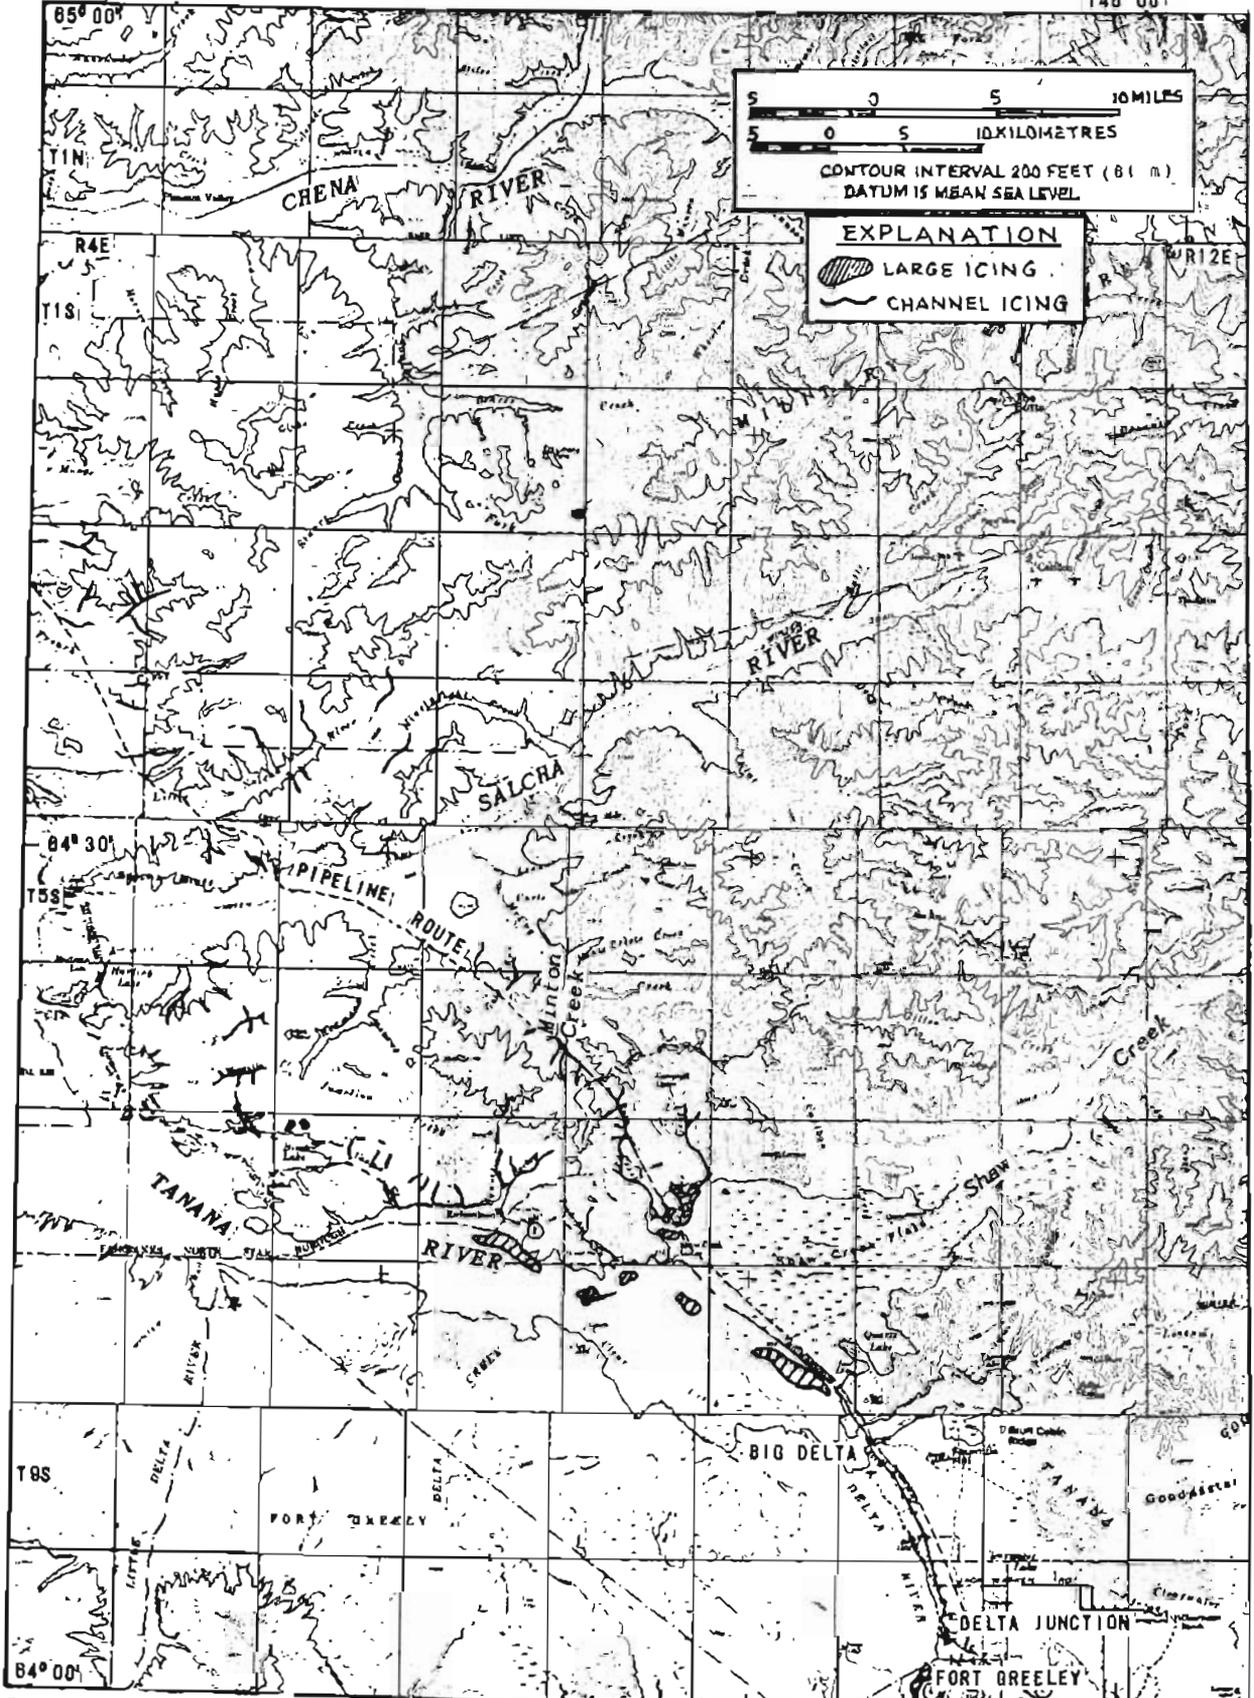
Figure 21.--Distribution of icings along the trans-Alaska pipeline route in the Big Delta quadrangle.
