ICINGS ALONG THE TRANS-ALASKA PIPELINE ROUTE

OPEN-FILE REPORT 75-87

By Charles E. Sloan, Chester Zenone,
and Lawrence R. Mayo

Anchorage, Alaska
1975

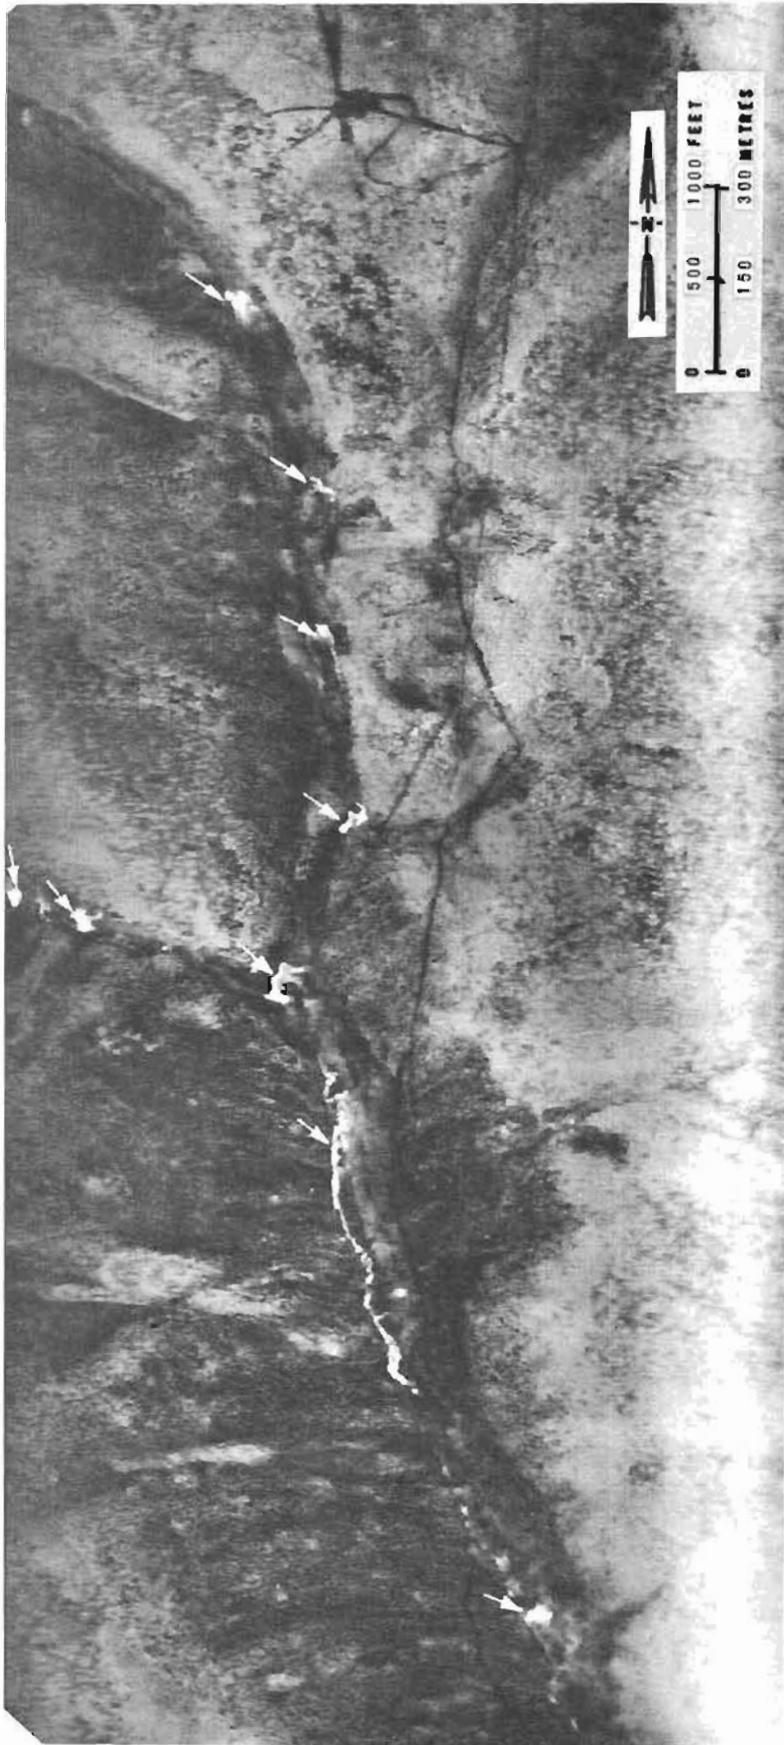
Figure 22.--Thermal infrared image of icings along Minton Creek February 4, 1974.
Water surfaces (arrows) contrast with snow and vegetation background.

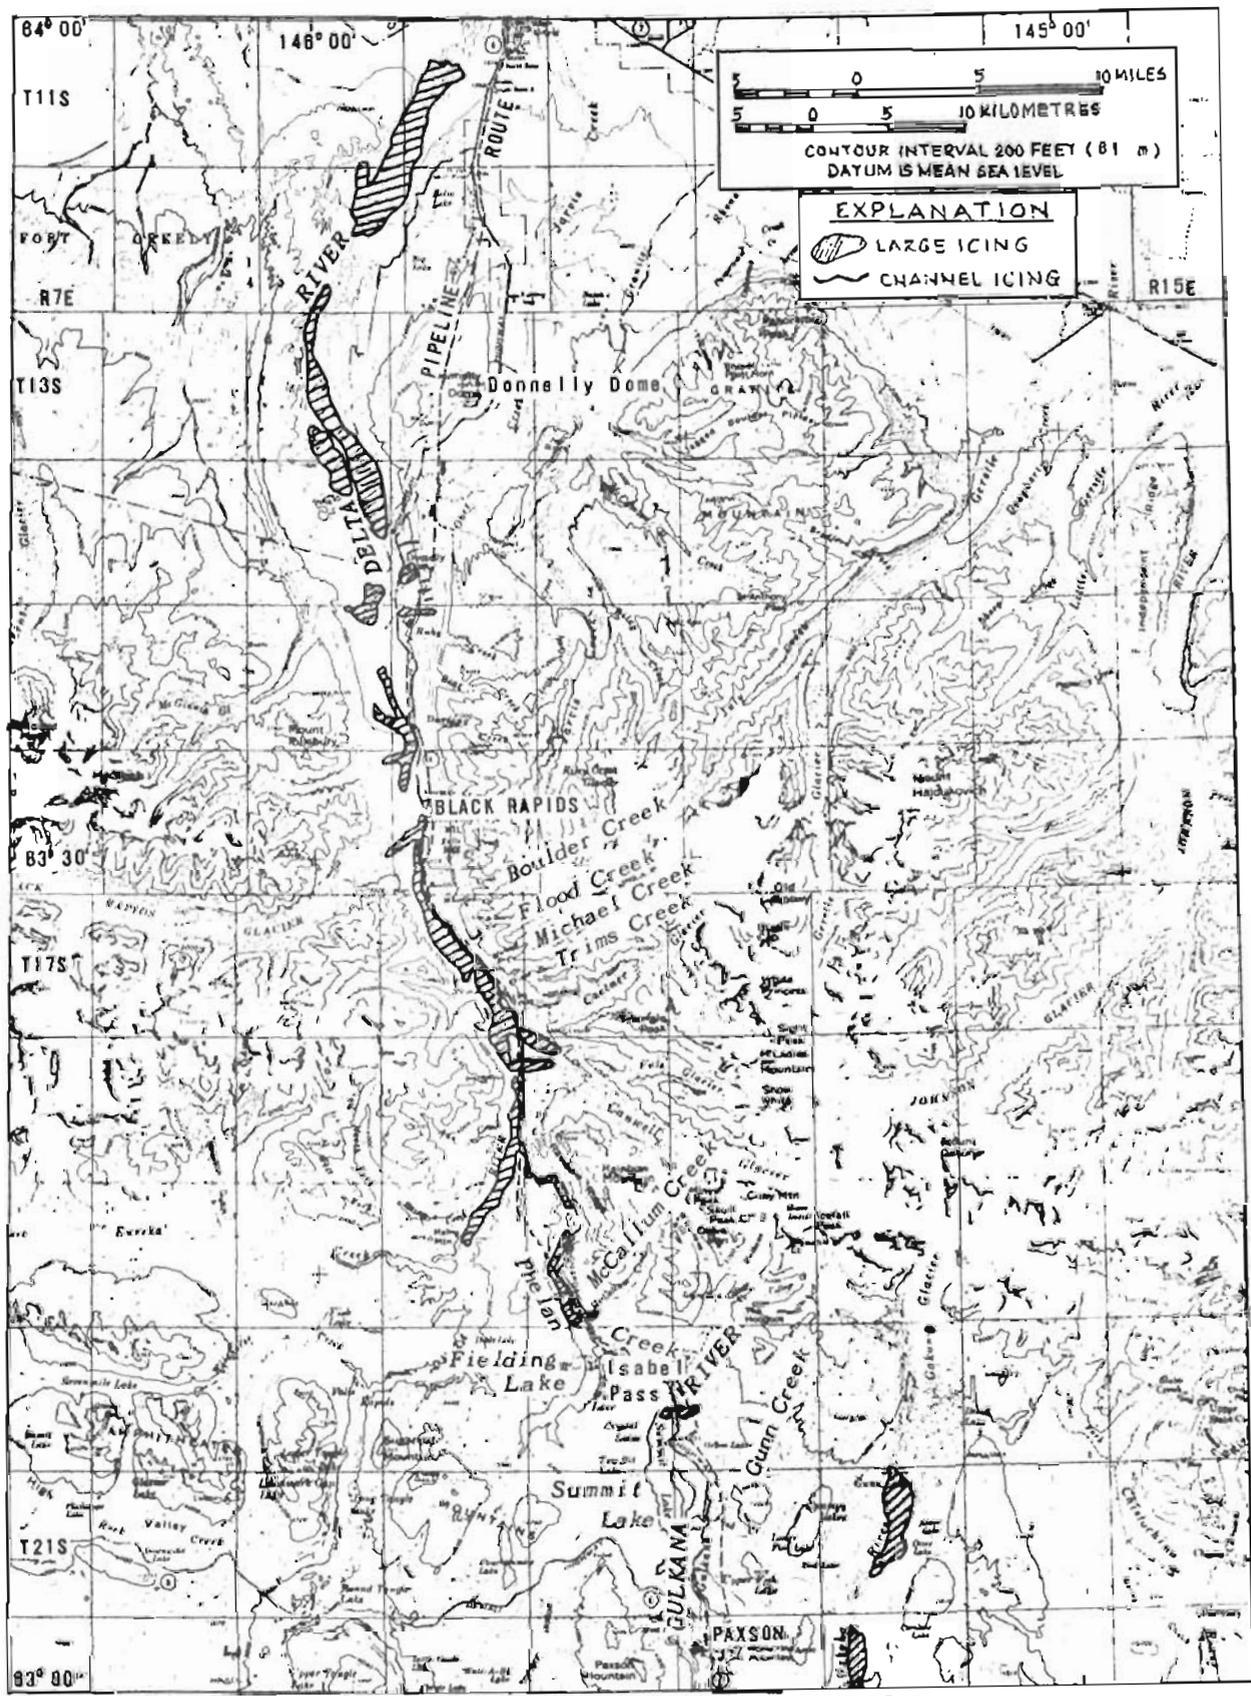
Small hillside and channel icings occur along the pipeline route between Donnelly Dome and Black Rapids (fig. 24). South of Black Rapids the pipeline route is in the active flood plain of the Delta River where extensive icings form annually (cover photograph; figs. 2, 25, and 26). The toes of several steep alluvial fans, including those of Boulder, Flood, and Trims Creeks, are crossed in this reach. The pipeline route also crosses the site of a large icing in Phelan Creek and site of another icing on the fan of McCallum Creek (fig. 27).

Figure 24.--Distribution of icings along the trans-Alaska pipeline route in the Mt. Hayes quadrangle.

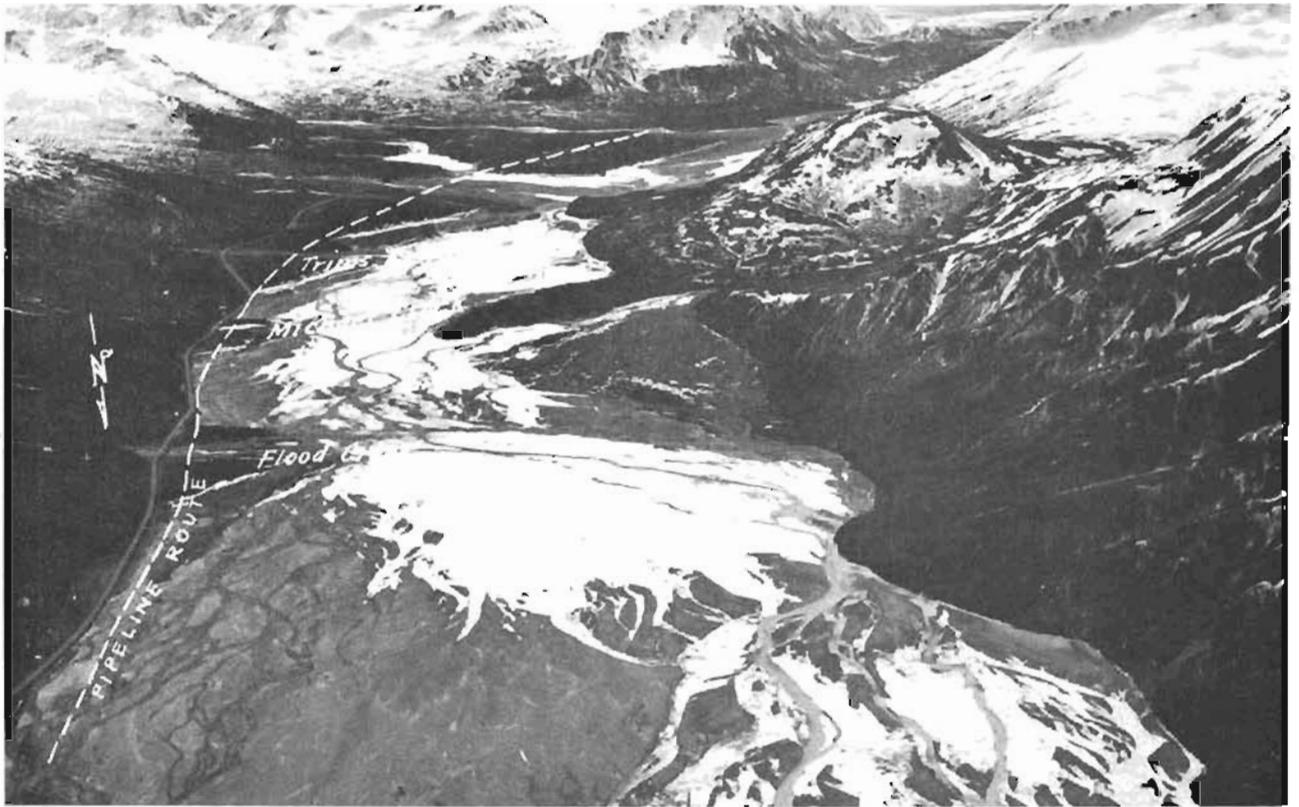
Figure 25.--Flood-plain icings along Delta River. Alluvial fans of Flood, Michael, and Trims Creek in left foreground. View south (upstream) on May 29, 1973.

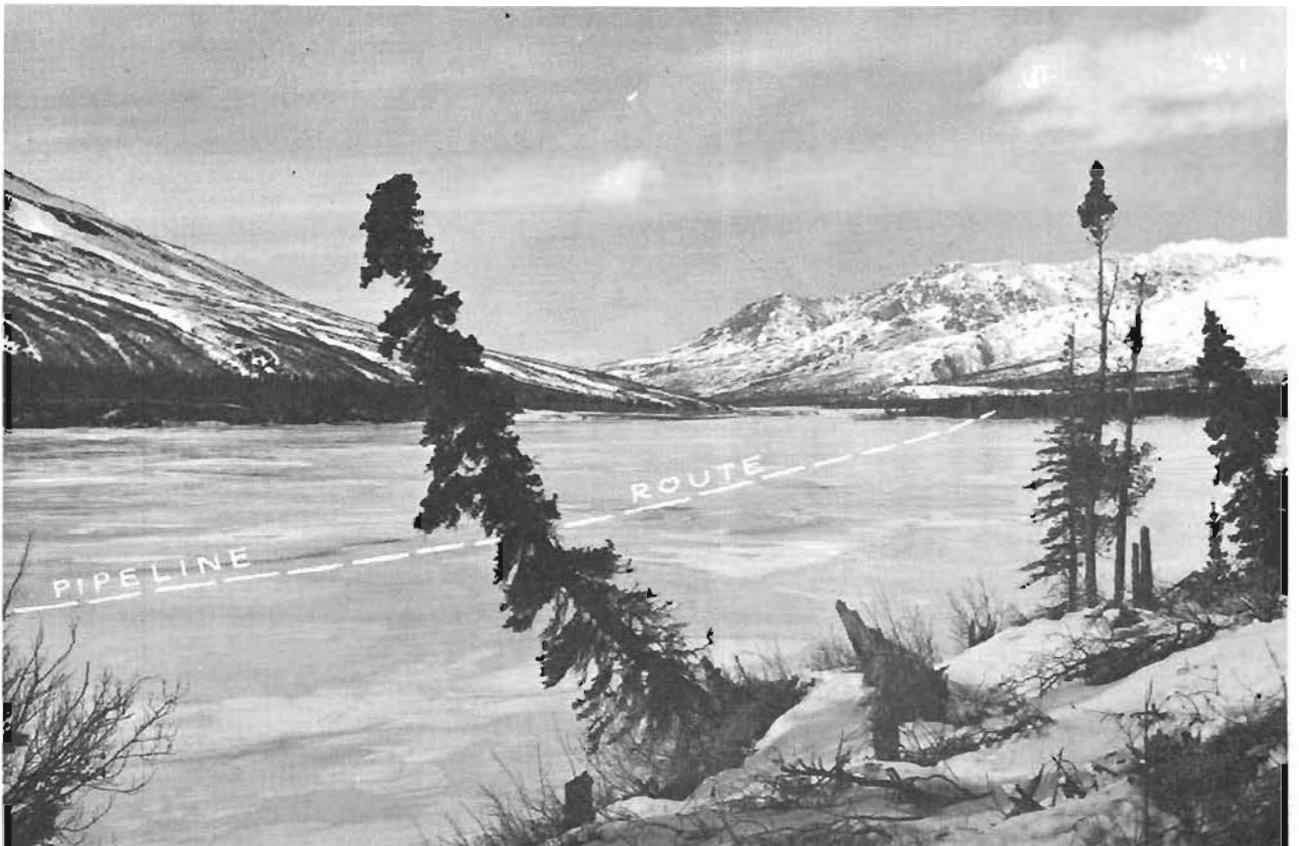
Figure 26.--Flood-plain icing in Delta River valley upstream from Miller Creek, April 18, 1974.

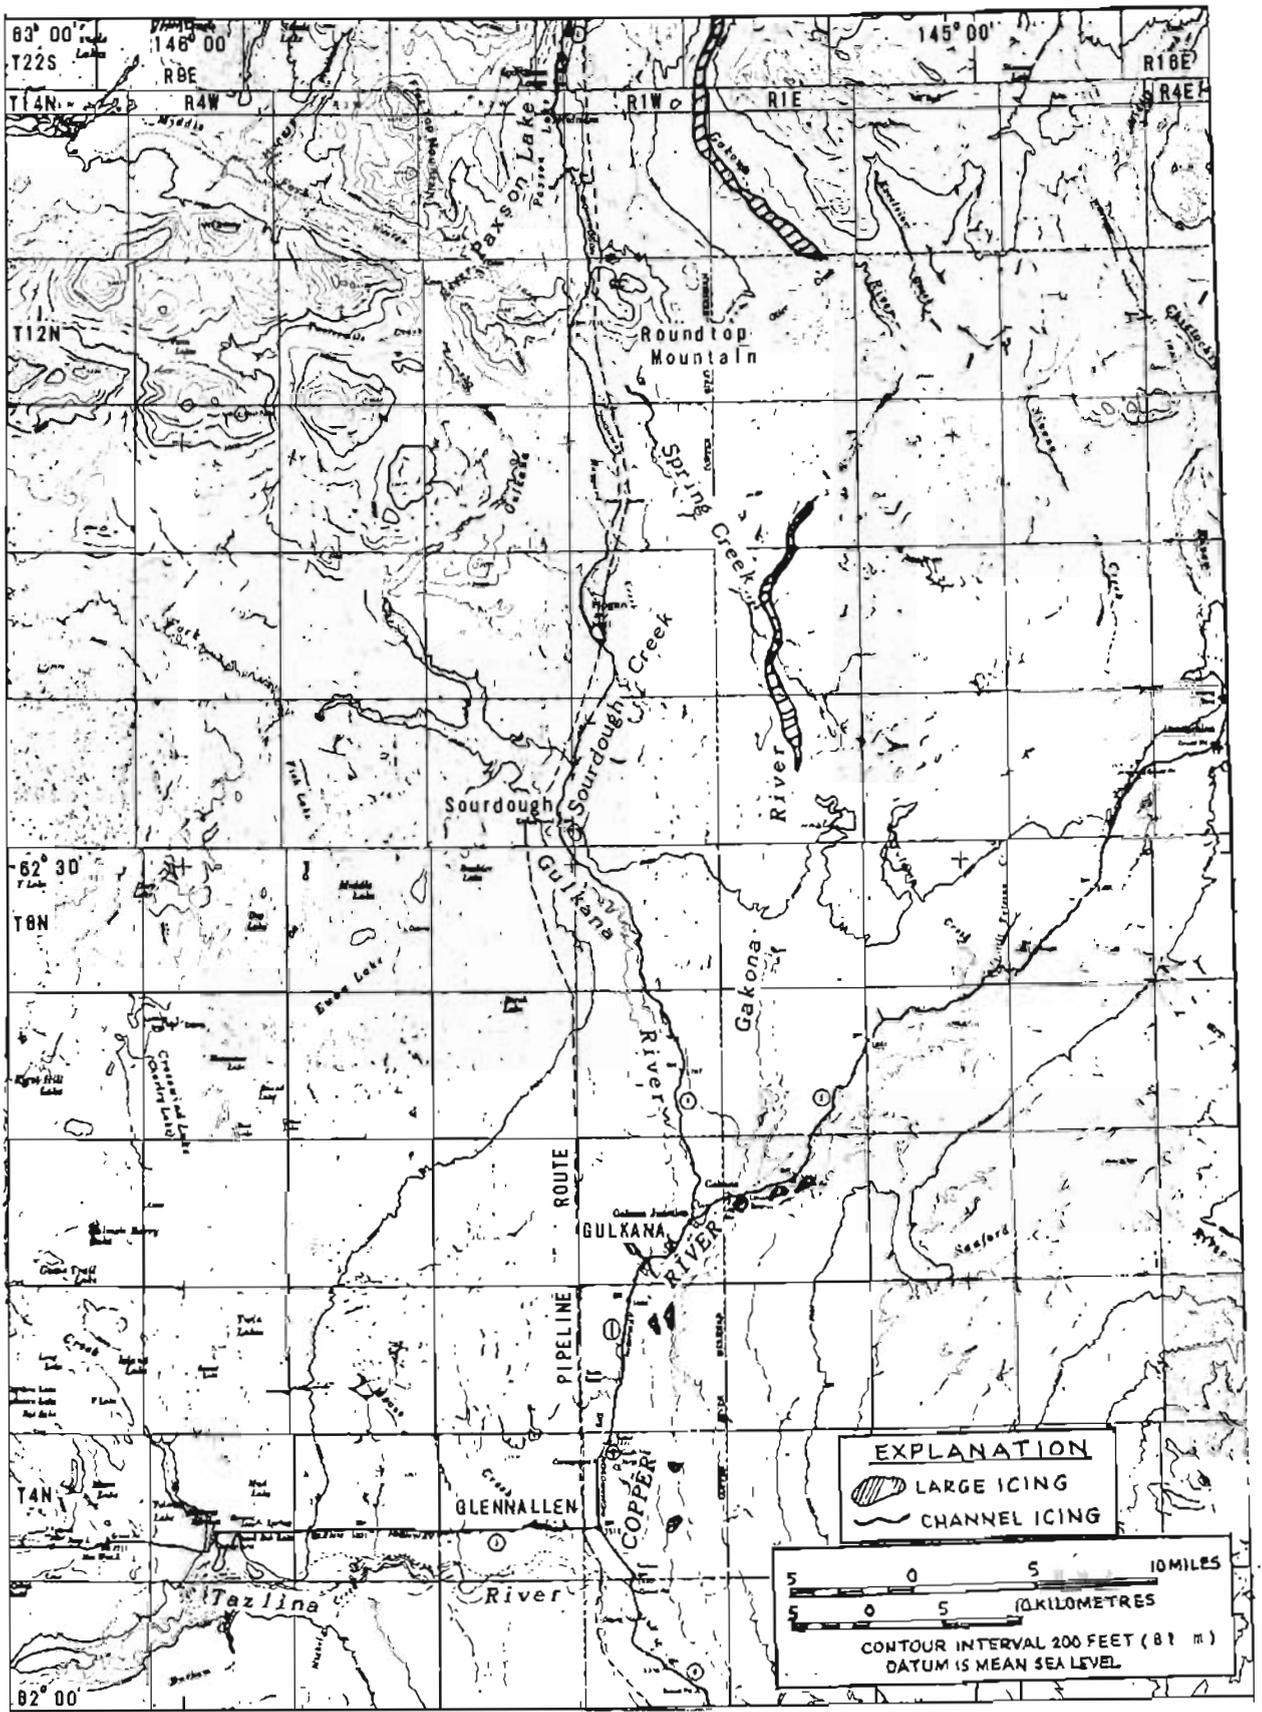
The main icings along the pipeline route through the Copper River basin are due to hillside springs and seeps, such as those along the Richardson Highway near Paxson Lake (fig. 30). Areas of stream icing occur along Spring Creek near Roundtop Mountain and along Sourdough Creek near the Gulkana River. Major icings have occurred at the Klutina River (fig. 31) and have inundated part of the town of Copper Center (U.S. Army Corps of Engineers, 1967). Large icings also form on the Tonsina River and Squirrel Creek below the pipeline crossing and have been reported on the Tazlina River (Williams, 1953). Normal channel ice with only minor overflow forms on the Gulkana River in the crossing reach (fig. 30).

Figure 30.--Distribution of icings along the trans-Alaska pipeline route in the Gulkana quadrangle.
