THE ALASKA EARTHQUAKE, MARCH 27, 1964:
EFFECTS ON TRANSPORTATION, COMMUNICATIONS, AND UTILITIES

Effect of the Earthquake
Of March 27, 1964, on
The Eklutna Hydroelectric
Project, Anchorage, Alaska

By MALCOLM H. LOGAN

GEOLOGICAL SURVEY PROFESSIONAL PAPER 545-A

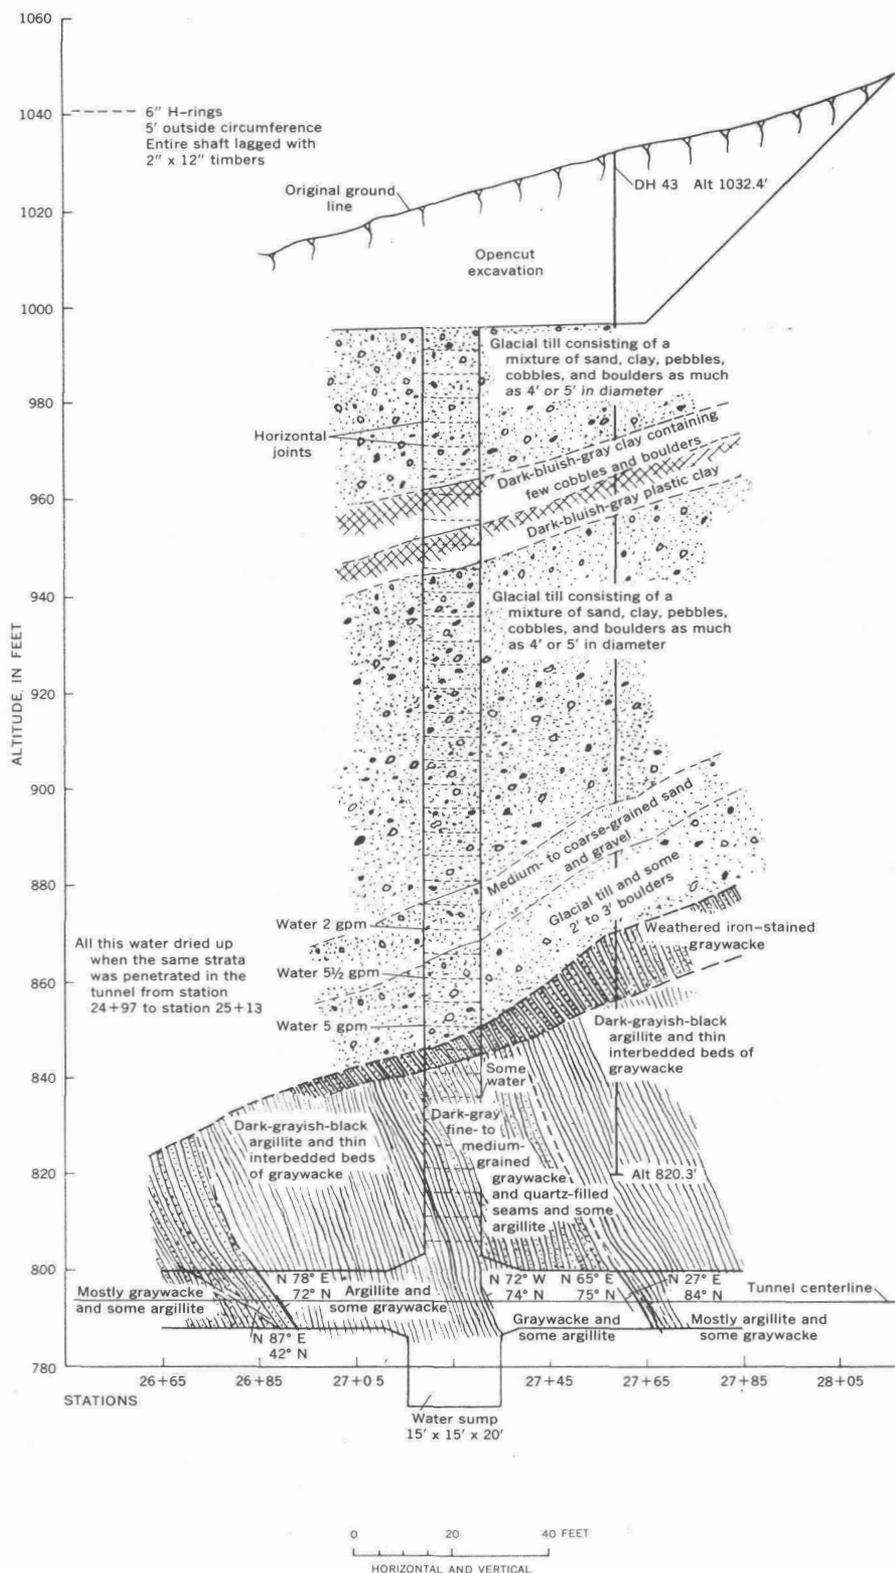
10.—Geologic section through gate shaft.

As part of the plan to design an earthquake-resistant structure, the gate shaft at station 27+25 was founded in competent rock (figs. 8, 10); it was reinforced to withstand internal bursting pressures. Horizontal joints in the shaft, indicated by dashed lines on figure 10, helped compensate for any possible vertical deflections during an earthquake. No damage to this structure was discernible.

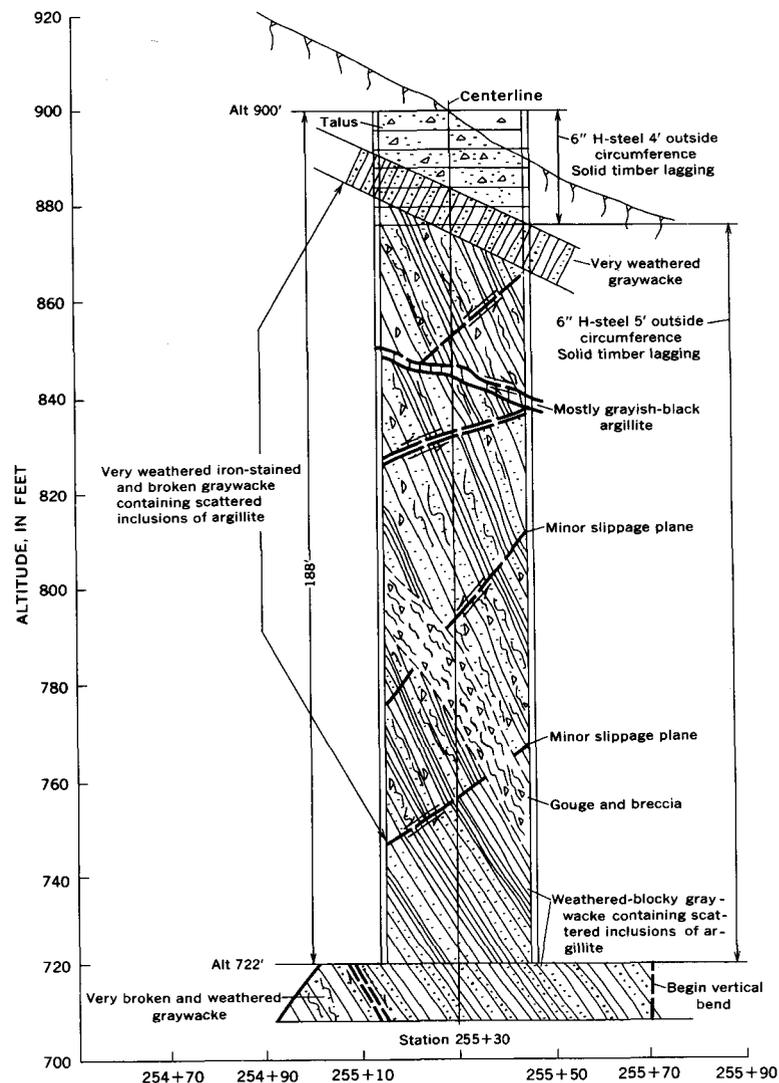
11.—Geologic section through surge tank.

The penstock tunnel was excavated in weathered rock, except at the lower end where the tunnel section emerges into overburden material (figs. 11, 12). In order to traverse this overburden material, which lay between the rock-tunnel section and the pile-supported penstock anchor, a special tunnel section had to be designed and built. In effect, this reach of tunnel was designed as a length of conduit supported at one end by the tunnel rock and at the other end by a pile-supported bent.

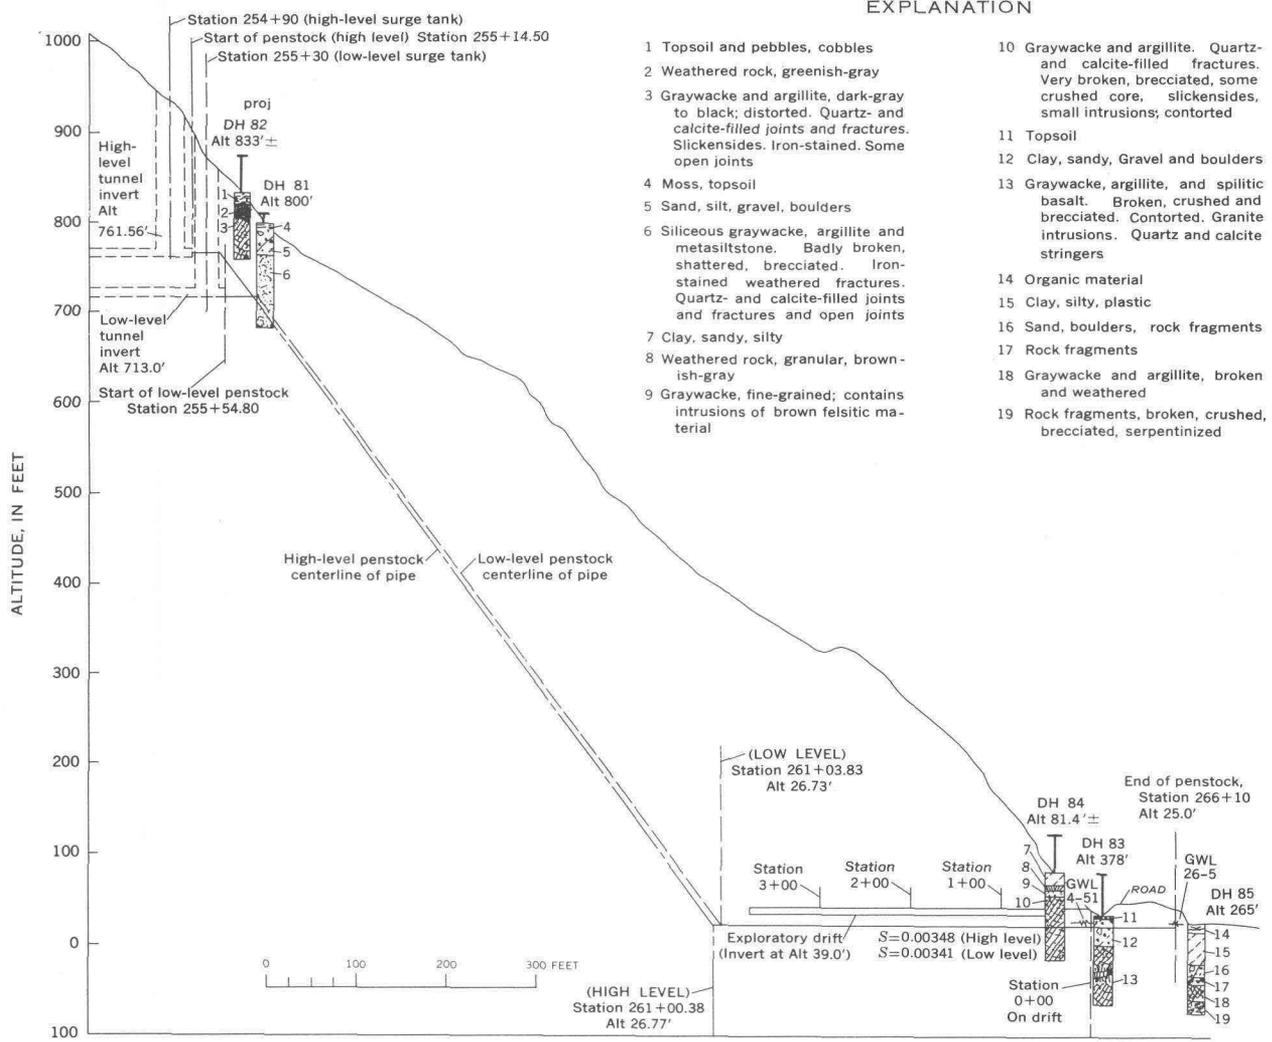
12 (above).—Section through surge tank, penstock, and anchor-block area, showing drill-hole data.

The penstock, surge tank, pile-supported anchor block, and powerhouse evidently oscillated as an integral unit during the earthquake. Very little relative movement occurred between these features although backfill in the anchor-block area subsided (fig. 13).

A maximum residual separation of one-sixteenth to one-eighth inch was measured in the penstock ports of the powerhouse wall. The entire penstock from the tunnel to the units appeared to have sustained no permanent deformation. Fine line cracks in the overlapped painted surfaces at the coupled sleeve joints did, however, indicate unusual pipe vibration.
