**MAP SHOWING GROUND WATER CONDITIONS
IN THE FAIRBANKS D-2 NW QUADRANGLE, ALASKA**

BY
TROY L. PEÑE AND JOHN W. BELL
1975

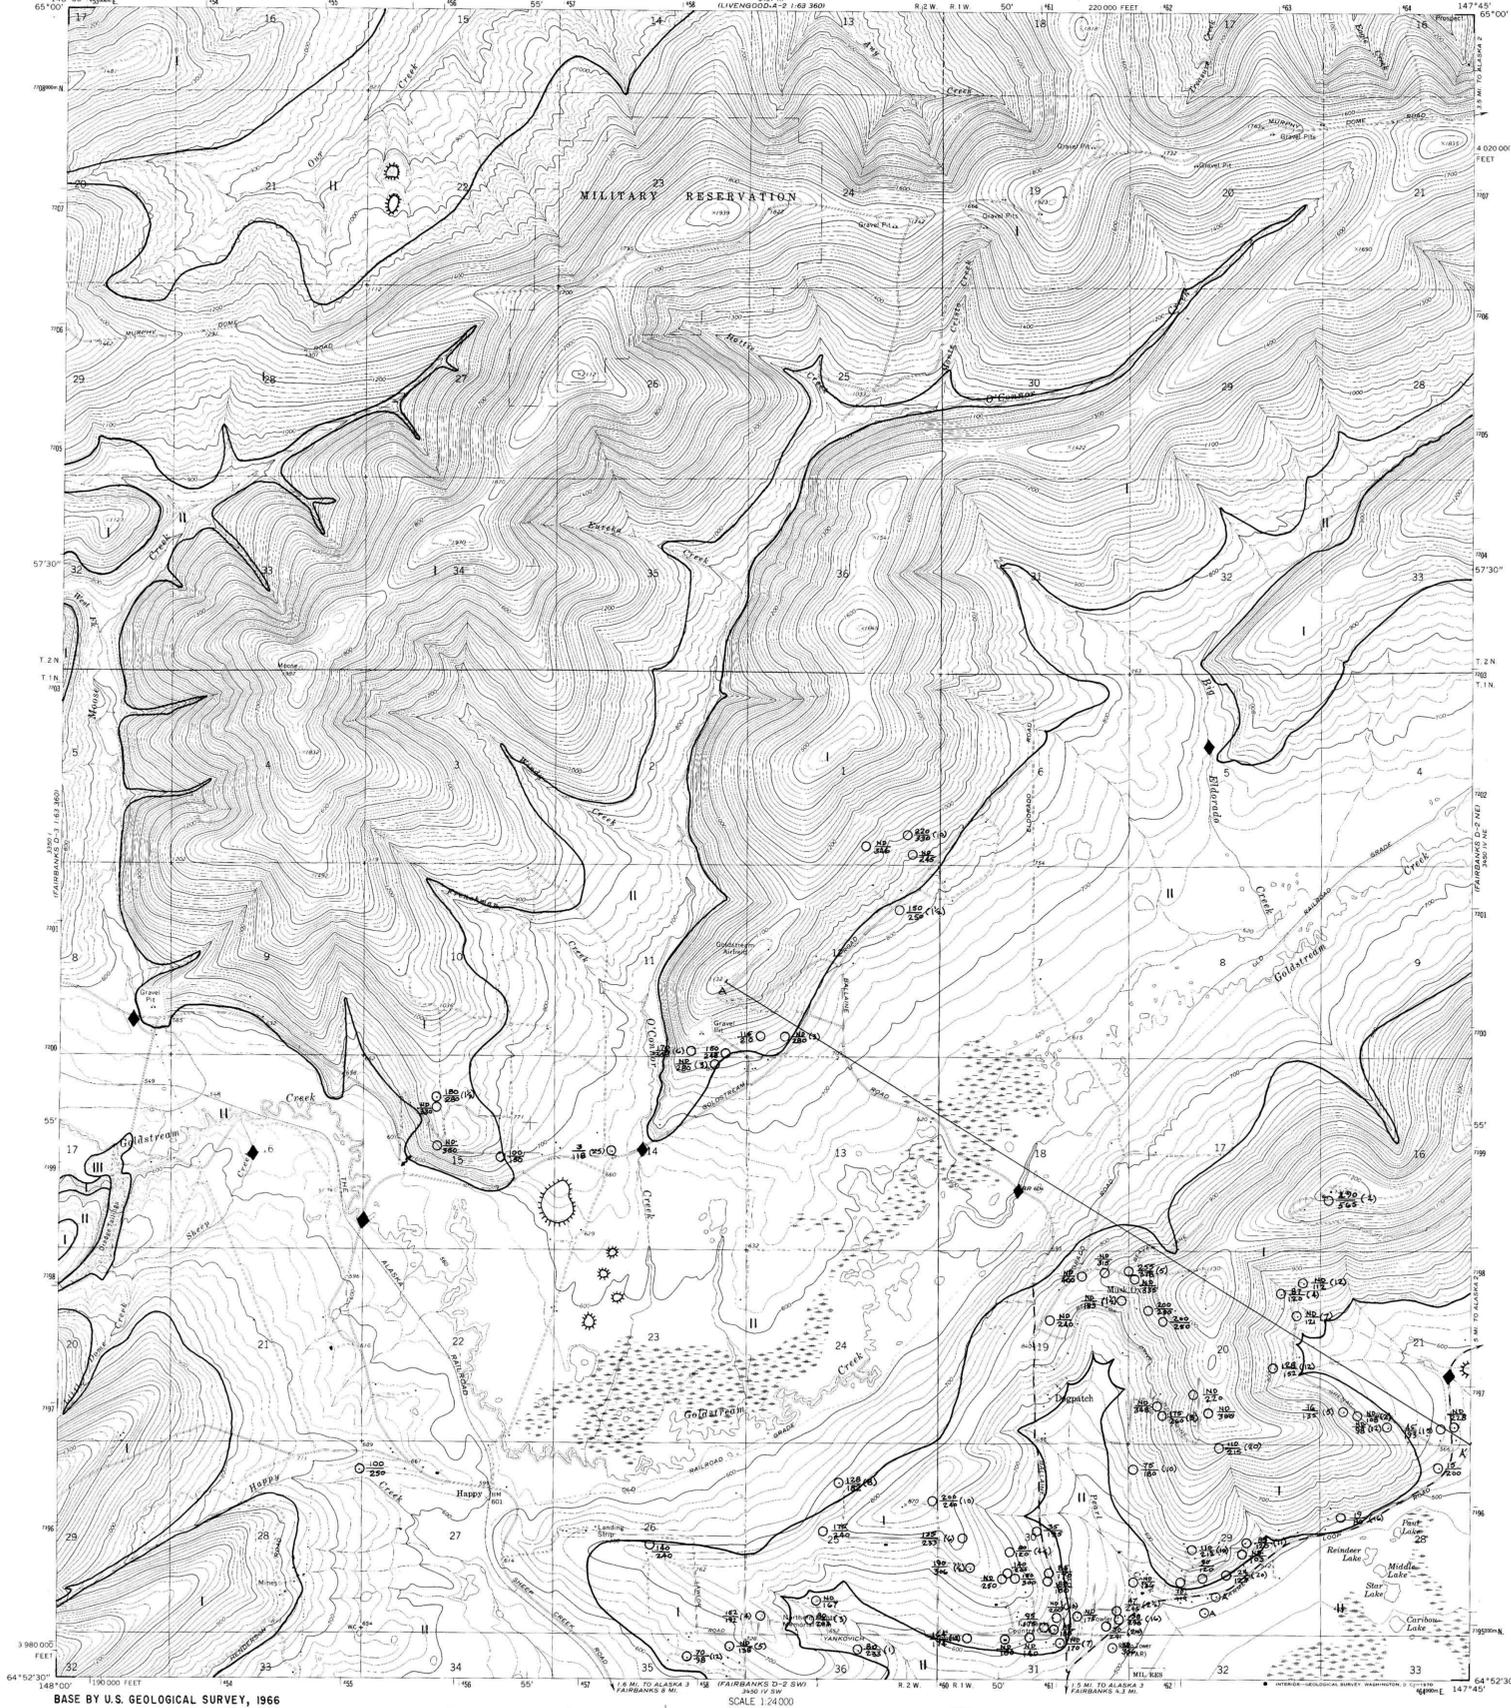
The ground-water units described below have been defined on the basis of occurrence, yield, recharge, and quality of ground water and type of aquifer. These units represent generalized conditions, and local variations may occur, especially near contacts between units.

Bedrock hills covered by 3-200 feet of windblown silt; 100-200 feet above valley bottom; water table influenced by permafrost along lower slopes. Water restricted to fractures, joints, and quartz veins. Good to very good quality; high hardness (100-400 ppm) but low iron content. Yields are generally low (2-10 gpm), recharge slow, and drawdown large.

Valley-bottom organic silt overlies creek gravel in major stream valleys of upland. Material permeability frozen; ground water available under permafrost. Ground water available locally beneath loess on permafrost-free loess-covered low hills (for example, Gold Hill). Unfrozen gravel 30-200 feet below the surface can yield moderate to high quantities (75-200 gpm). Very poor quality because of high organic content; very high iron content. Water quality probably better if water obtained from bedrock beneath muck and gravel. Artesian wells have moderate and continuous yields.

Exposed placer-mine dredge tailings as much as 75 feet thick; ground water present near base. Water-bearing characteristics similar to buried creek gravel; yield moderate to high. Poor quality because of possible organic contamination from adjacent muck. Better quality water obtained by penetrating underlying bedrock. Yield from bedrock 2-15 gpm.

Well
Top number, static water level; bottom number, total depth of well; number in parentheses, yield (gallons per minute) if known; ND, no data; A, artesian well. Only representative or available wells shown.
