THE ALASKA EARTHQUAKE, MARCH 27, 1964:  
EFFECTS ON THE HYDROLOGIC REGIMEN

Effects of the March 1964  
Alaska Earthquake  
On the Hydrology  
Of South-Central Alaska

By ROGER M. WALLER

GEOLOGICAL SURVEY PROFESSIONAL PAPER 544-A

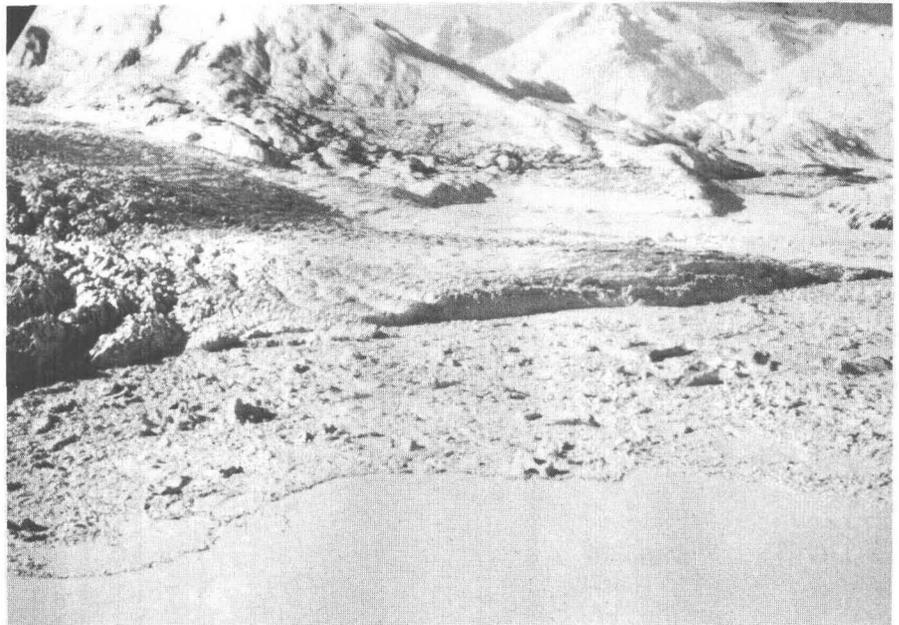
3.—Front of Colony Glacier shattered by earthquake and scattered on Lake George ice; photograph by C. M. Hembree, April 4, 1964.

Where the lakes fronted glaciers (fig. 3), some glacier fronts were shattered and glacial ice was thrown out onto the ice-covered lake. Although Ragle and others

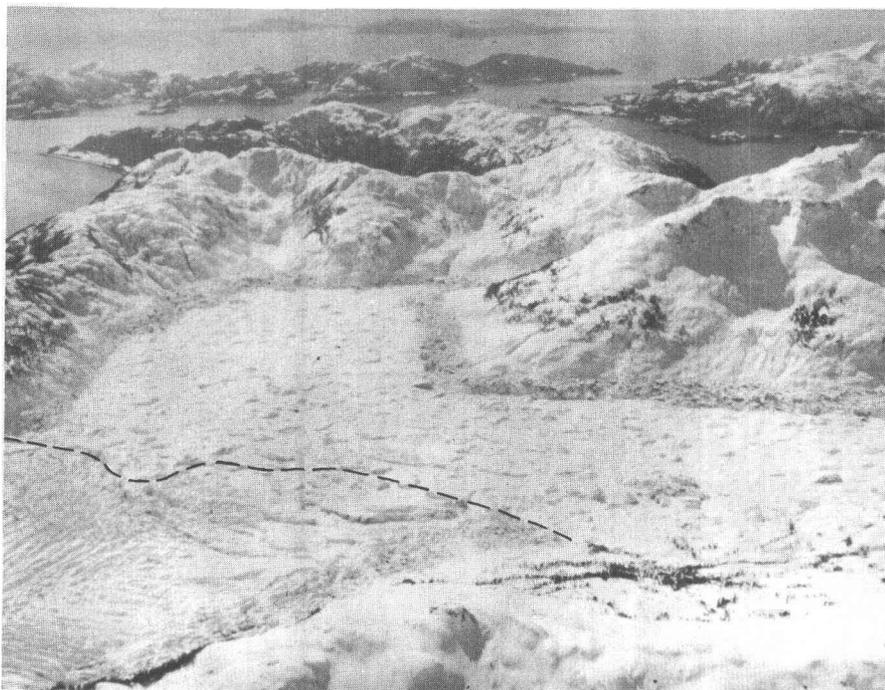
4.—Earthquake-induced features on lakes. A, Pressure ridges on Kenai Lowland lake. B, Broken ice on a lake fronting Columbia Glacier; dashed line indicates front of glacier; photograph by C. H. Hembree, April 4, 1964.

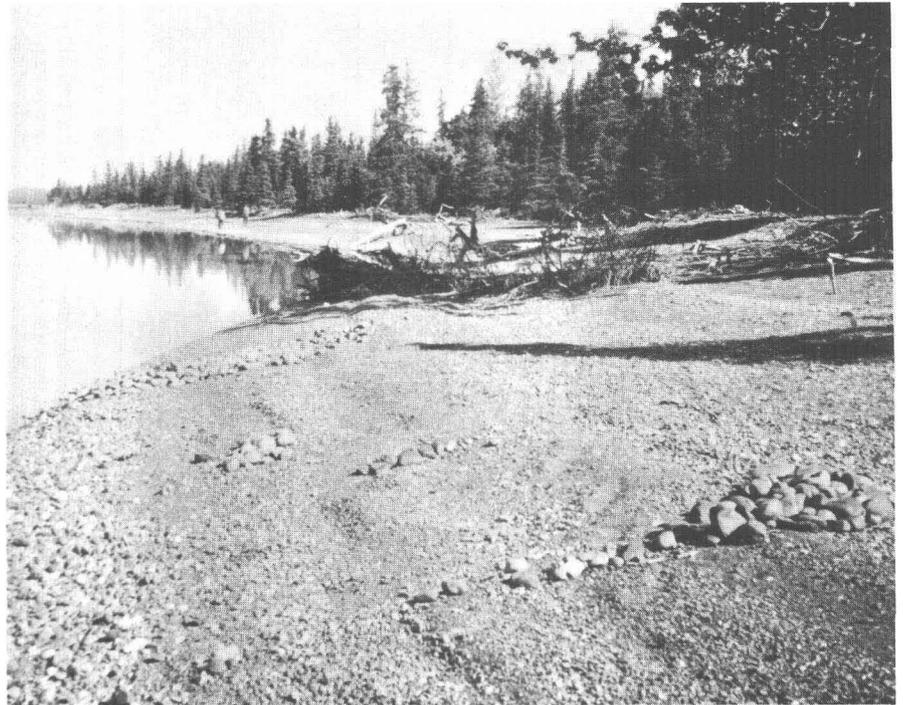
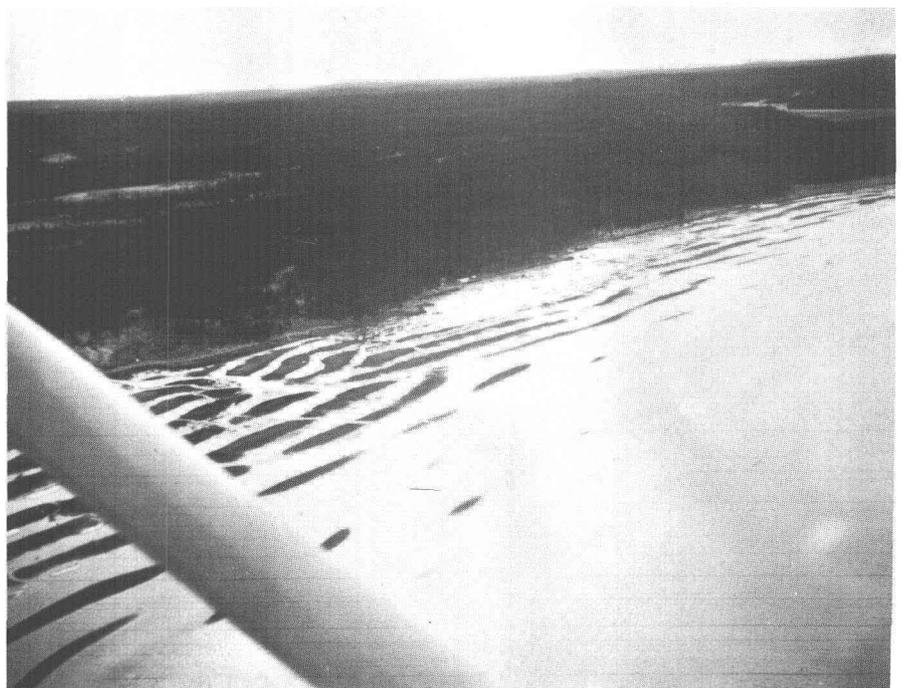
5.—Seiche-induced features on lakes. A, Deposits of iron-stained gravel derived from nearshore lake ice washed up on the beach by seiche waves. B, Lake-bottom ripples possibly formed by organic material sorted by seiche waves.

Some effects of wave action continued to be visible long after the earthquake. At Tustumena Lake, isolated piles of gravel and cobbles on the beach (fig. 5A) were obviously foreign to the beach and were probably derived from the underside of ice blocks that had been washed up on shore by wave action. The nearshore lake ice had frozen into the beach prior to the quake. Other investigators noted similar deposits on other lakeshores. In the Copper River basin the Alaska Department of Fish and Game (1965, p. 35) reported that ridges of sand and gravel, deposited from ice, blocked some lake outlets. Ripples composed of organic material, probably derived from the beach, formed in a shallow embayment of Tustumena Lake at low lake level (fig. 5B). The ripples were about 1-2 feet high and about 50 feet between crests. These ripples may have been formed by the extended seiche action after the quake. Local residents did not recall having seen such ripples prior to the quake.

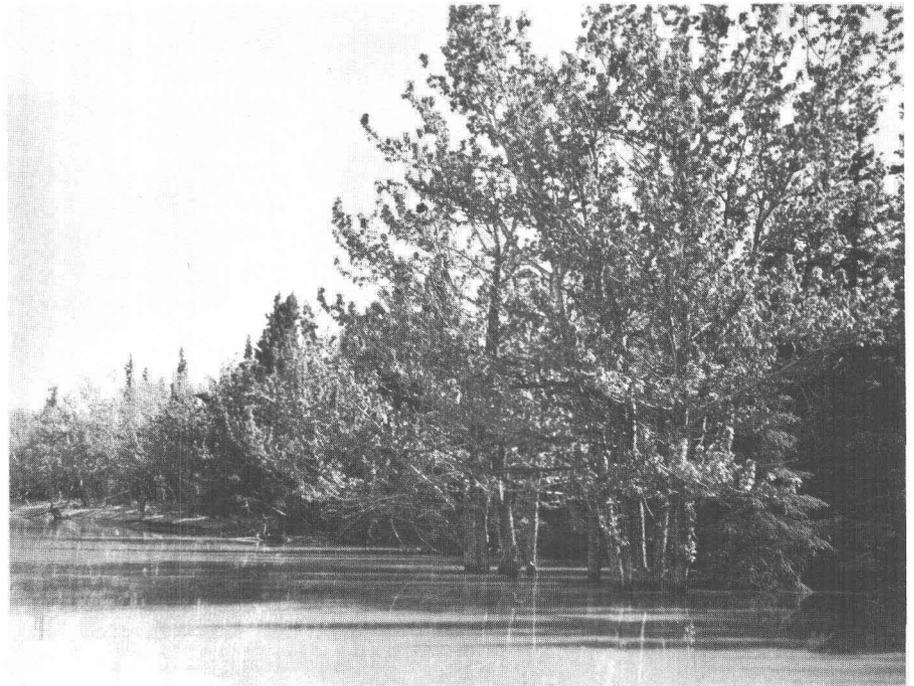
7.—Trees submerged by minor earth slump along lakeshore.

were submerged (fig. 7) as the land subsided. McCulloch (1966) reported that the earthquake-induced slides in Kenai Lake generated waves that washed back into the slide area and also waves that hit the opposite shore. These waves destroyed buildings and scarred the trees several feet above ground level.

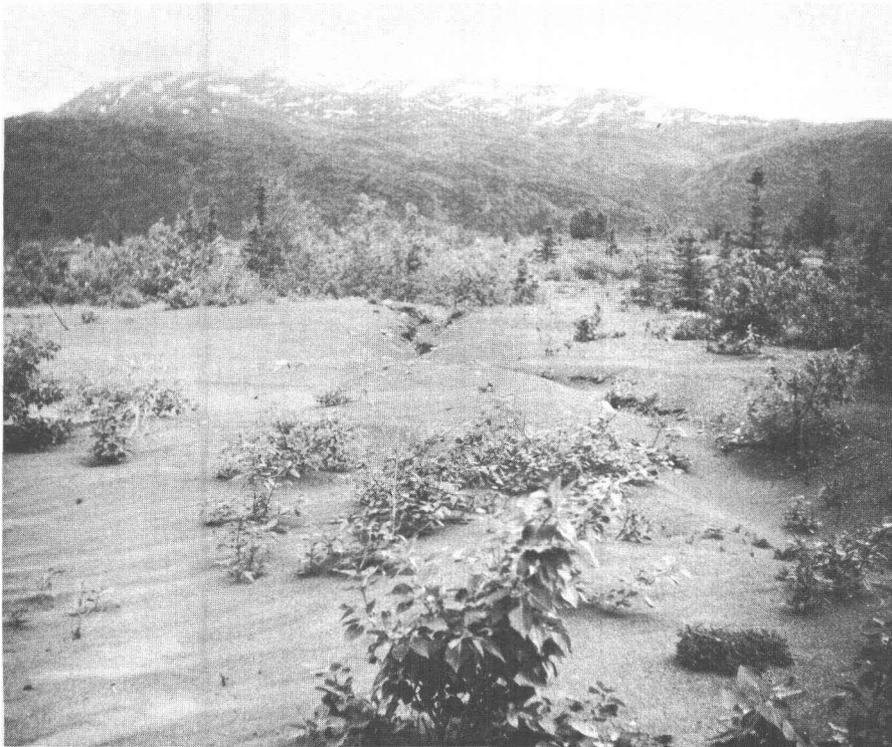
17.—Sand flow from 2-foot fissure more than 200 feet long, parallel to Tustumena Lake shore. Sand flowed mainly to left toward the lake.

In some places (fig. 17, p. A16), the outflows removed so much ma-
